Savannah (SC 170, US 17) and Pinckney Island (US 278) National Wildlife Refuges

Road Safety Audit

Beaufort and Jasper Counties, South Carolina

March 5-6, 2008

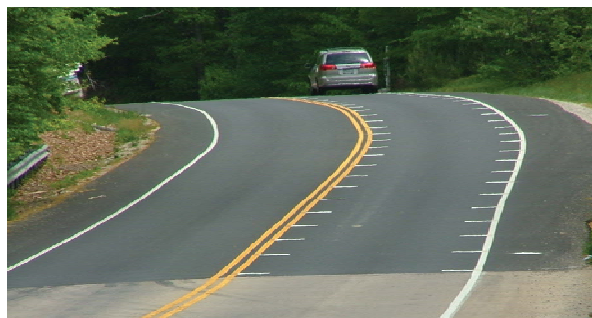
Example of placement of optical speed bars. These will have minimal noise impacts on the refuge.

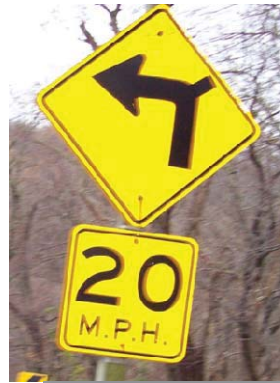
Photo shows an example warning sign that could be used to warn motorists of the entrance to the Laurel Hill Wildlife Drive. The speed advisory plaque should be based on current roadway conditions. There is currently a 45mph curve advisory sign near the entrance to Laurel Hill.

Suggestions: Consider installing signs to warn motorists of turning and entering vehicles.

- The MUTCD shows that a W1-10 may be considered for warning of entrances to park and maintenance facility because it shows location of intersection on curve (photo to the right shows a similar sign).
- The sign described above could be supplemented with flashing beacons. Curve advance warning sign with flashing beacon can result in a 30% reduction in total crashes (FHWA-SA-07-015).
- For the maintenance facility, special warning signs may be appropriate to warn motorists on SC-170 of heavy vehicles turning into and out of the maintenance facility.
- US-278 can have a traffic signal in flash mode, provided the signal warrants are met. The signal would flash yellow on the mainline and red on the side roads during the day. The signal could be dormant at night because the park is closed.

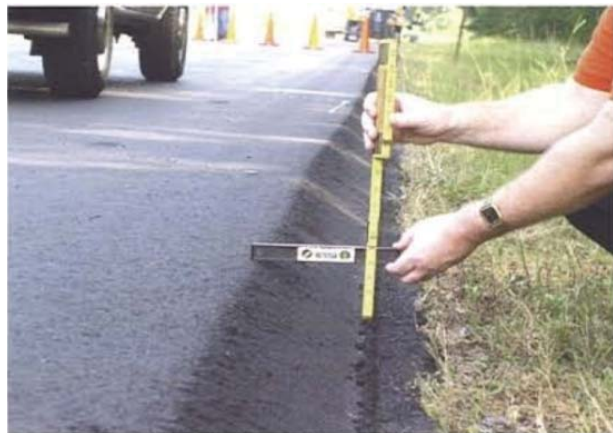
Photo shows an example of a safety edge. The beveled edge is installed at a 30 degree angle.

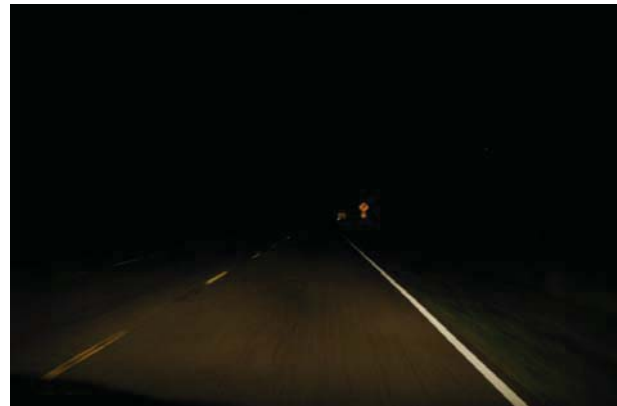
Photo shows a relatively good example of a section with retroreflective pavement markings and high-intensity signs.

Suggestions: Consider options to enhance guidance for motorists during nighttime and poor visibility conditions:

- Upgrade to retroreflective signs and pavement markings.
- Replace missing RPMs.
- Install post-mounted delineators along corridor, especially at horizontal curves. Post-mounted delineators on rural two-lane curves reduced run-off-road crashes by 15 percent (Foody and Taylor, 1966). The FHWA Low Cost Safety Improvements Workshop indicates that post-mounted delineators reduce run-off-road crashes between 25 to 58 percent.

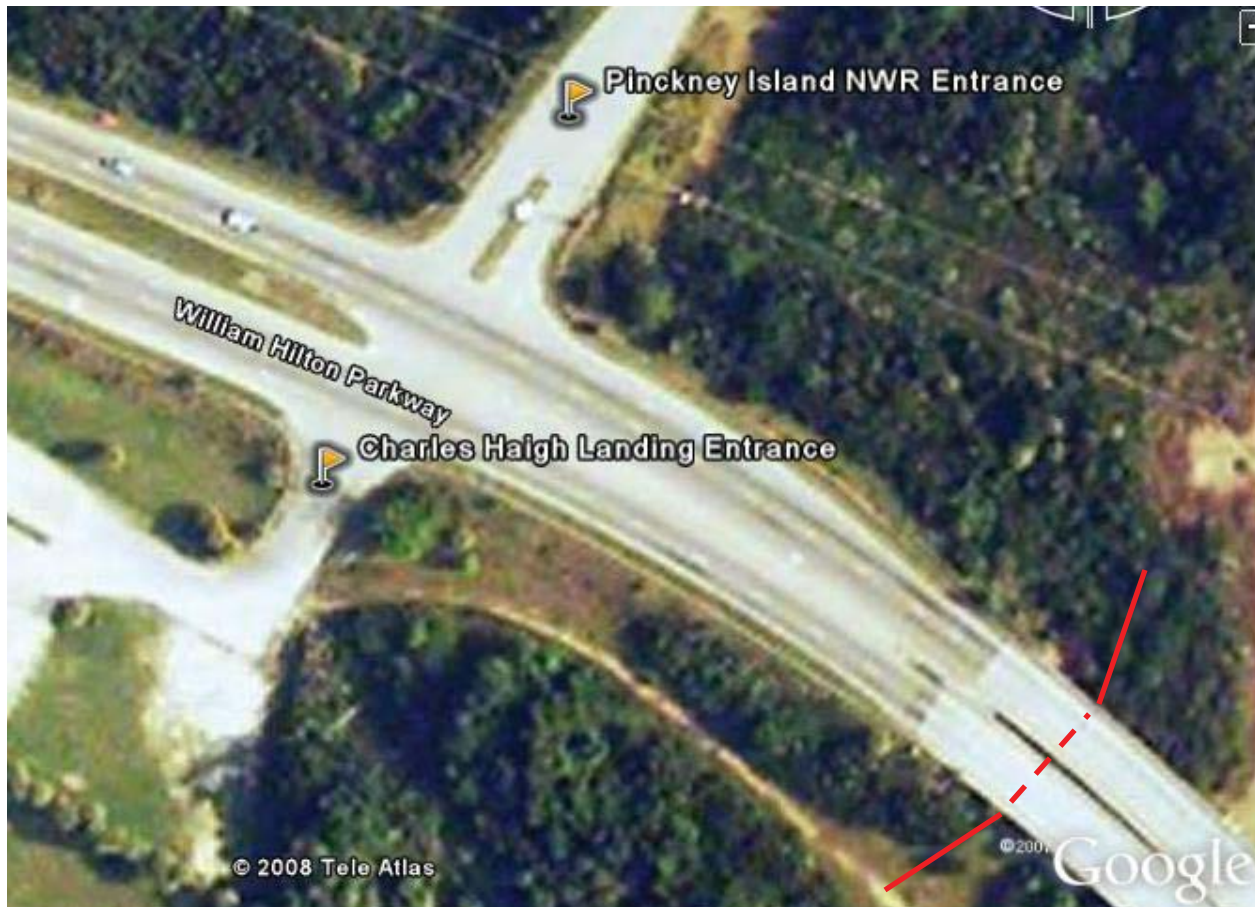
Appendix B: Illustration of Proposed Underpass at Pinckney Island

Photo shows existing access points to Pinckney Island NWR and Charles Haigh Landing. Visitors traveling from one to the other must cross US-278 (William Hilton Parkway), which has been identified as a major safety concern. There is the potential to construct an underpass to provide a safe route between the two locations without crossing US-278. With the construction of an underpass, the entrances to the two facilities could also restrict left-turns, which would also enhance safety. There is an existing access road from the parking lot of Haigh Landing toward Hilton Head Island, which would provide access to the proposed underpass. The proposed location of the underpass is shown by the red line in the photo.
