The Road Inventory of Long Lake National Wildlife Refuge Moffit, North Dakota

Prepared By:
Federal Highway Administration
Central Federal Lands Highway Division
June 2008

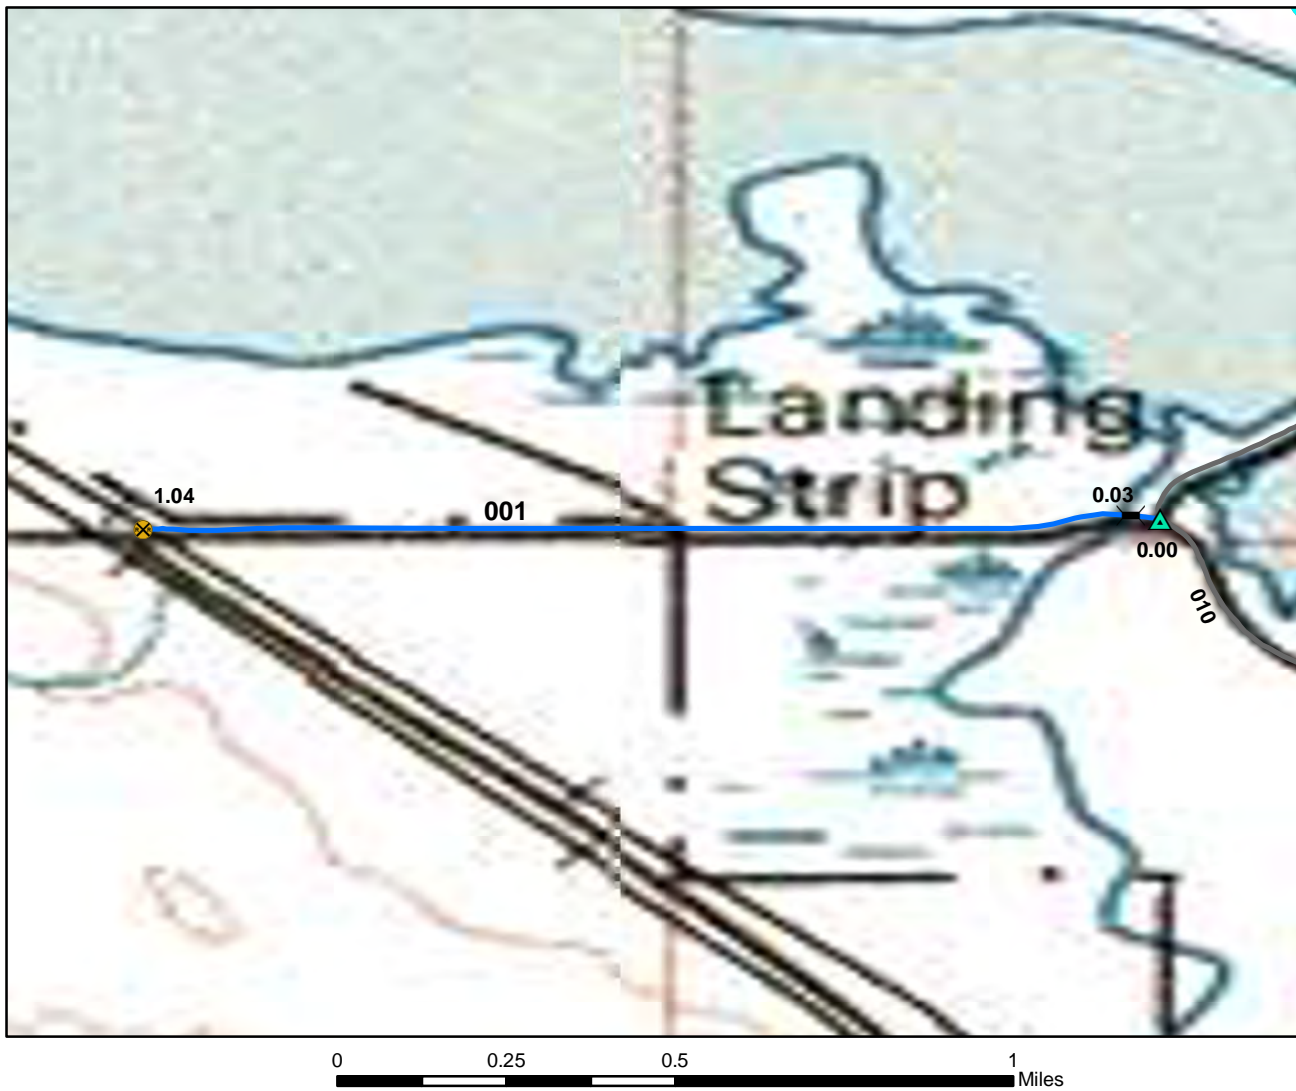
ROUTE: 011 West Access Road TOTAL LENGTH: 1.04 Miles

Section Number	001				
Section Length (miles)	1.04				
Inspection Date	6/16/2008				
Section Information					
Surface Type	Gravel				
Number of Lanes	2				
Roadway Width (feet)	24				
Roadway Condition Information					
Condition	Excellent				
Remaining Service Life (years)	8				
Cost Estimate	\$0				
CRV	\$683700

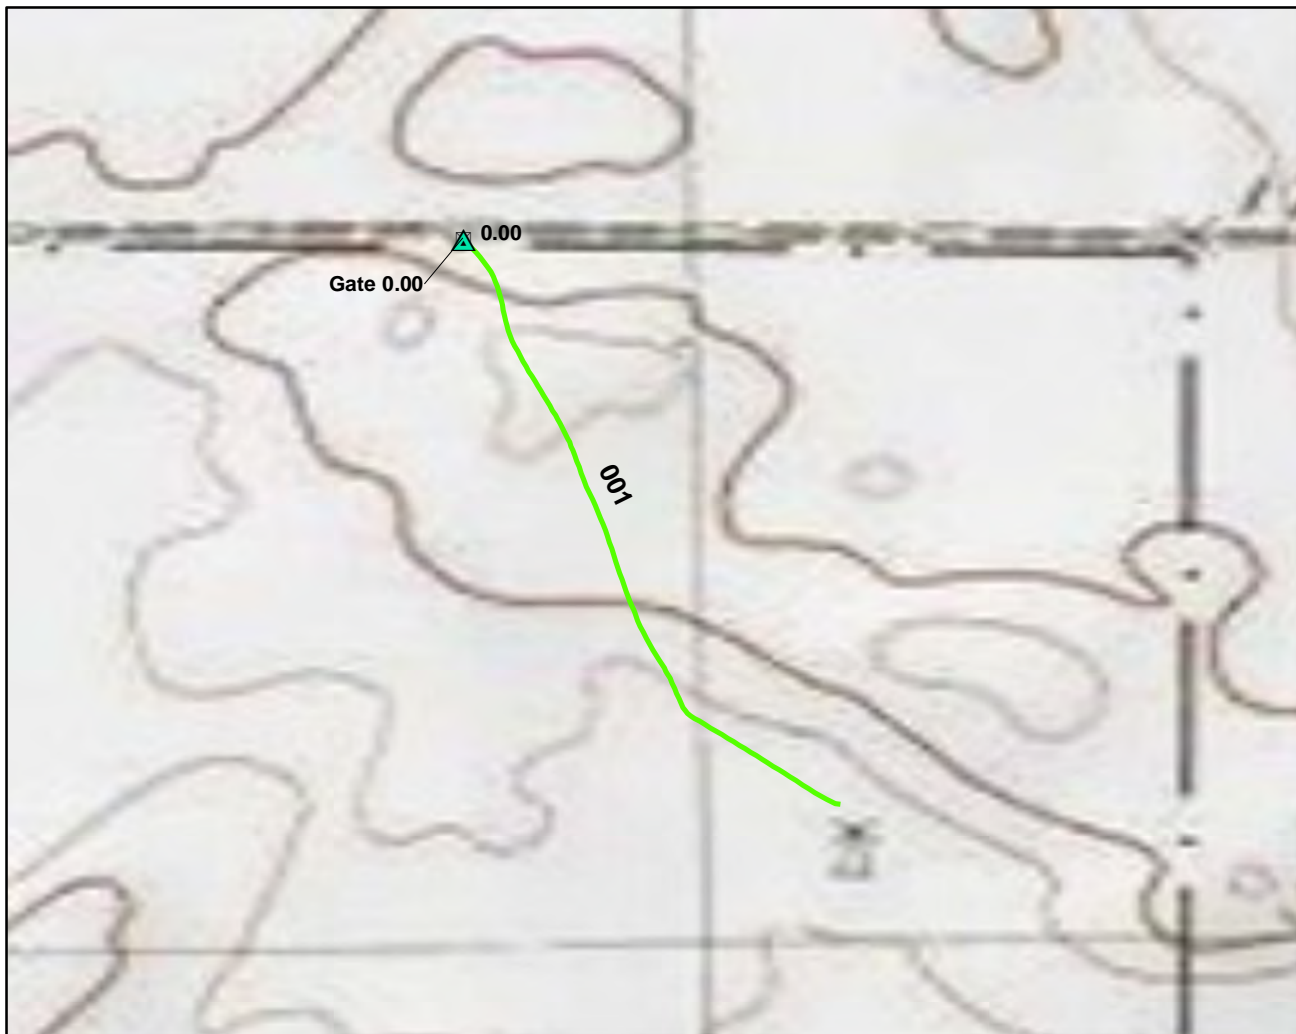
ROUTE: 400 G-7/G-8 Service Trail TOTAL LENGTH: 1.08 Miles

Section Number	001	002			
Section Length (miles)	1.03	0.05			
Inspection Date	6/16/2008	6/16/2008			
Section Information					
Surface Type	Native	Primitive			
Number of Lanes	1	1			
Roadway Width (feet)	8	8			
Roadway Condition Information					
Condition	Fair	Good			
Remaining Service Life (years)	3	5			
Cost Estimate	\$2100	\$0			
CRV	\$349100	\$0

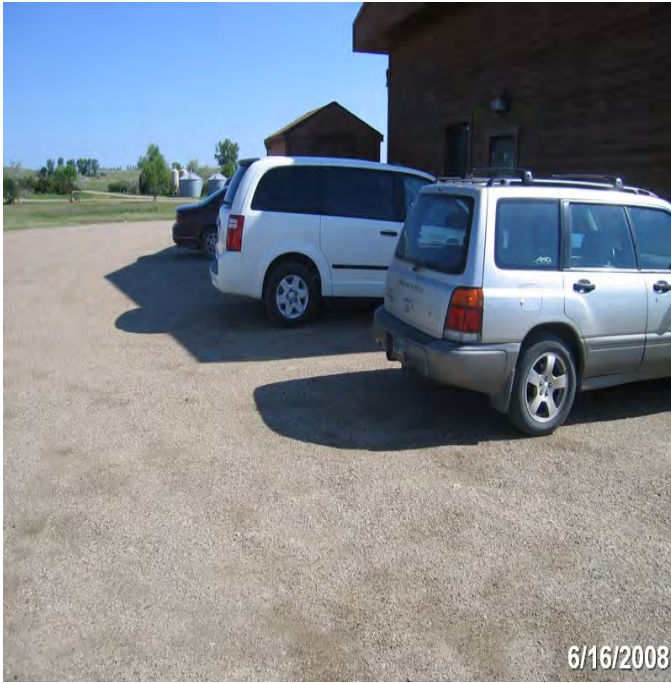
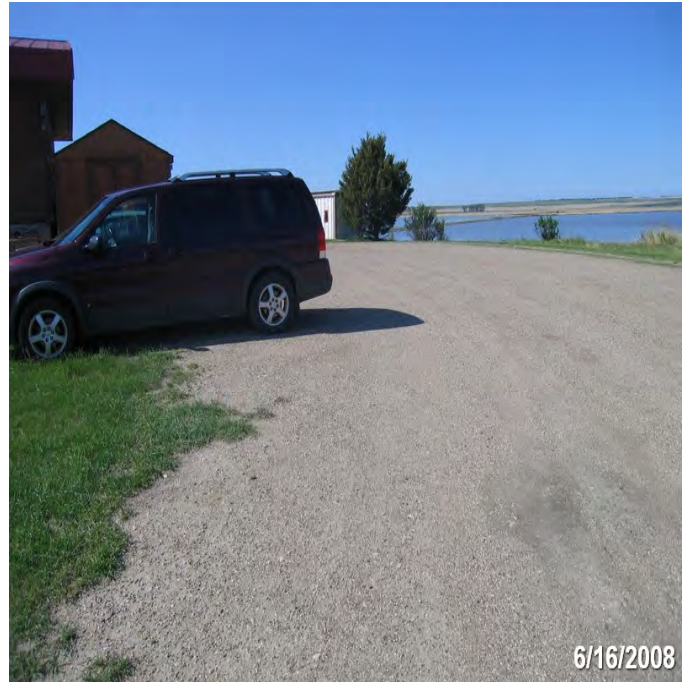
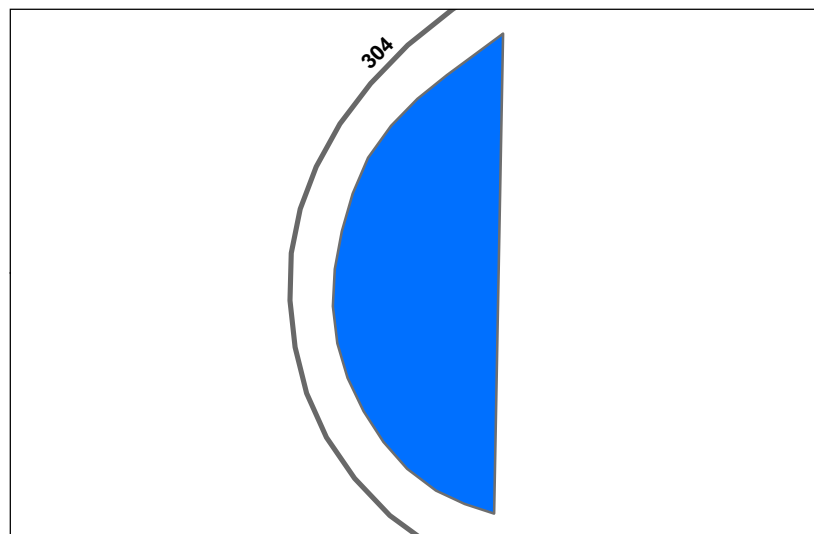
Route 800: Headquarters Employee Parking

Asset Number	Date Visited	Surface Type	Area (sq ft)	Condition	Cost to Improve
10045727	6/16/2008	Gravel	3287	Excellent	\$0

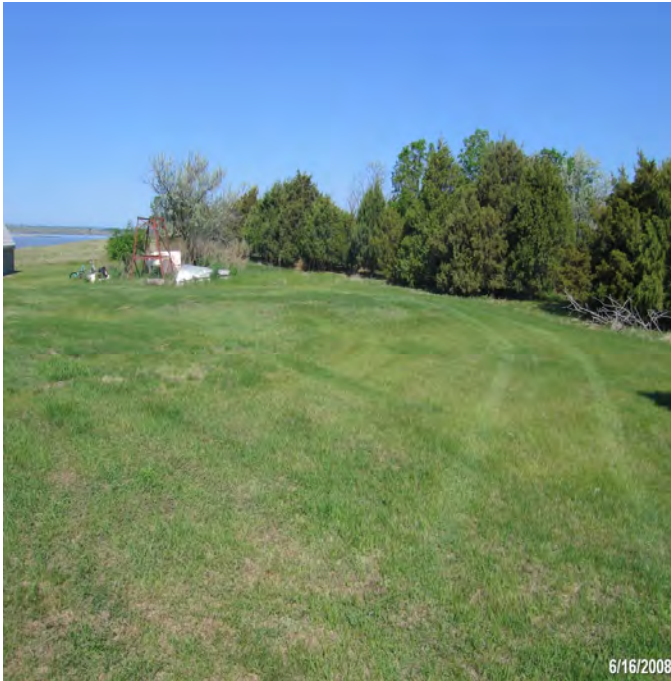
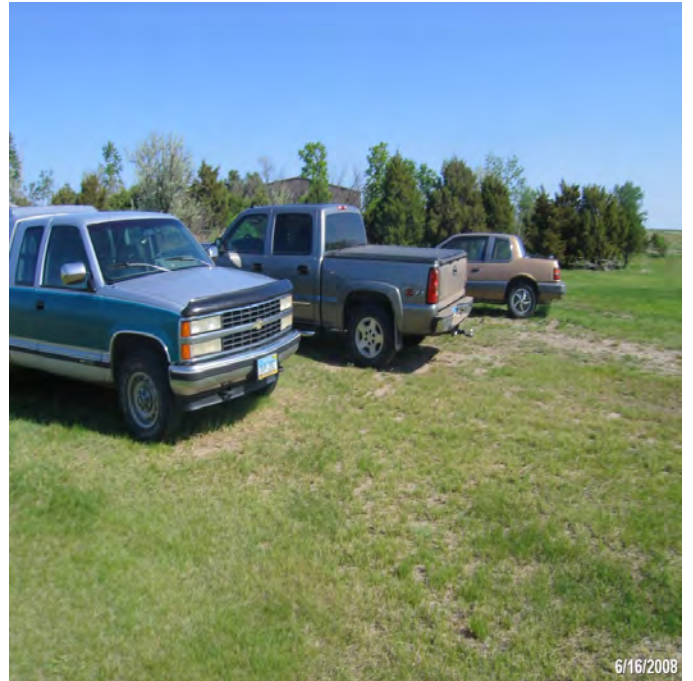
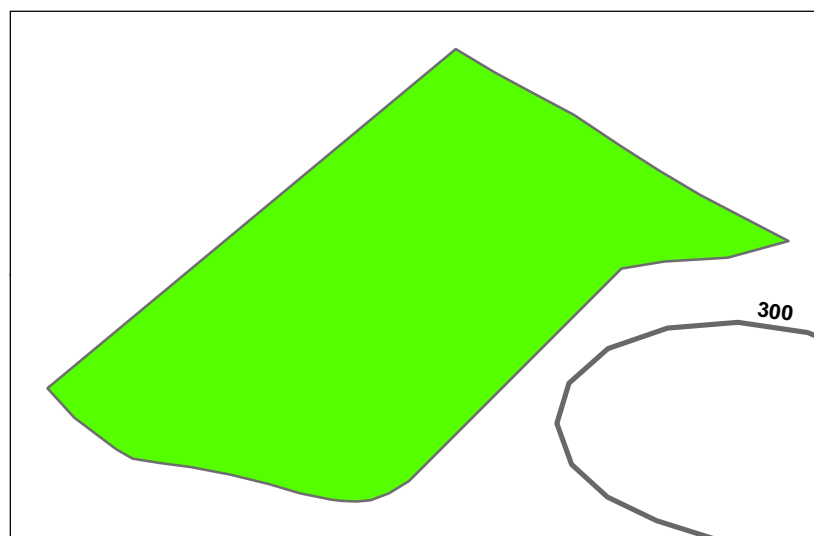
Route 801: Employee Quarters Parking

Asset Number	Date Visited	Surface Type	Area (sq ft)	Condition	Cost to Improve
10045727	6/16/2008	Native	5255	Good	\$800

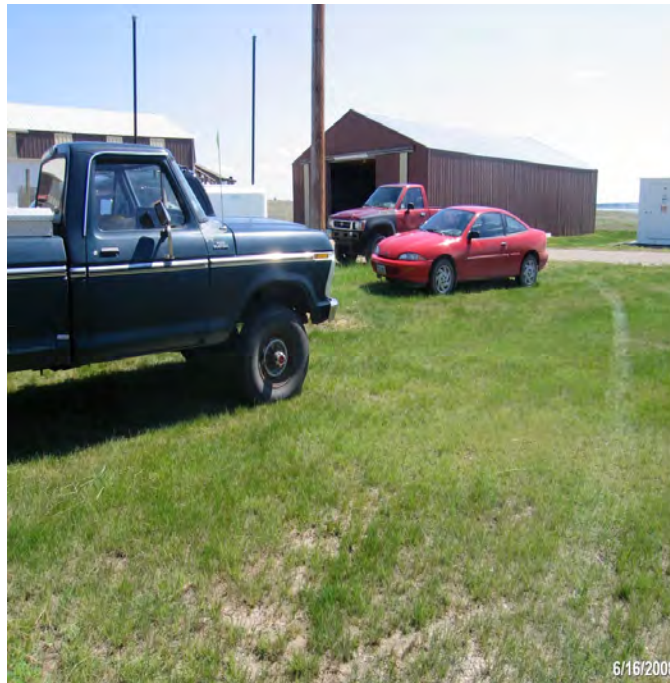
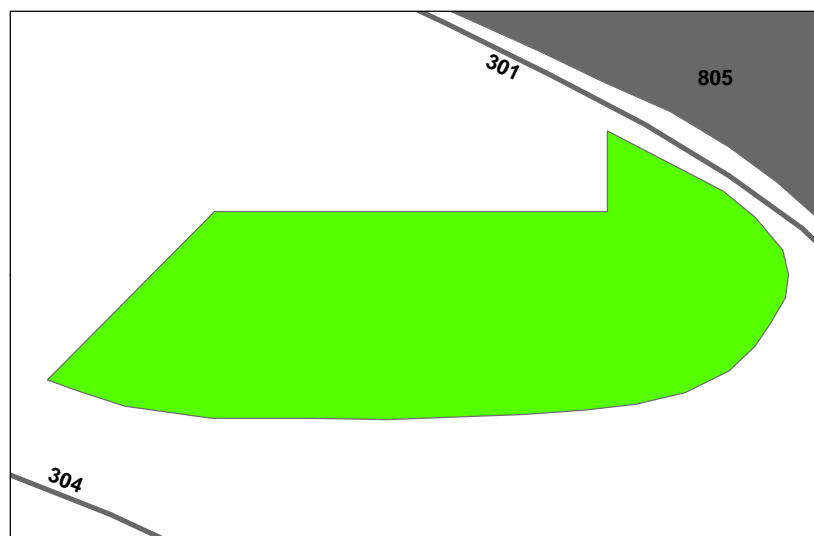
Route 804: Shop Parking C

Asset Number	Date Visited	Surface Type	Area (sq ft)	Condition	Cost to Improve
10045733	6/16/2008	Native	2799	Good	\$400

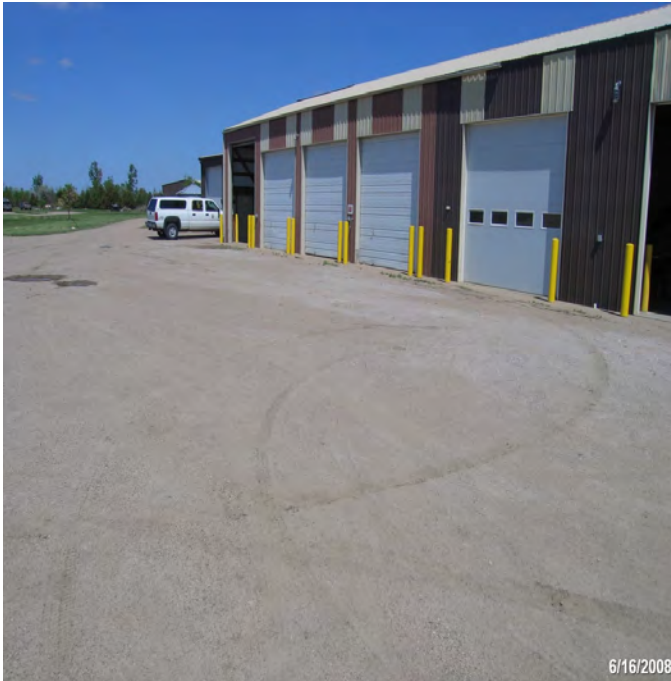
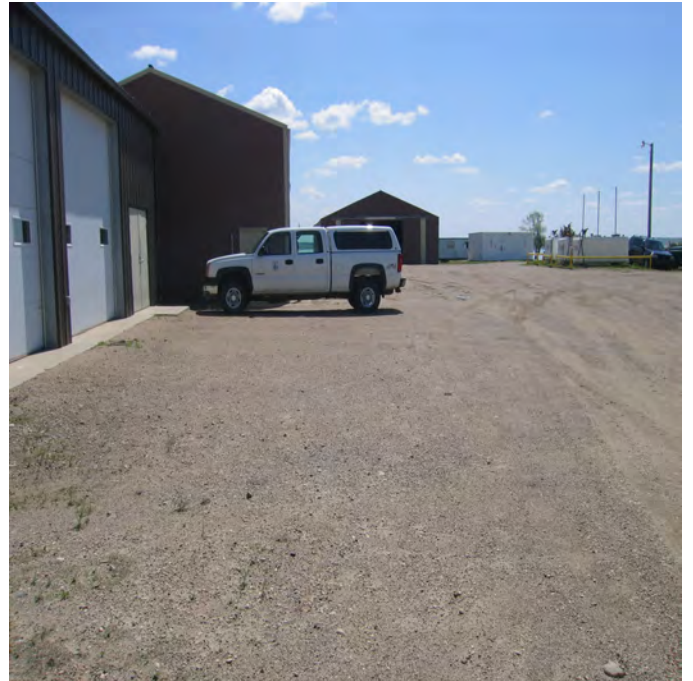
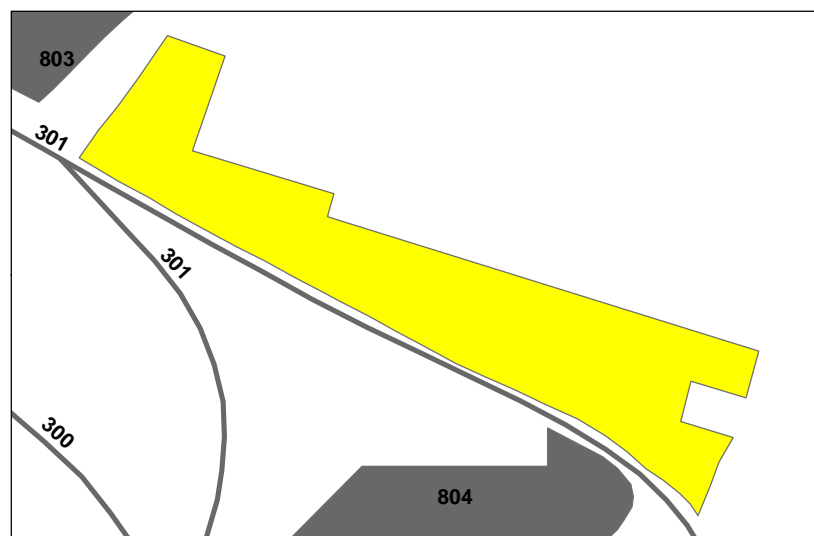
Route 805: Shop Parking D

Asset Number	Date Visited	Surface Type	Area (sq ft)	Condition	Cost to Improve
10045733	6/16/2008	Gravel	6871	Fair	\$1700

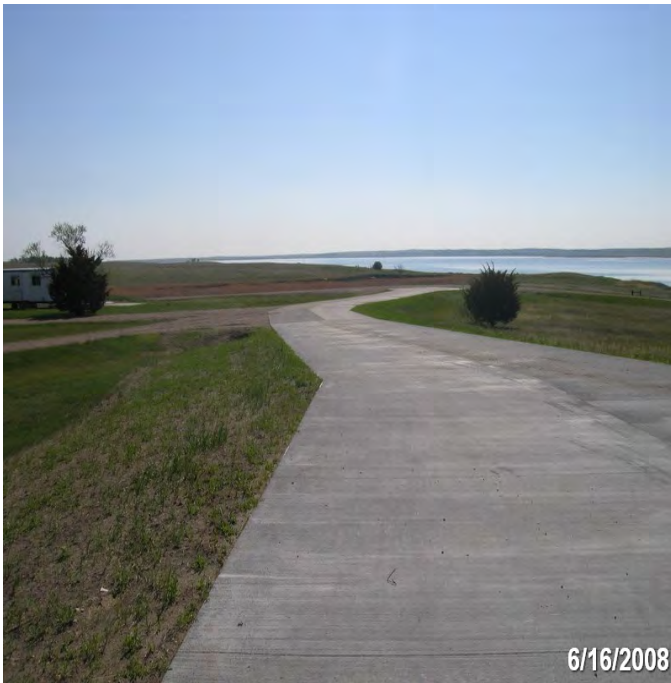
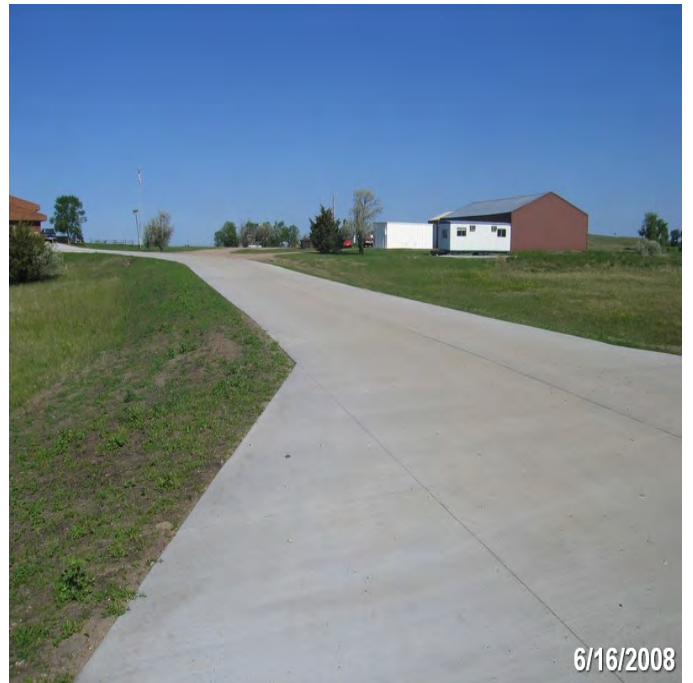
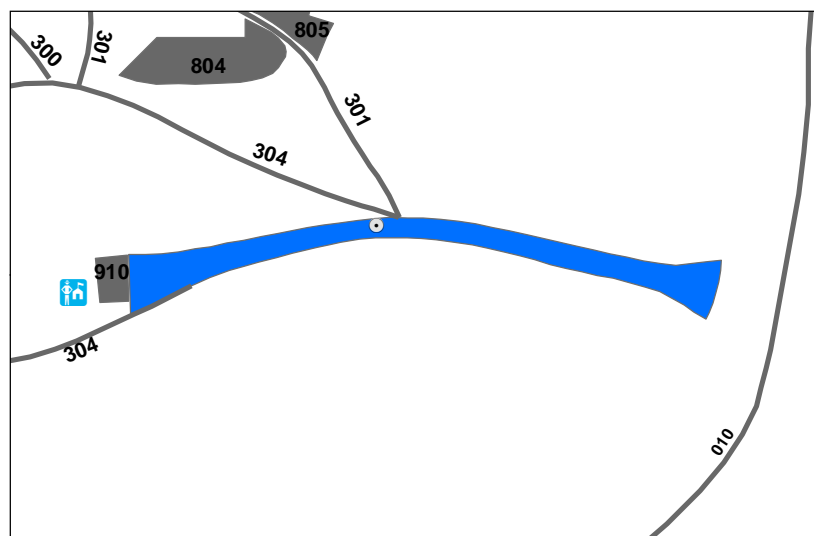
Route 900: Headquarters Entrance Parking

Asset Number	Date Visited	Surface Type	Area (sq ft)	Condition	Cost to Improve
10045695	6/16/2008	Concrete	6802	Excellent	\$0

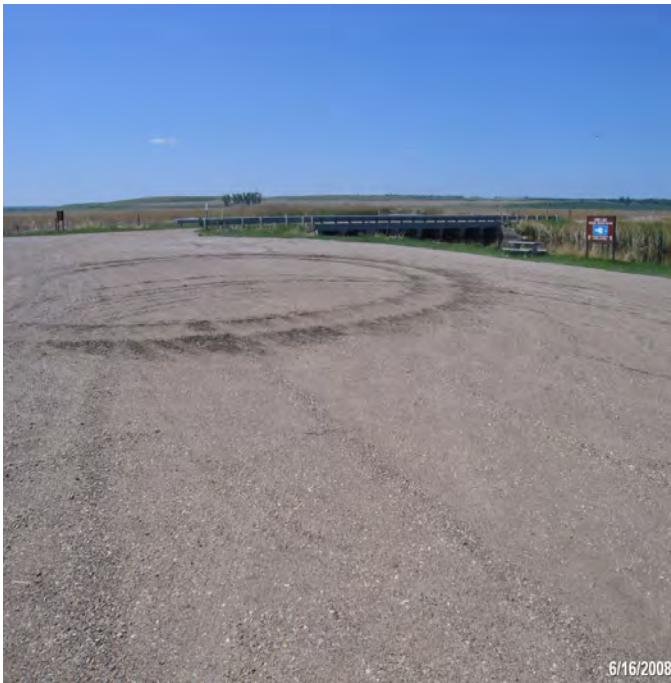
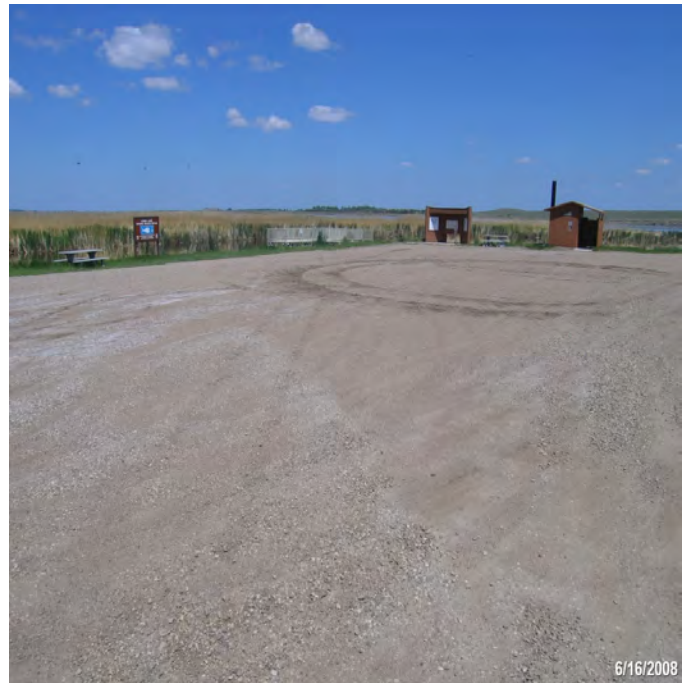
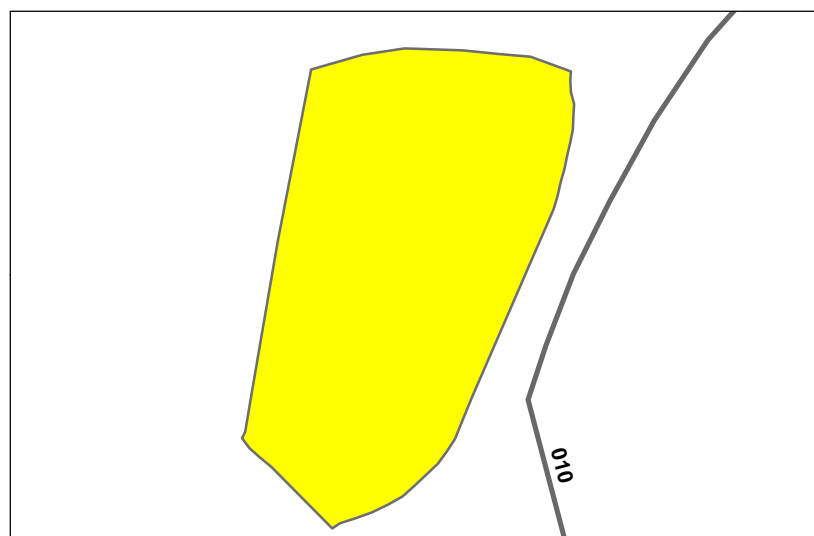
Route 902: Fishing Access Parking

Asset Number	Date Visited	Surface Type	Area (sq ft)	Condition	Cost to Improve
10027527	6/16/2008	Gravel	12186	Fair	\$3100

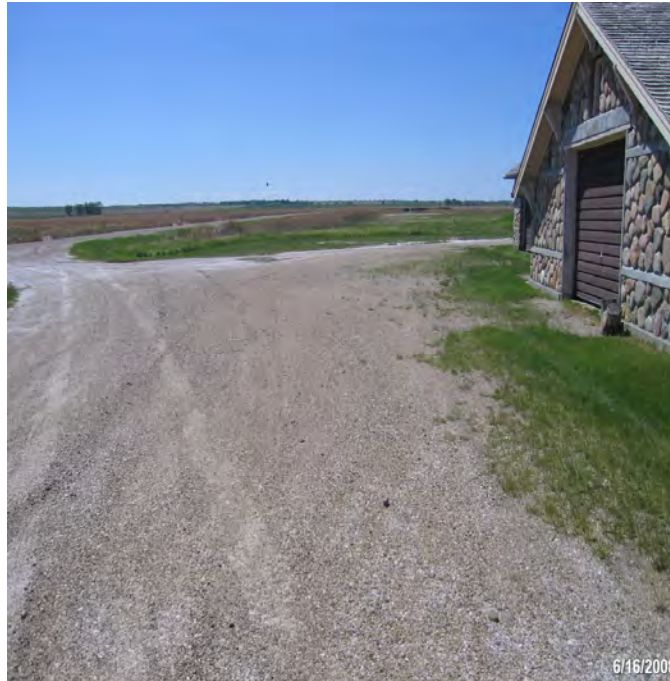
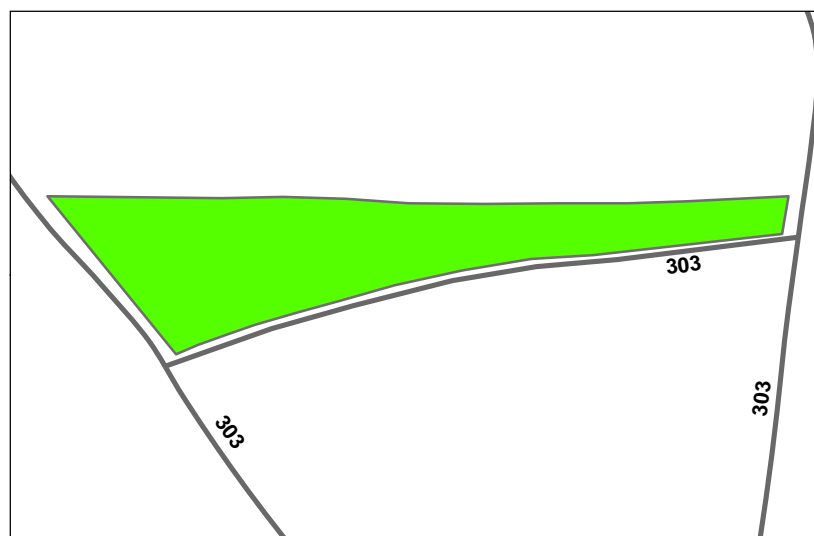
Route 904: Old Headquarters Parking

Asset Number	Date Visited	Surface Type	Area (sq ft)	Condition	Cost to Improve
10045696	6/16/2008	Gravel	2677	Good	\$400

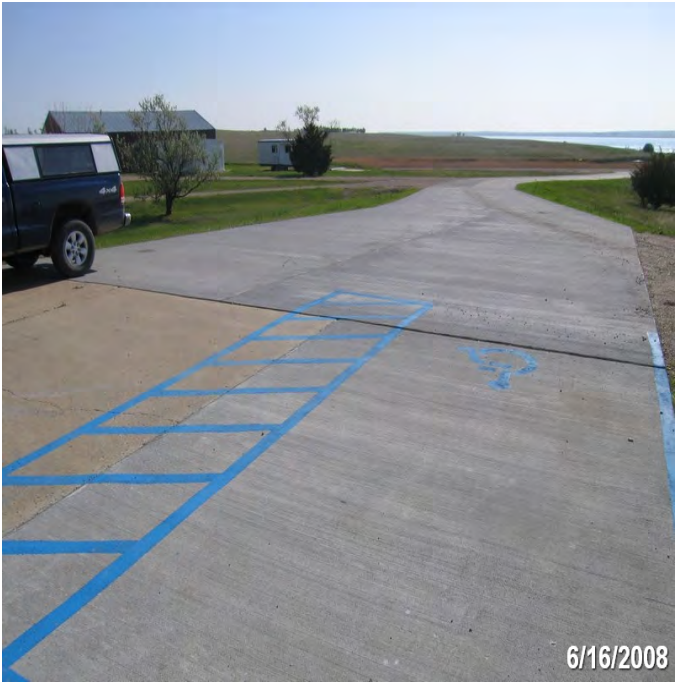
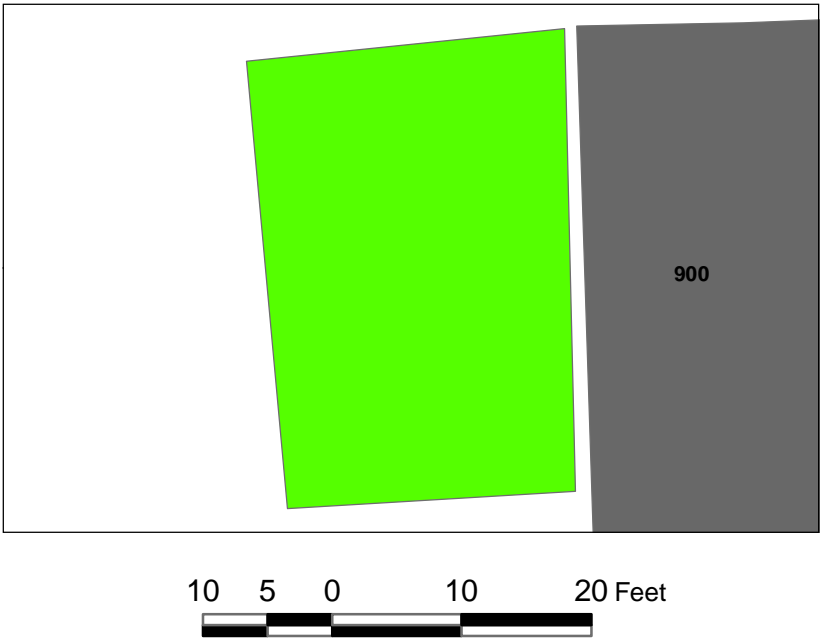
Route 910: Headquarters Parking

Asset Number	Date Visited	Surface Type	Area (sq ft)	Condition	Cost to Improve
10045695	6/16/2008	Concrete	568	Good	\$100
