# **MARSH AND WATER MANAGEMENT PLAN**

**NECEDAH NATIONAL WILDLIFE REFUGE**  
**Necedah, Wisconsin**

**Written By: Richard G. Nord**  
**Biologist, Necedah NWR**

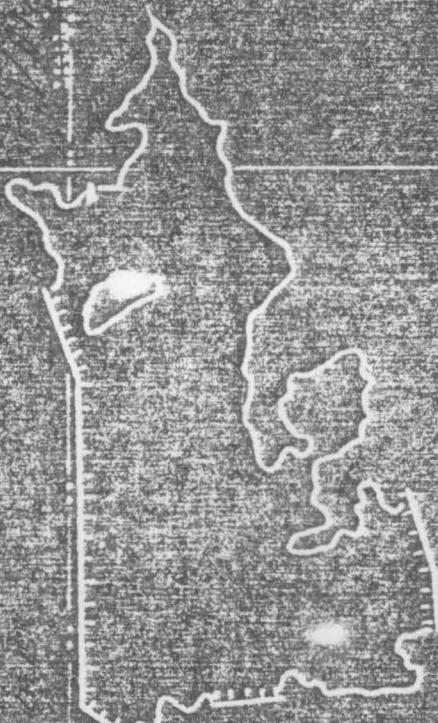
Flowage No. 17

USE EXISTING CONTROL STRUCTURE  
DANIELSON LATERAL  
IN LITTLE YELLOW DITCH TO DIVERT WATER  
INTO FISHCAMP
