The Road Inventory of Rocky Mountain Arsenal National Wildlife Refuge Commerce City, CO

Prepared By:
Federal Highway Administration
Central Federal Lands Highway Divisio
October 2008

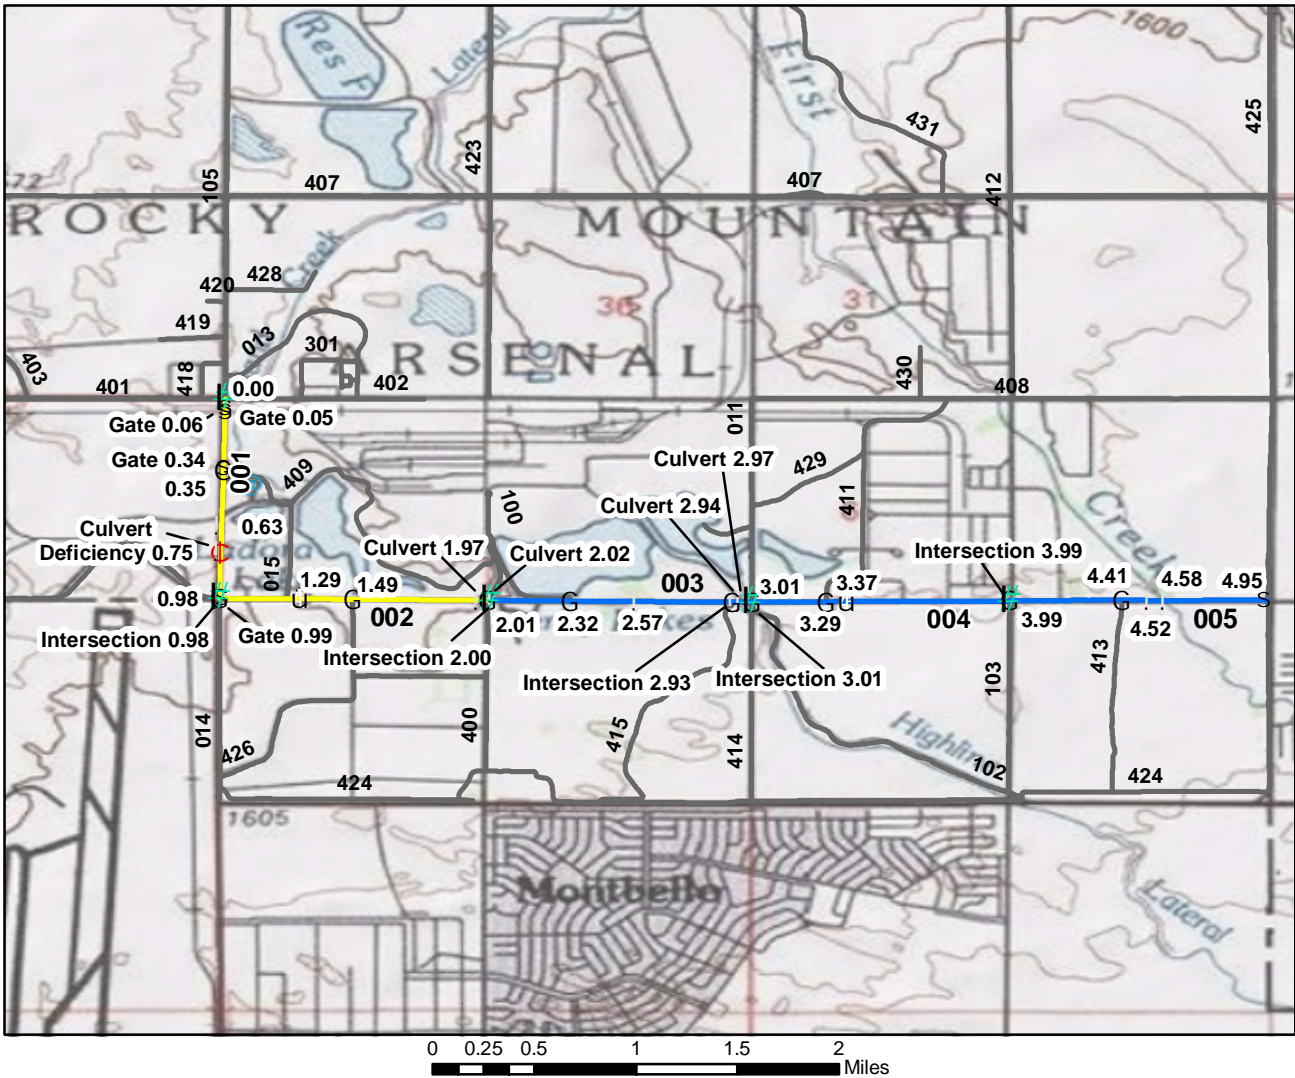
ROUTE: 010 Southern Tram Route TOTAL LENGTH: 4.97 Miles

RTE DESCRIPTION: From Rattlesnake Hill Loop (Rte 013) to end of route at East boundary

001	002	003	004	005
Section Number	001	002	003	004	005
Section Length (miles)	0.98	1.03	0.99	0.98	0.98
Inspection Date	10/21/2008	10/21/2008	10/22/2008	10/22/2008	10/22/2008
Section Information					
Surface Type	Asphalt	Asphalt	Gravel	Gravel	Native
Number of Lanes	2	2	2	1	1
Roadway Width (feet)	22	24	20	14	14
Roadway Condition Information					
Condition	Fair	Fair	Excellent	Excellent	Excellent
Remaining Service Life (years)	10	12	10	9	9
Cost Estimate	\$112800	\$118500	\$0	\$0	\$0
CRV	\$1249000	\$1312700	\$727300	\$720000	\$372500

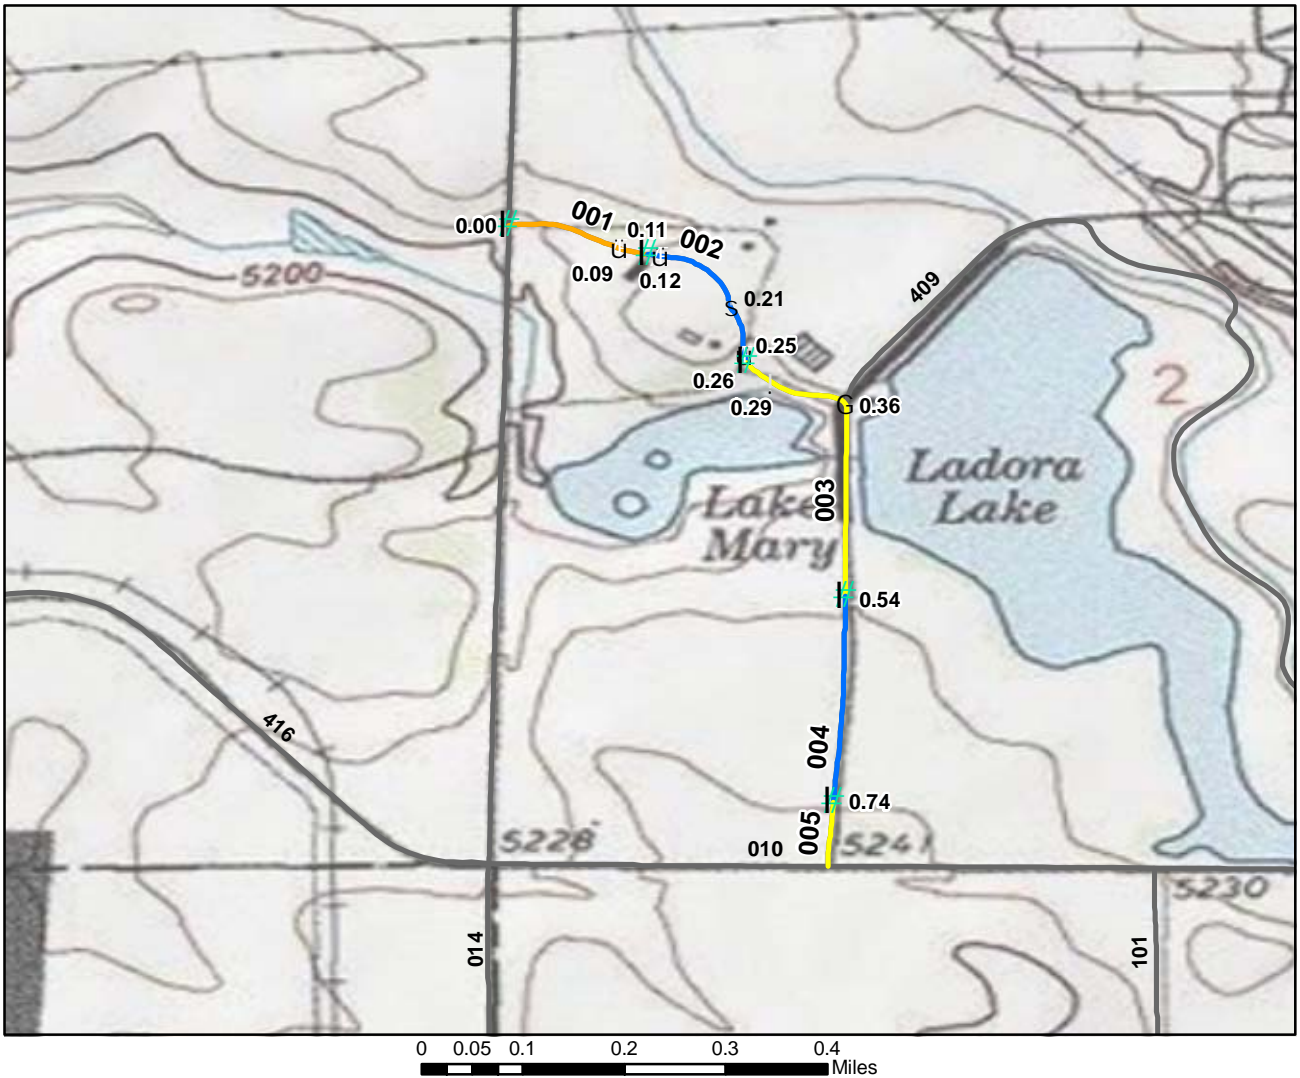
RTE DESCRIPTION: From Southern Tram Route (Rte 010) at 'C' Street to Southern Tram Route (Rte 010) at 6th Ave

Section Number	001	002	003	004	005
Section Length (miles)	0.11	0.15	0.28	0.20	0.06
Inspection Date	10/22/2008	10/22/2008	10/22/2008	10/22/2008	10/22/2008
Section Information					
Surface Type	Asphalt	Gravel	Asphalt	Gravel	Asphalt
Number of Lanes	2	2	2	2	2
Roadway Width (feet)	22	18	22	22	22
Roadway Condition Information					
Condition	Poor	Excellent	Fair	Excellent	Fair
Remaining Service Life (years)	6	8	8	10	12
Cost Estimate	\$69100	\$0	\$32200	\$0	\$6900
CRV	\$140200	\$110200	\$356900	\$146900	\$76500

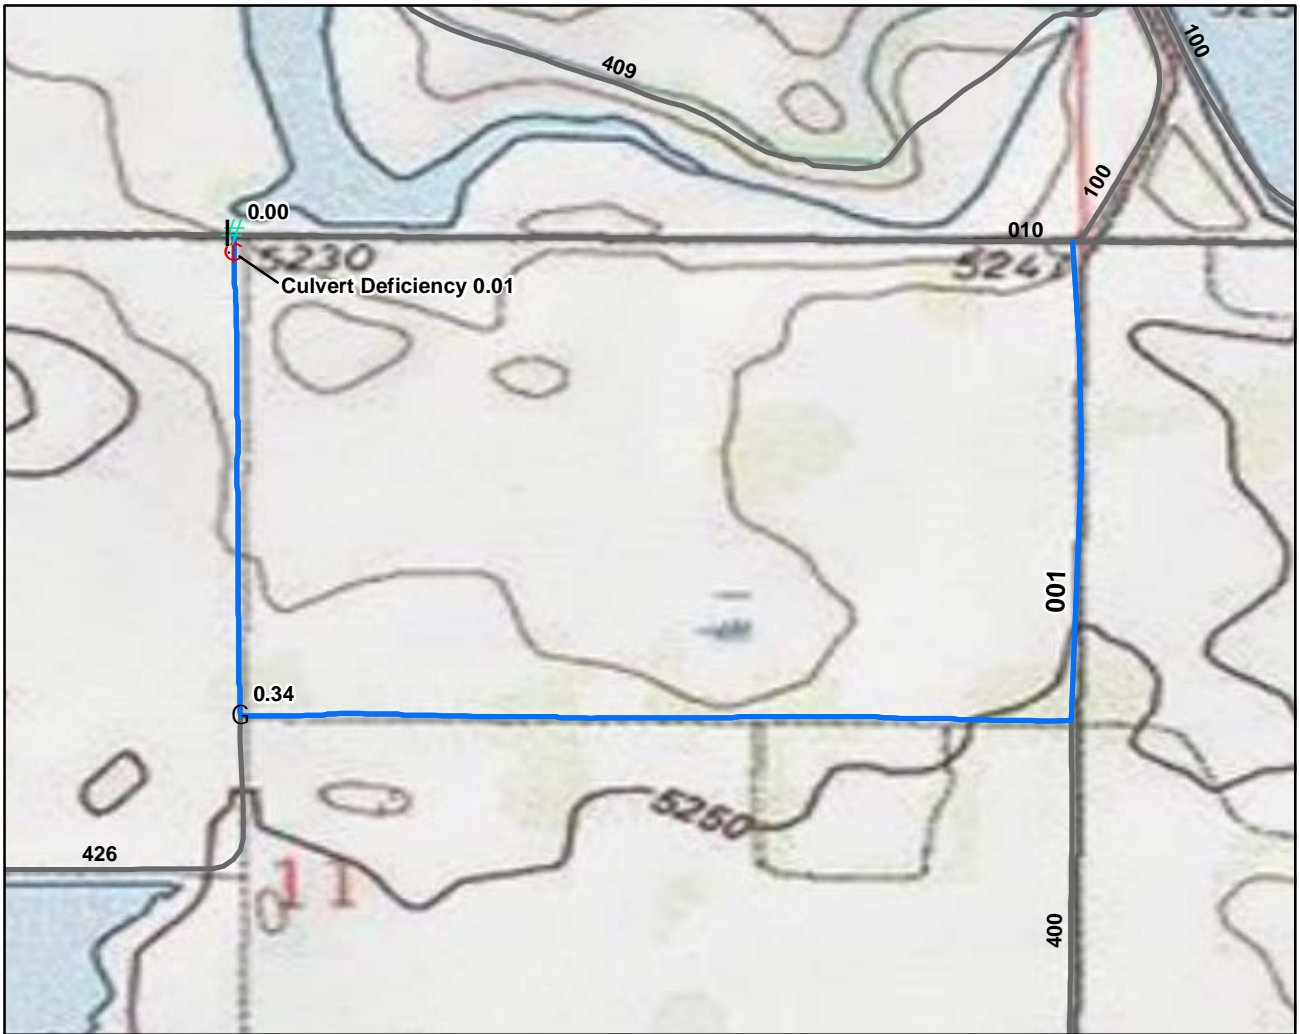
RTE DESCRIPTION: From Southern Tram Route (Rte 010) West to Southern Tram Route (Rte 010) East

Section Number	001				
Section Length (miles)	1.26				
Inspection Date	10/20/2008				
Section Information					
Surface Type	Native				
Number of Lanes	1				
Roadway Width (feet)	12				
Roadway Condition Information					
Condition	Excellent				
Remaining Service Life (years)	9				
Cost Estimate	\$0				
CRV	\$478900

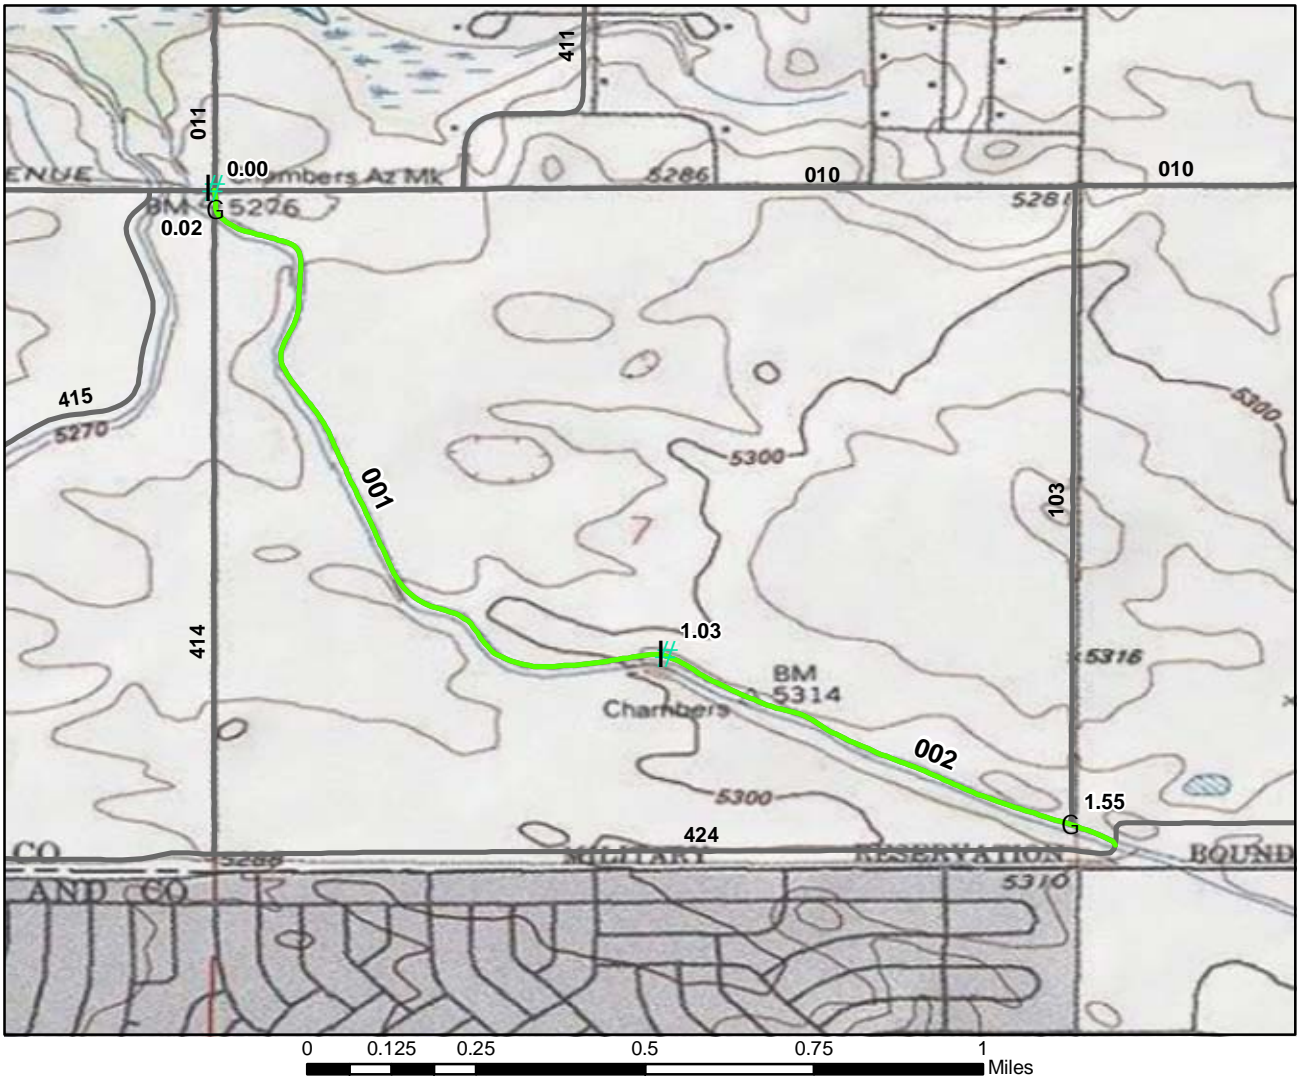
ROUTE: 102 Highline Canal Loop TOTAL LENGTH: 1.61 Miles
 ASSET: 10024546

RTE DESCRIPTION: From Southern Tram Route (Rte 010) to South Perimeter Road (Rte 424)

Section Number	001	002		
Section Length (miles)	1.03	0.59		
Inspection Date	10/21/2008	10/21/2008		
Section Information				
Surface Type	Gravel	Gravel		
Number of Lanes	1	1		
Roadway Width (feet)	12	12		
Roadway Condition Information				
Condition	Good	Good		
Remaining Service Life (years)	7	7		
Cost Estimate	\$1800	\$1000		
CRV	\$756700	\$433500

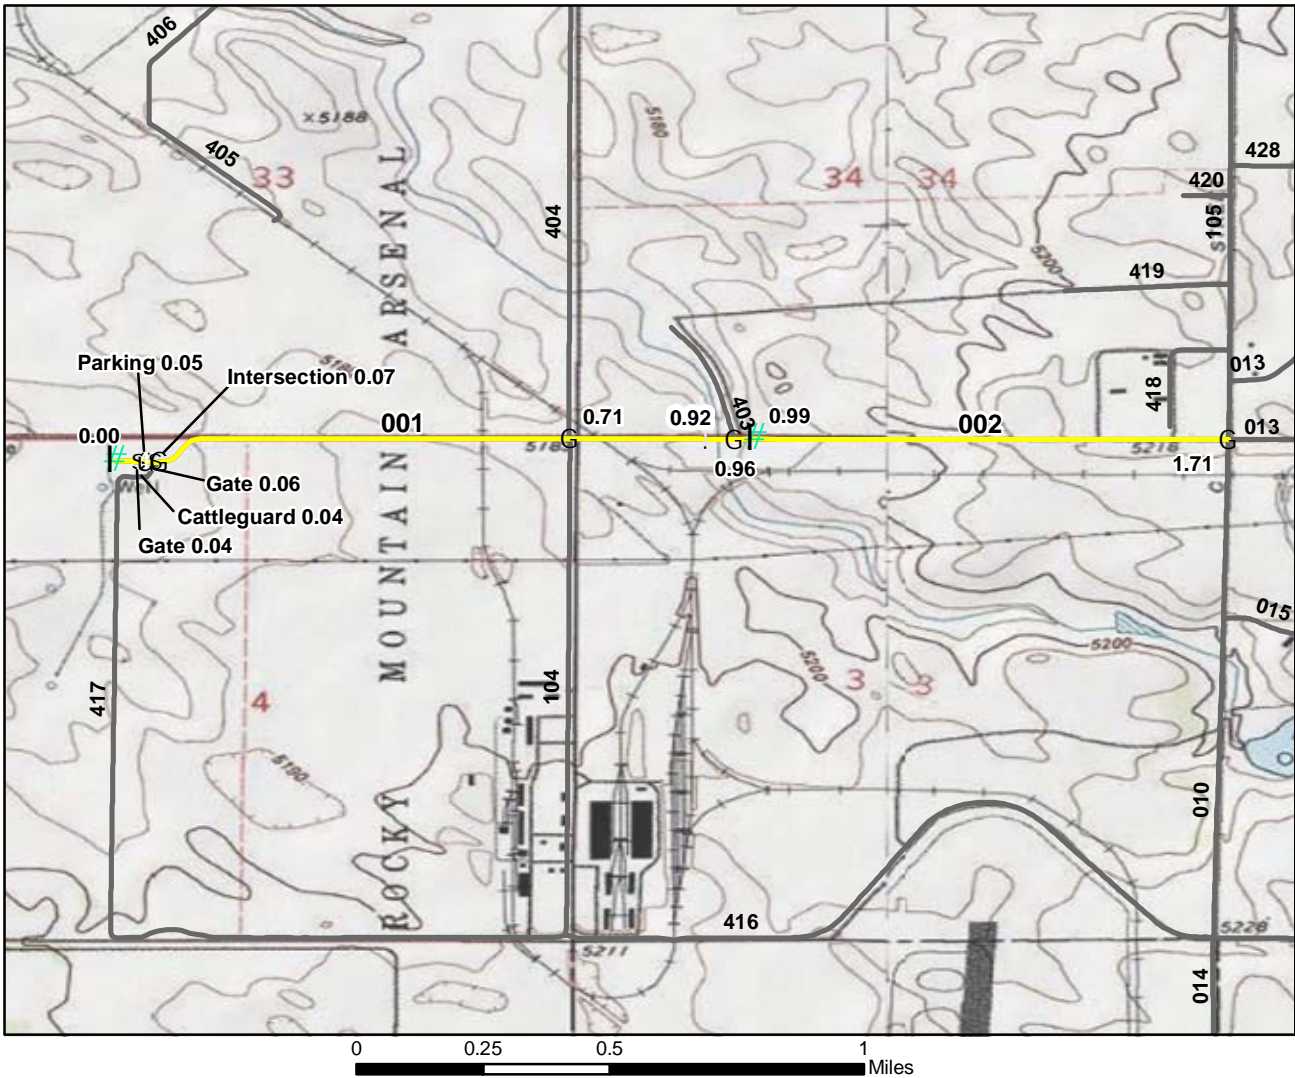
ROUTE: 401 West 7th Avenue TOTAL LENGTH: 1.71 Miles

RTE DESCRIPTION: From 72nd Avenue at FWS Boundary to Rattlesnake Hill Loop (Rte 013)

Section Number	001	002		
Section Length (miles)	0.99	0.72		
Inspection Date	10/21/2008	10/21/2008		
Section Information				
Surface Type	Asphalt	Asphalt		
Number of Lanes	2	2		
Roadway Width (feet)	22	22		
Roadway Condition Information				
Condition	Fair	Fair		
Remaining Service Life (years)	10	10		
Cost Estimate	\$113900	\$82900		
CRV	\$1261800	\$917600

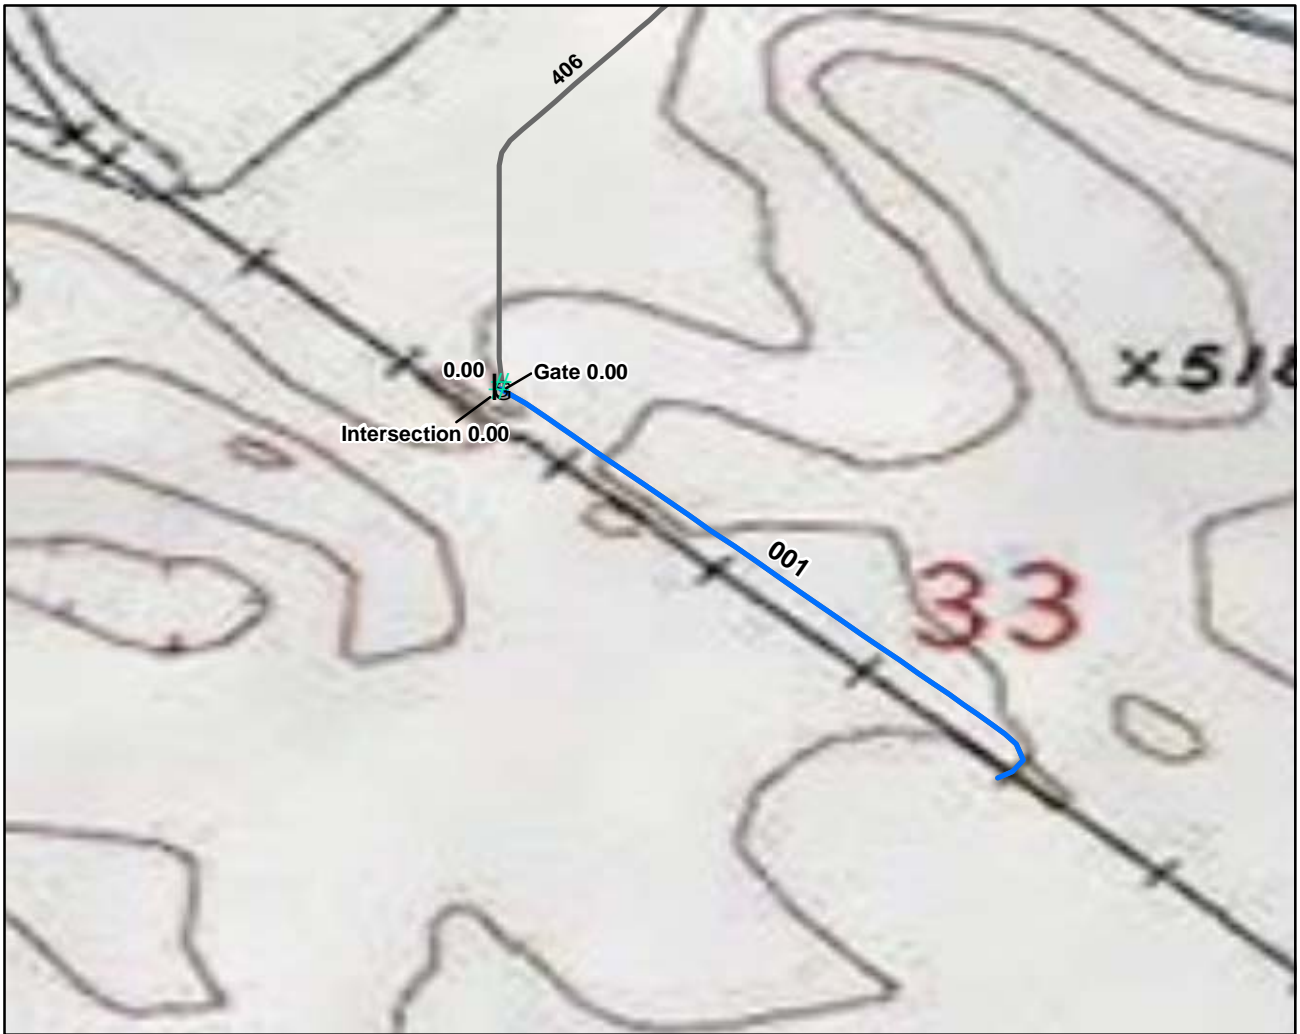
RTE DESCRIPTION: From West FWS Boundary to end of route

Section Number	001			
Section Length (miles)	0.28			
Inspection Date	10/21/2008			
Section Information				
Surface Type	Native			
Number of Lanes	1			
Roadway Width (feet)	10			
Roadway Condition Information				
Condition	Excellent			
Remaining Service Life (years)	9			
Cost Estimate	\$0			
CRV	\$106400

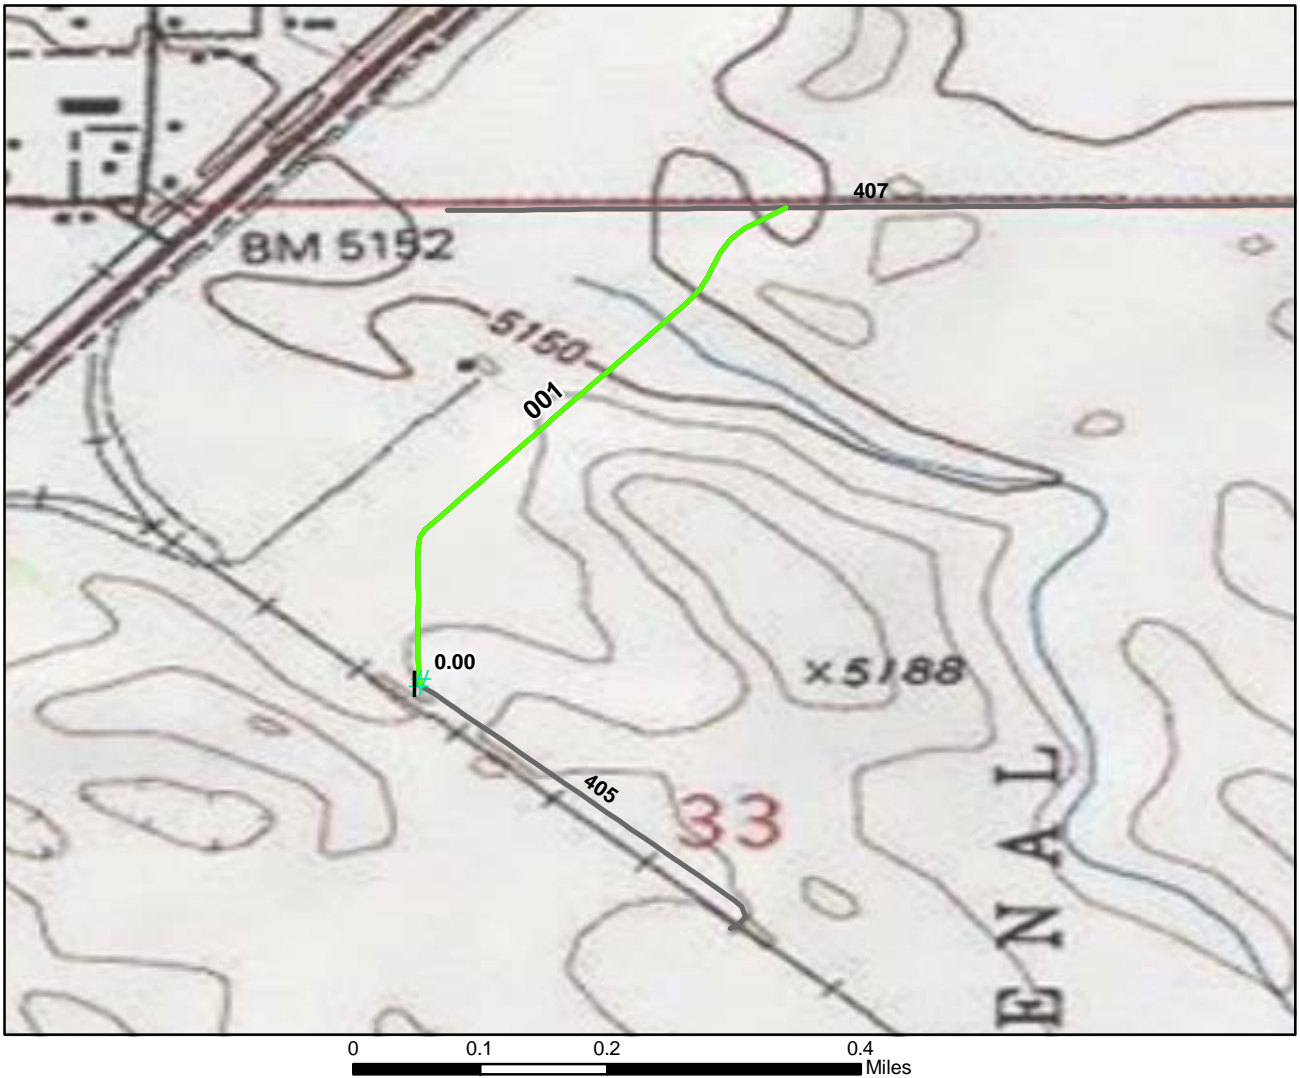
ROUTE: 406 Irondale Treatment Access Road TOTAL LENGTH: 0.46 Miles

Section Number	001			
Section Length (miles)	0.46			
Inspection Date	10/21/2008			
Section Information				
Surface Type	Native			
Number of Lanes	1			
Roadway Width (feet)	10			
Roadway Condition Information				
Condition	Good			
Remaining Service Life (years)	7			
Cost Estimate	\$800			
CRV	\$174800

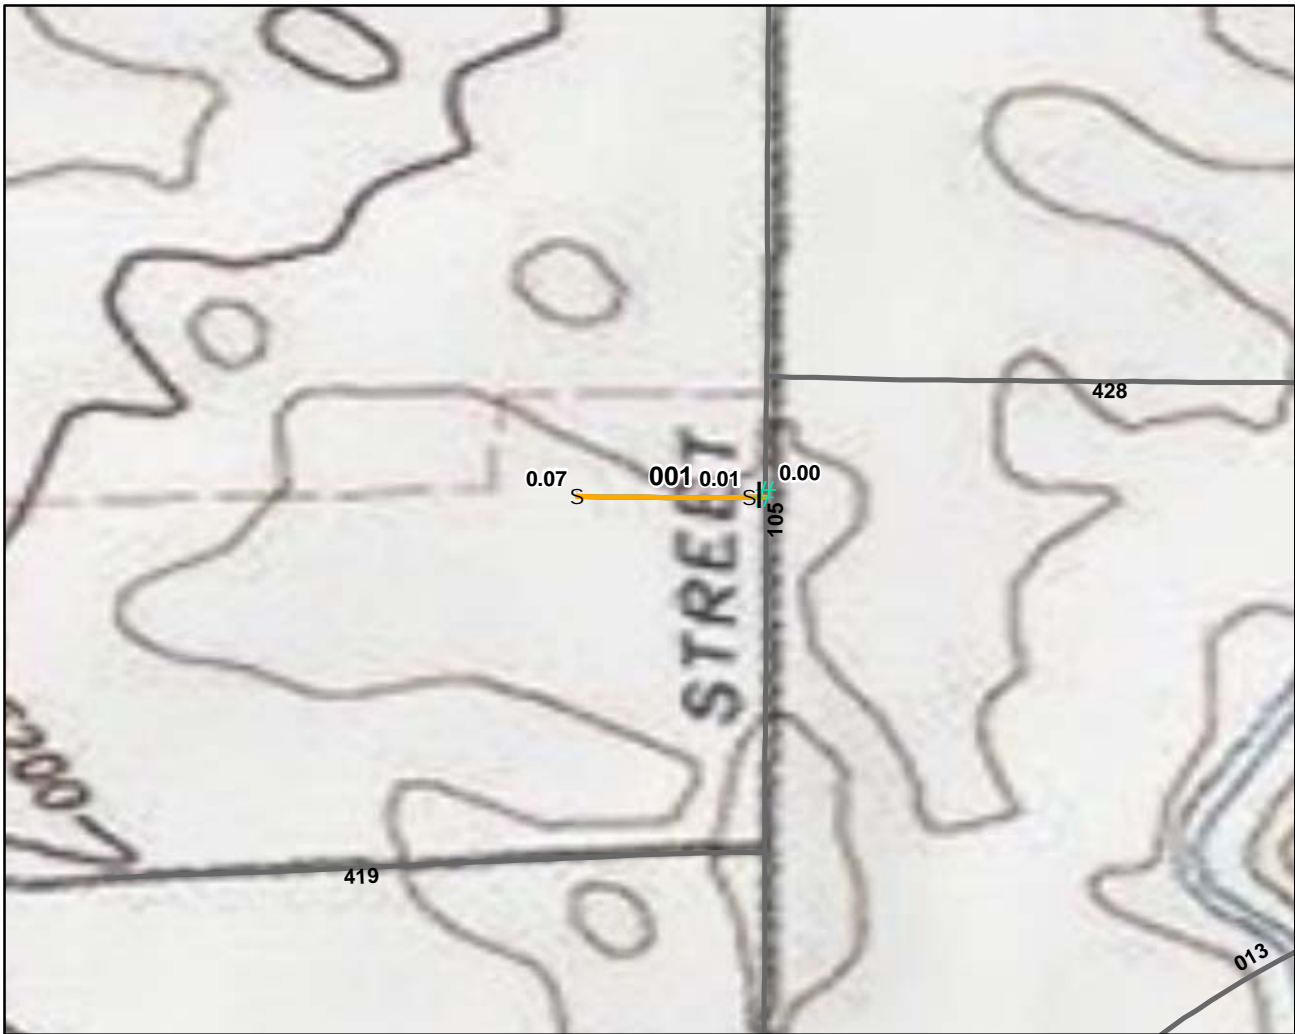
RTE DESCRIPTION: From 'C' Street (Rte 105) to end

Section Number	001				
Section Length (miles)	0.25				
Inspection Date	10/21/2008				
Section Information					
Surface Type	Primitive				
Number of Lanes	1				
Roadway Width (feet)	8				
Roadway Condition Information					
Condition	Fair				
Remaining Service Life (years)	3				
Cost Estimate	\$200				
CRV	\$0

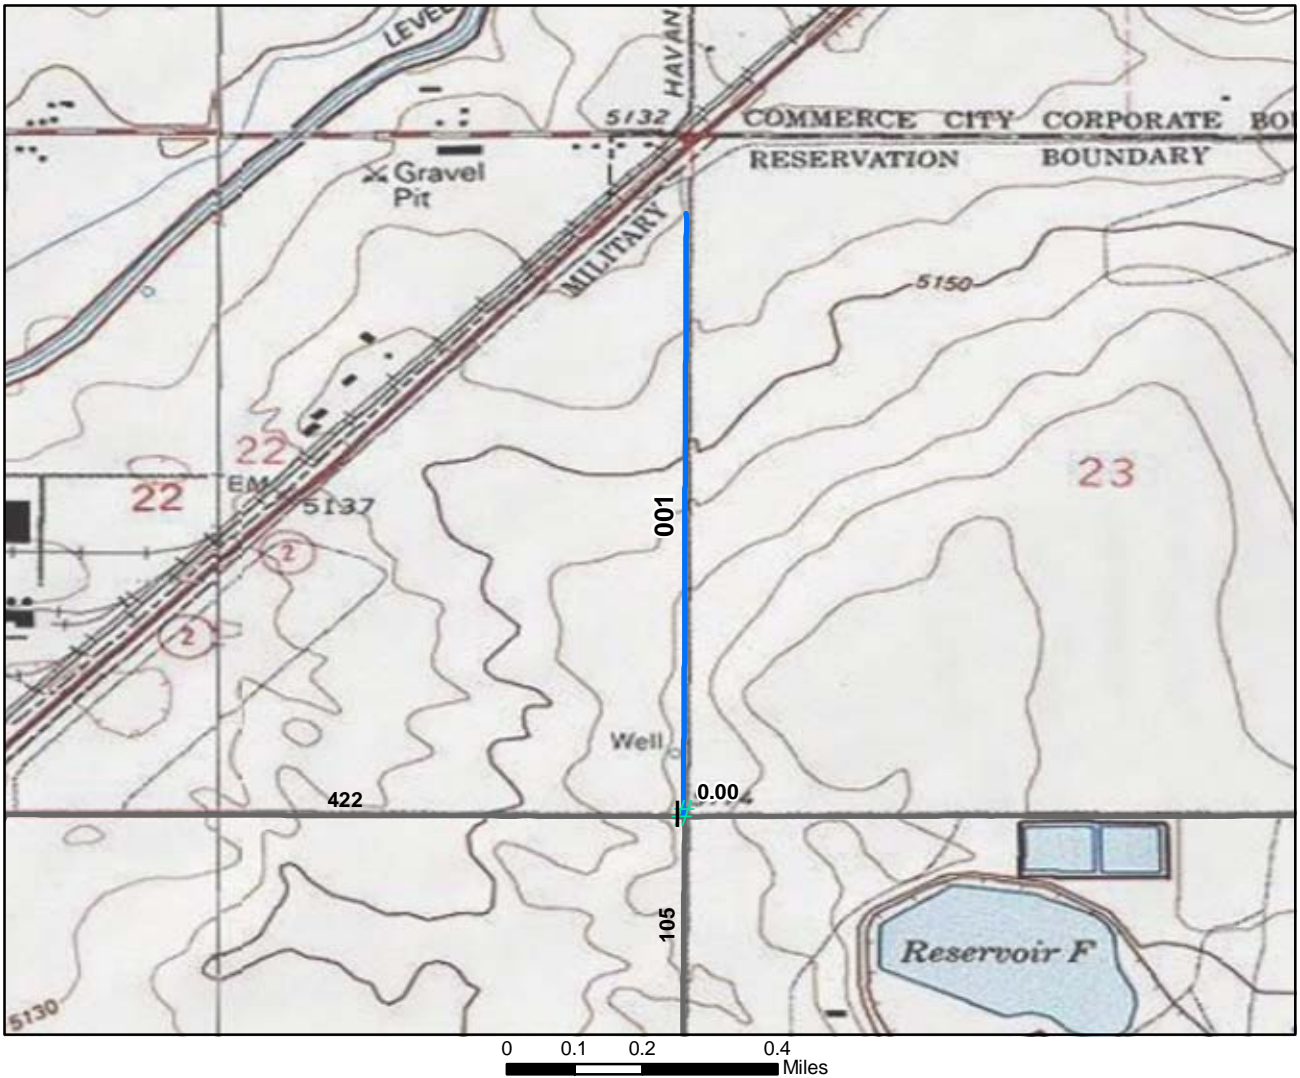
RTE DESCRIPTION: From South Perimeter Road (Rte 424) to Quad Loop Road (Rte 101)

Section Number	001			
Section Length (miles)	0.85			
Inspection Date	10/23/2008			
Section Information				
Surface Type	Native			
Number of Lanes	1			
Roadway Width (feet)	10			
Roadway Condition Information				
Condition	Good			
Remaining Service Life (years)	7			
Cost Estimate	\$1600			
CRV	\$323000

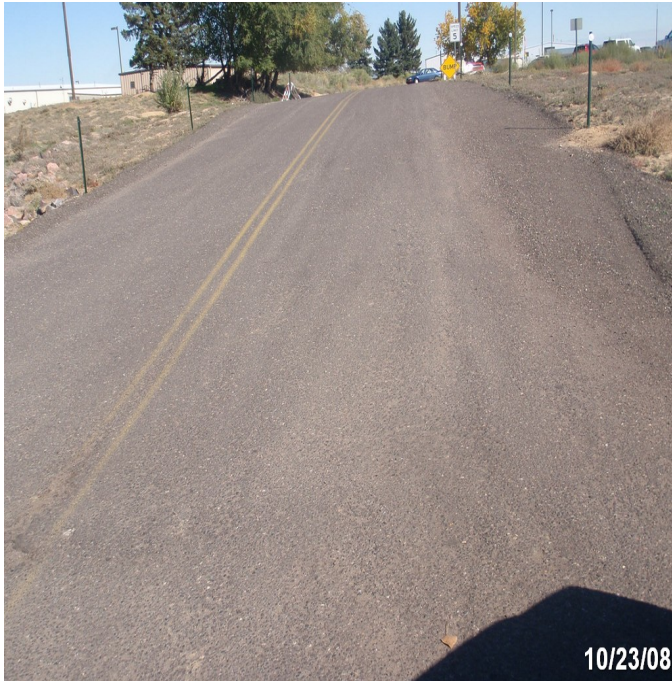
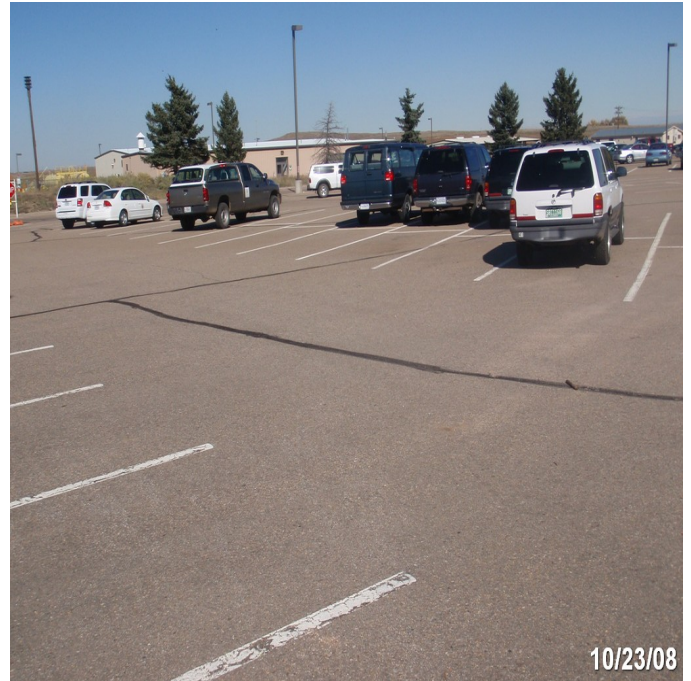
Route 800: Building 111 Parking

Asset Number	Date Visited	Surface Type	Area (sq ft)	Condition	Cost to Improve
10058012	10/23/2008	Asphalt	99808	Good	\$19700

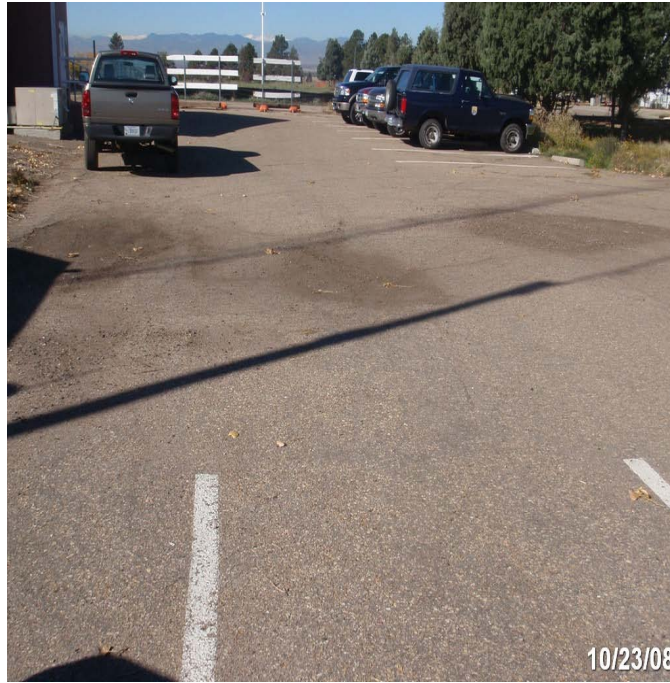
Route 801: Building 112 Parking

Asset Number	Date Visited	Surface Type	Area (sq ft)	Condition	Cost to Improve
10058024	10/23/2008	Asphalt	6956	Good	\$1400

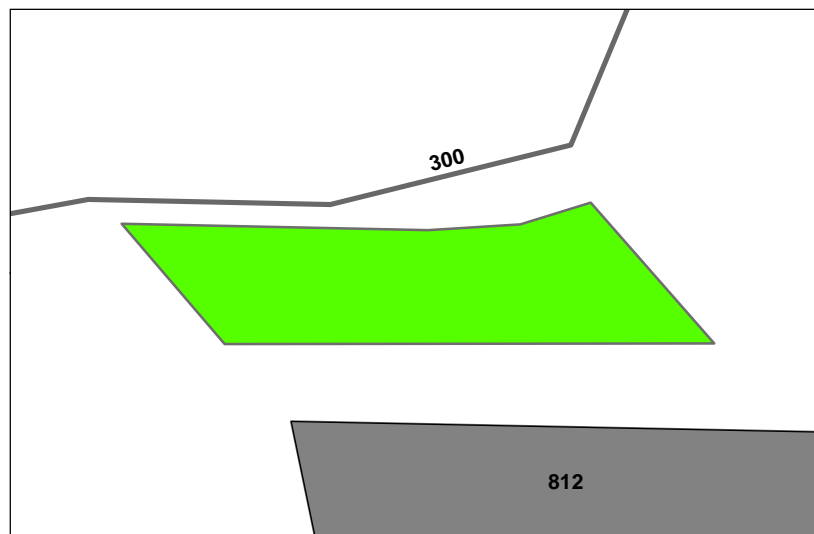
Route 802: Building 130 South Parking

Asset Number	Date Visited	Surface Type	Area (sq ft)	Condition	Cost to Improve
	10/23/2008	Asphalt	1966	Good	\$400

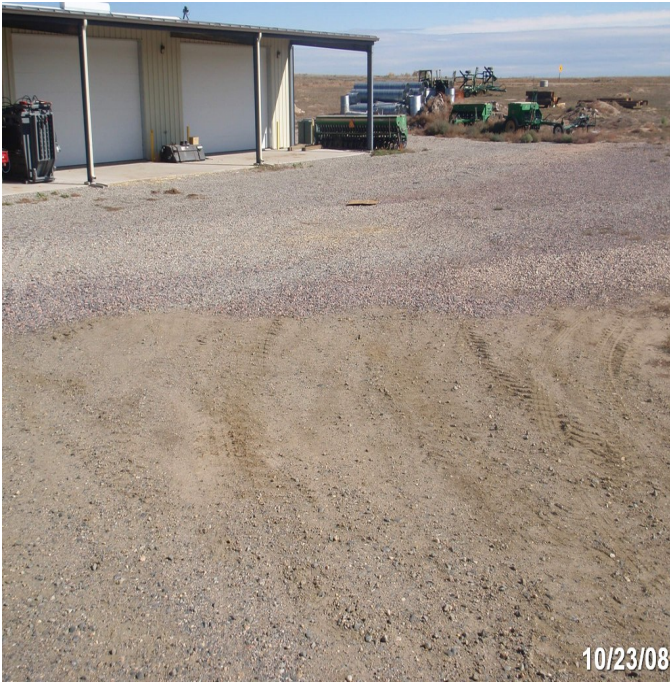
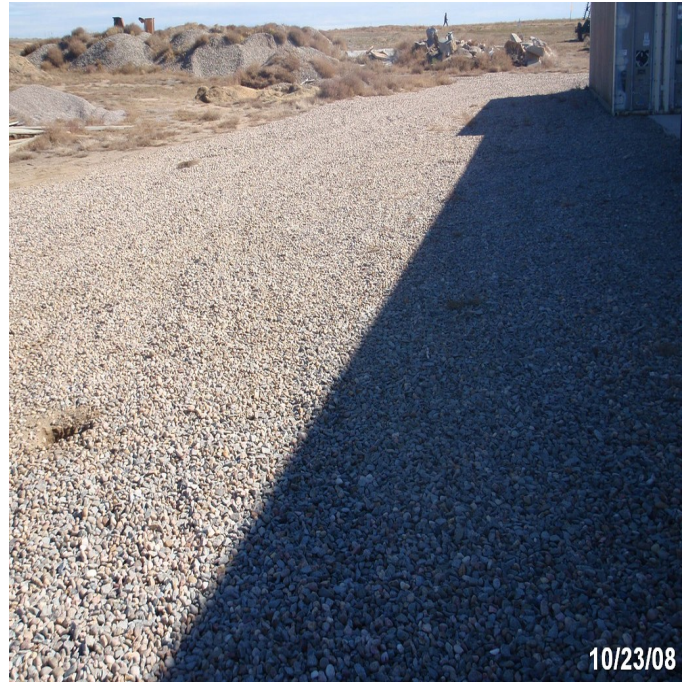
Route 804: Building 181 Parking

Asset Number	Date Visited	Surface Type	Area (sq ft)	Condition	Cost to Improve
10058011	10/23/2008	Gravel	28998	Good	\$4600

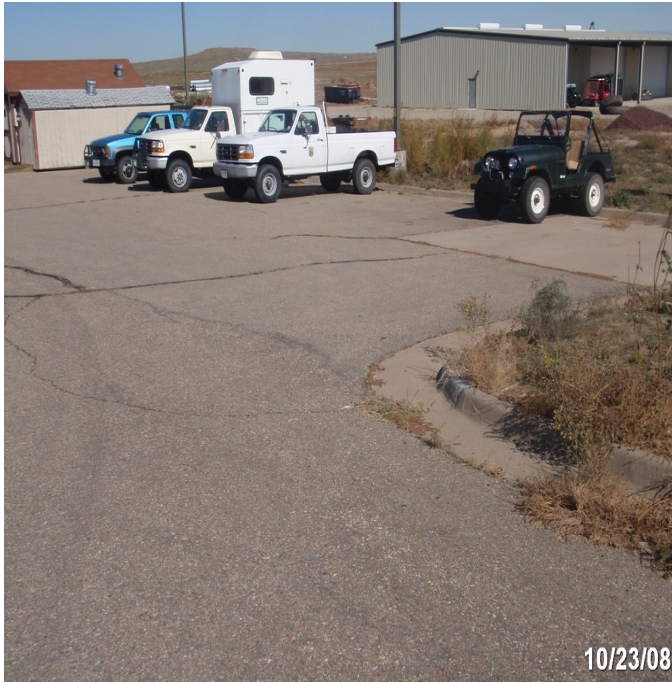
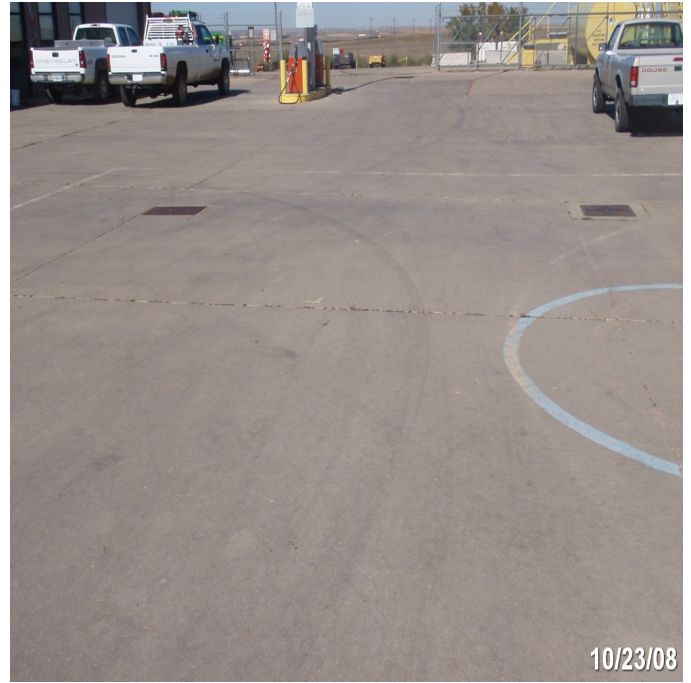
Route 805: Building 120 Shop Parking

Asset Number	Date Visited	Surface Type	Area (sq ft)	Condition	Cost to Improve
10058021	10/23/2008	Asphalt	37424	Good	\$7400

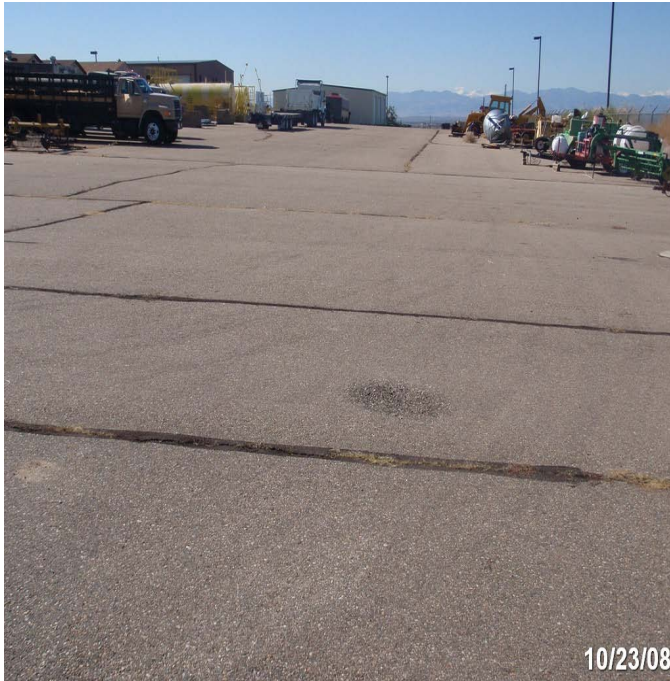
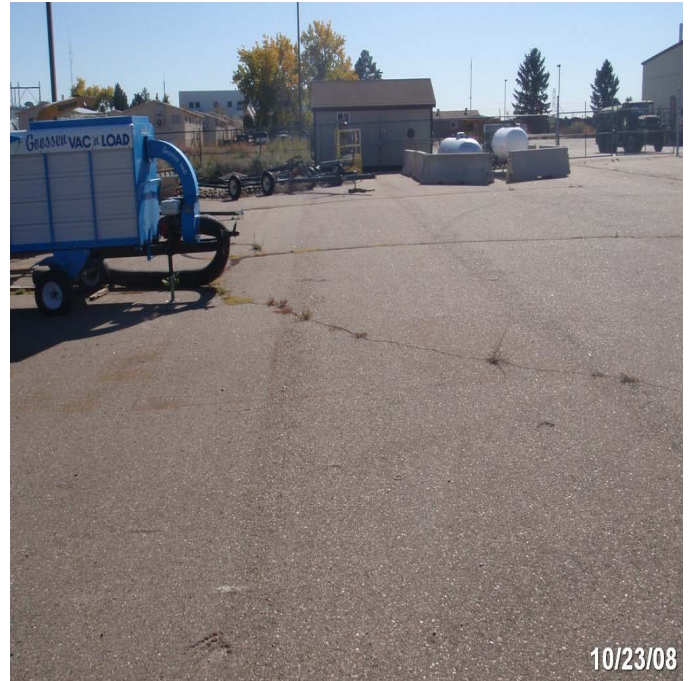
Route 806: Building 124 Equipment Parking

Asset Number	Date Visited	Surface Type	Area (sq ft)	Condition	Cost to Improve
10058021	10/23/2008	Asphalt	88856	Good	\$17500

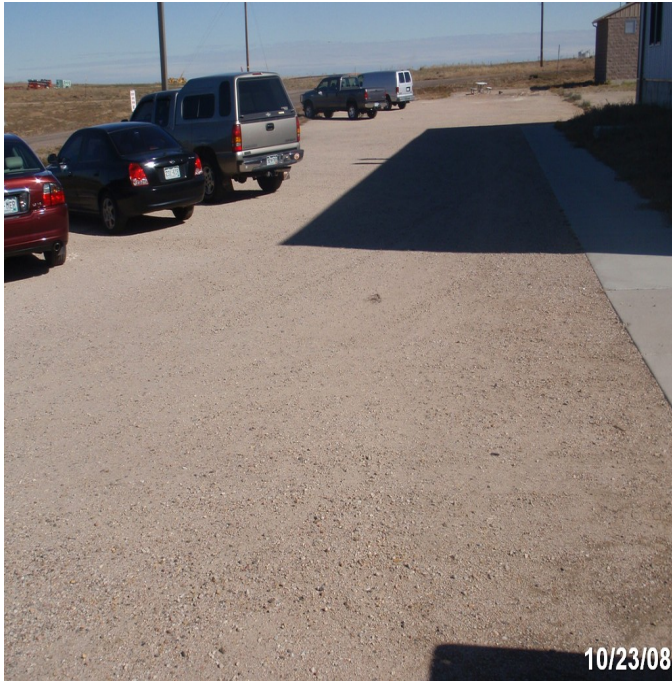
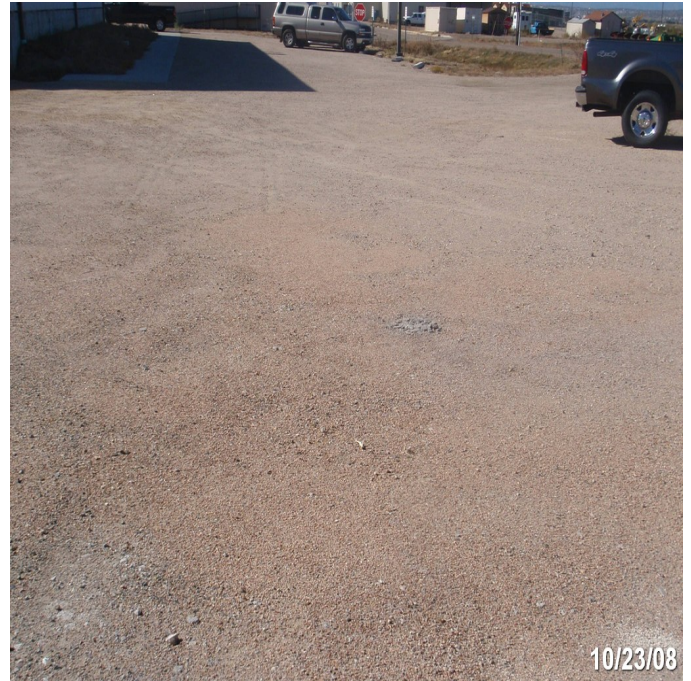
Route 807: Building 128 Parking

Asset Number	Date Visited	Surface Type	Area (sq ft)	Condition	Cost to Improve
	10/23/2008	Gravel	14355	Good	\$2300

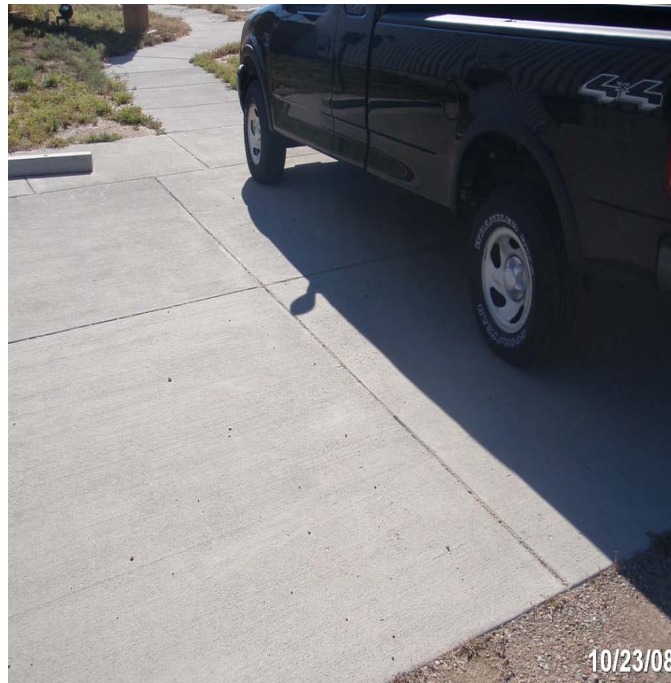
Route 808: Building 128 West Handicapped Parking

Asset Number	Date Visited	Surface Type	Area (sq ft)	Condition	Cost to Improve
	10/23/2008	Concrete	650	Good	\$100

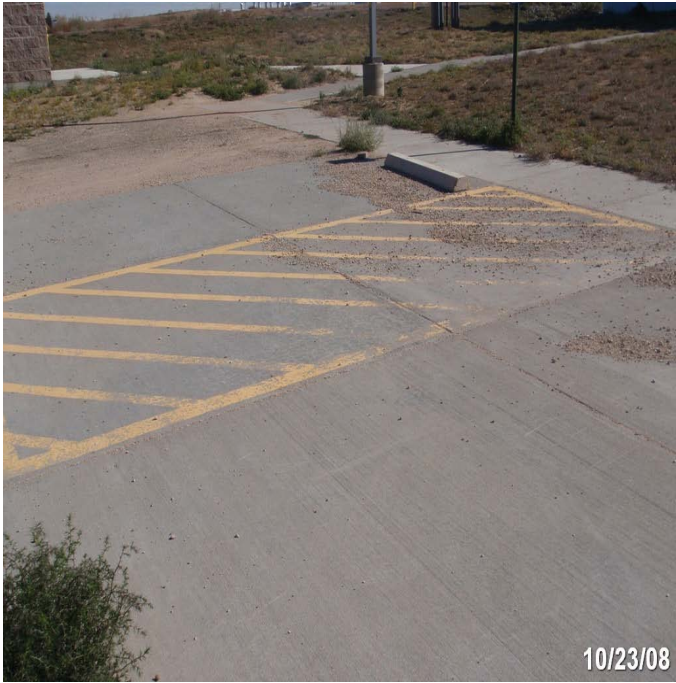
Route 809: Building 128 East Handicapped Parking

Asset Number	Date Visited	Surface Type	Area (sq ft)	Condition	Cost to Improve
	10/23/2008	Concrete	594	Good	\$100

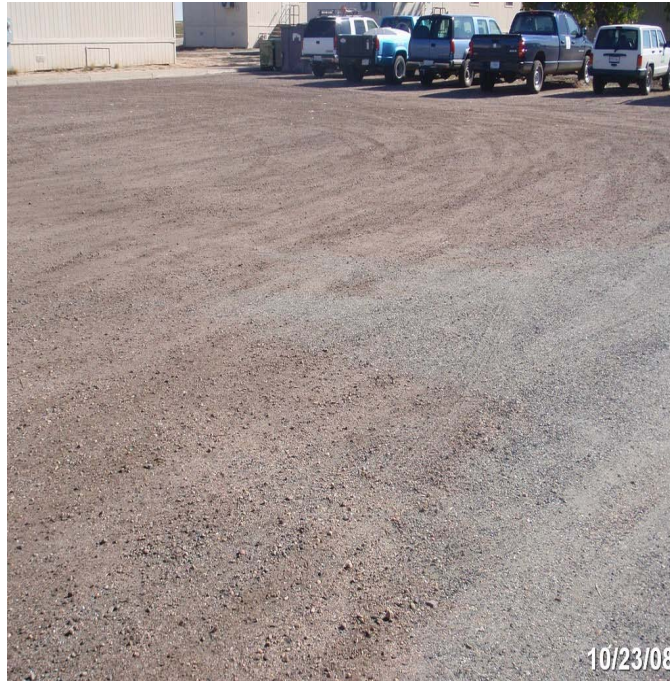
Route 810: Building 120 Southeast Parking

Asset Number	Date Visited	Surface Type	Area (sq ft)	Condition	Cost to Improve
10058020	10/23/2008	Gravel	10188	Good	\$1600

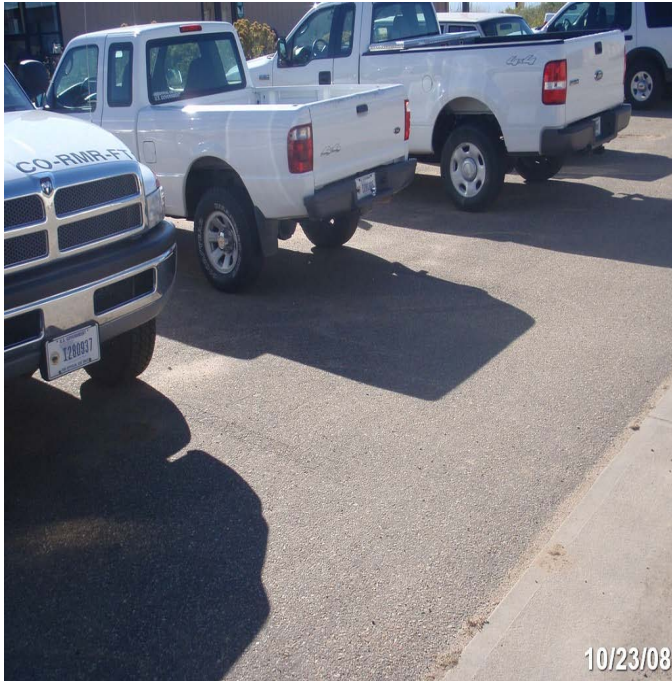
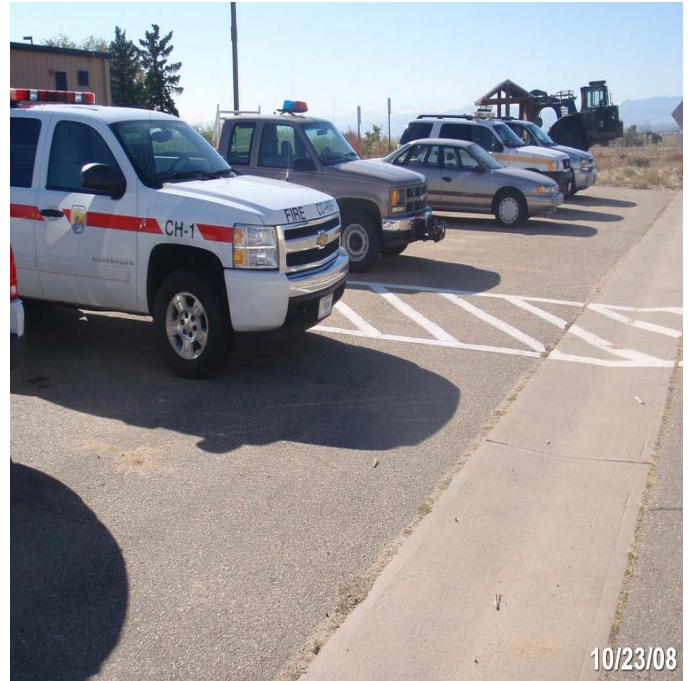
Route 811: Building 121 Parking

Asset Number	Date Visited	Surface Type	Area (sq ft)	Condition	Cost to Improve
10058022	10/23/2008	Asphalt	4156	Good	\$800

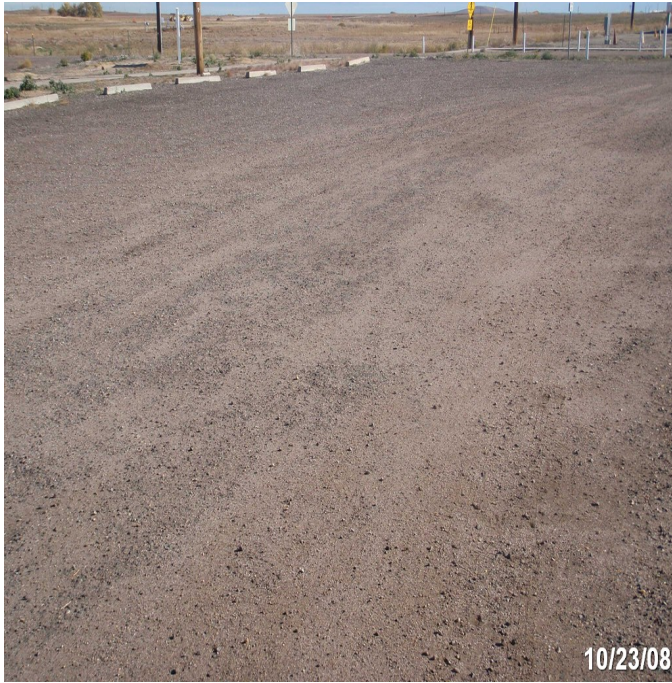
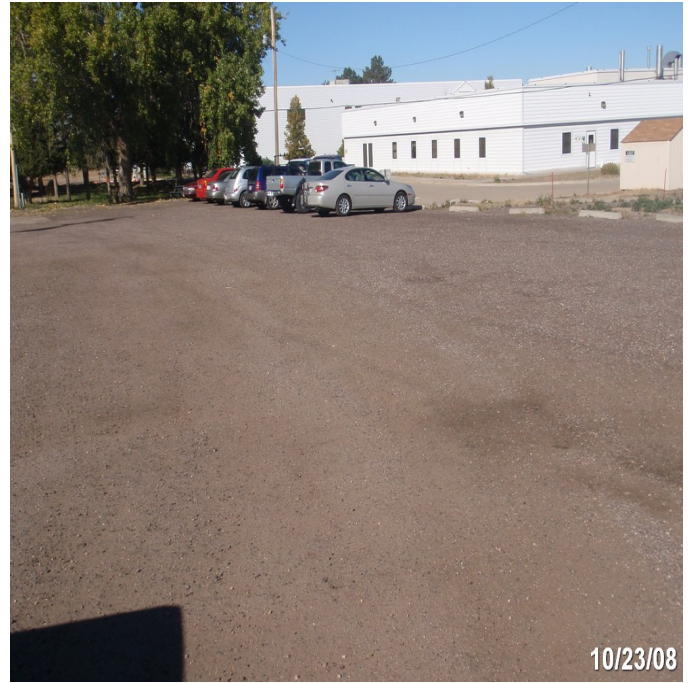
Route 812: Building 112A Parking

Asset Number	Date Visited	Surface Type	Area (sq ft)	Condition	Cost to Improve
10058024	10/23/2008	Gravel	9318	Good	\$1500
