The Road Inventory of Rocky Mountain Arsenal National Wildlife Refuge Commerce City, CO

Prepared By:
Federal Highway Administration
Central Federal Lands Highway Divisio
October 2008

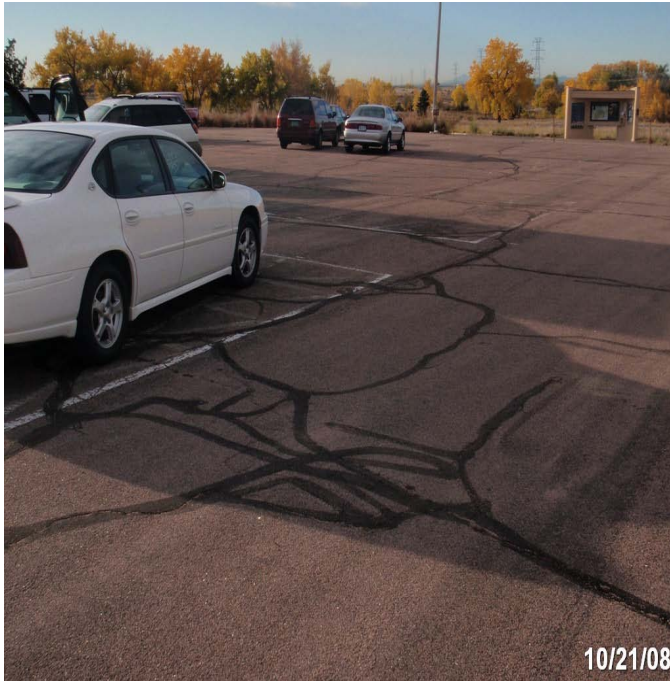
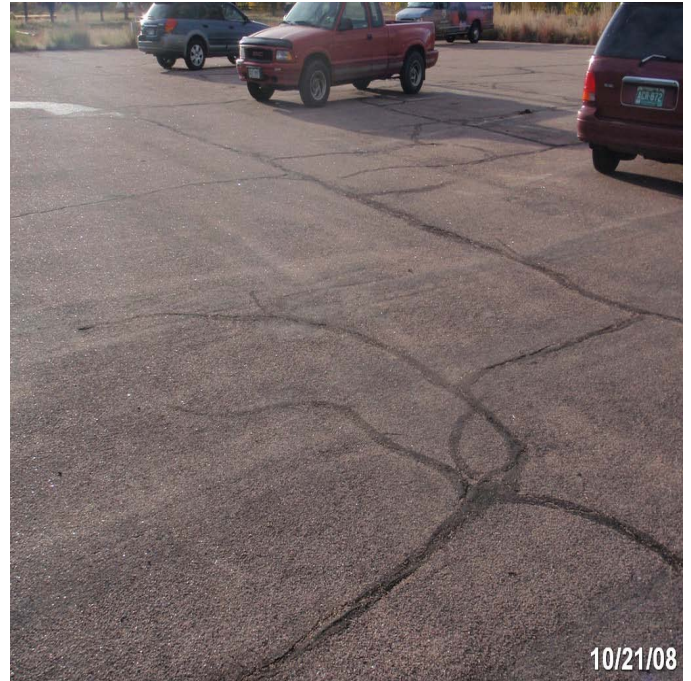
Route 900: Visitor Center Parking

Asset Number	Date Visited	Surface Type	Area (sq ft)	Condition	Cost to Improve
10024556	10/21/2008	Asphalt	30389	Fair	\$27700

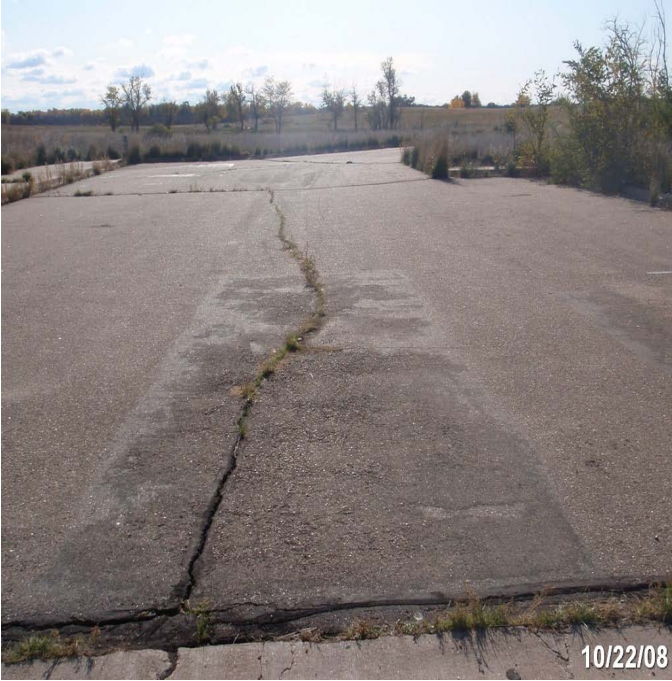
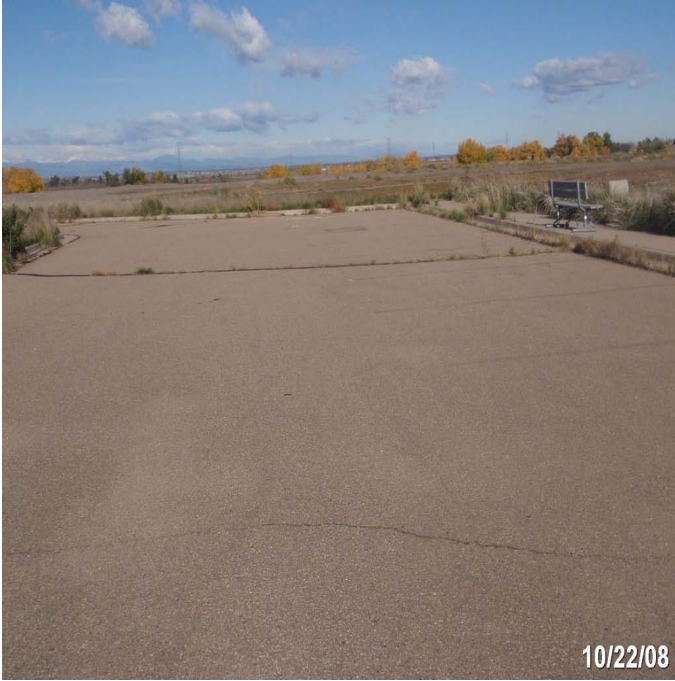
Route 901: Lake Ladora Angler Parking

Asset Number	Date Visited	Surface Type	Area (sq ft)	Condition	Cost to Improve
10024552	10/22/2008	Asphalt	15586	Fair	\$14200

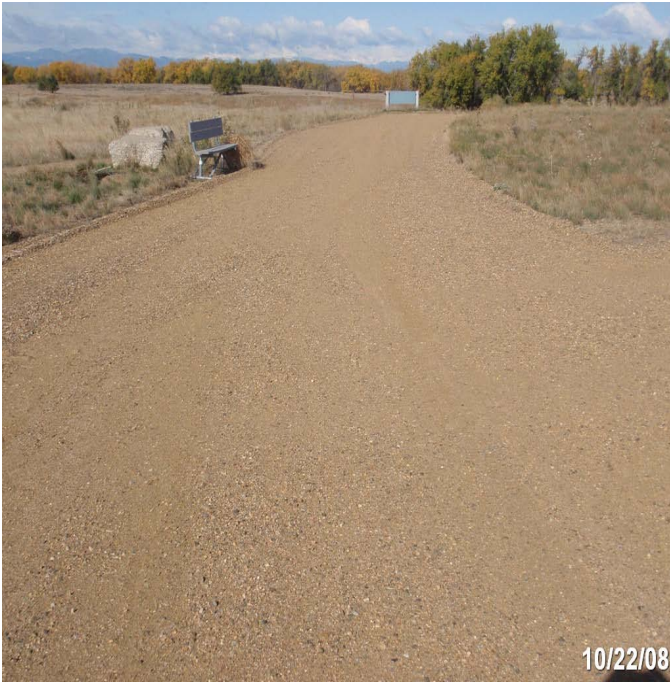
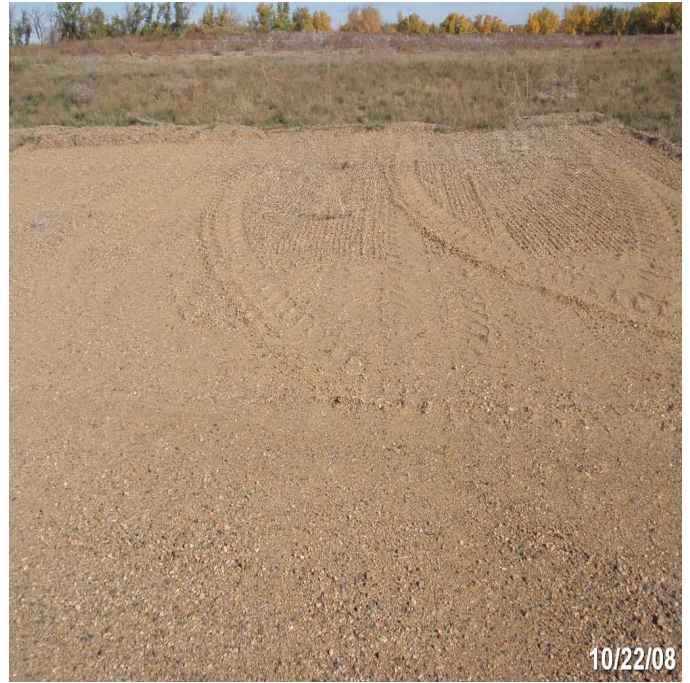
Route 902: Wetlands Turnaround Parking

Asset Number	Date Visited	Surface Type	Area (sq ft)	Condition	Cost to Improve
	10/22/2008	Gravel	11314	Good	\$1800

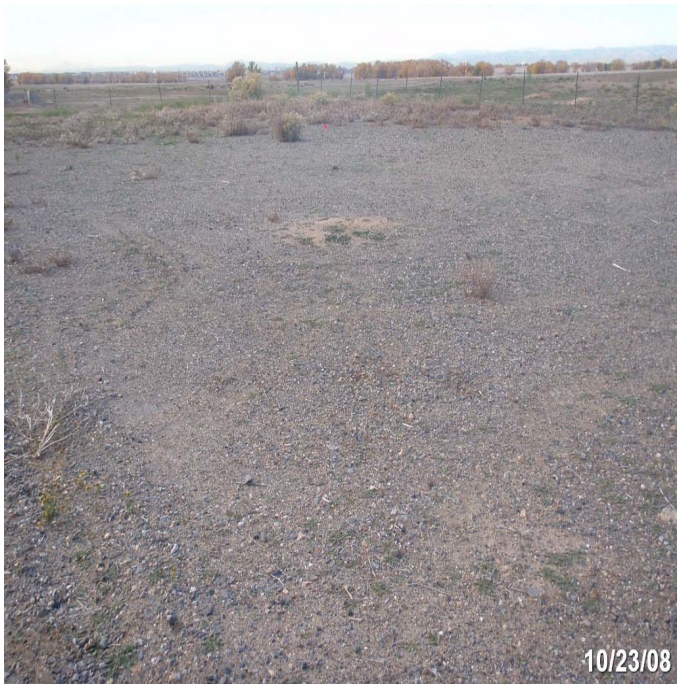
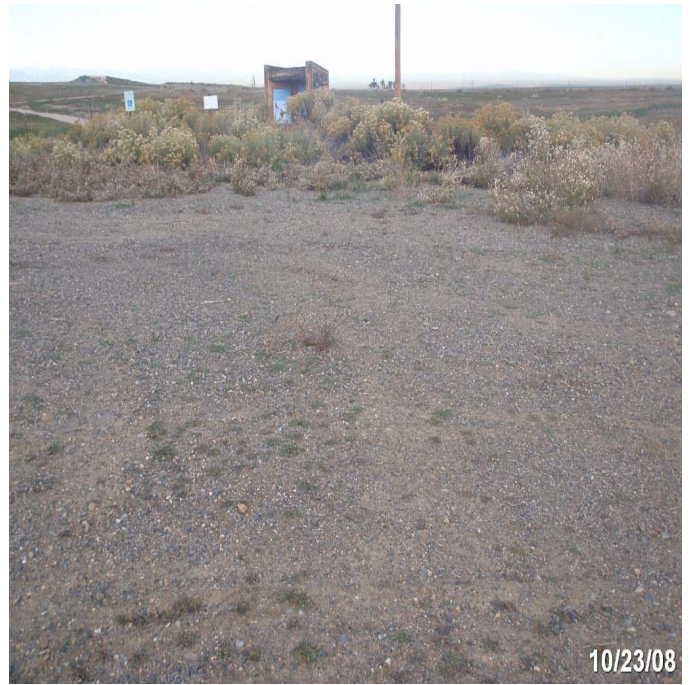
Route 903: Wildlife Watch Parking

Asset Number	Date Visited	Surface Type	Area (sq ft)	Condition	Cost to Improve
10050714	10/23/2008	Gravel	14554	Fair	\$4100

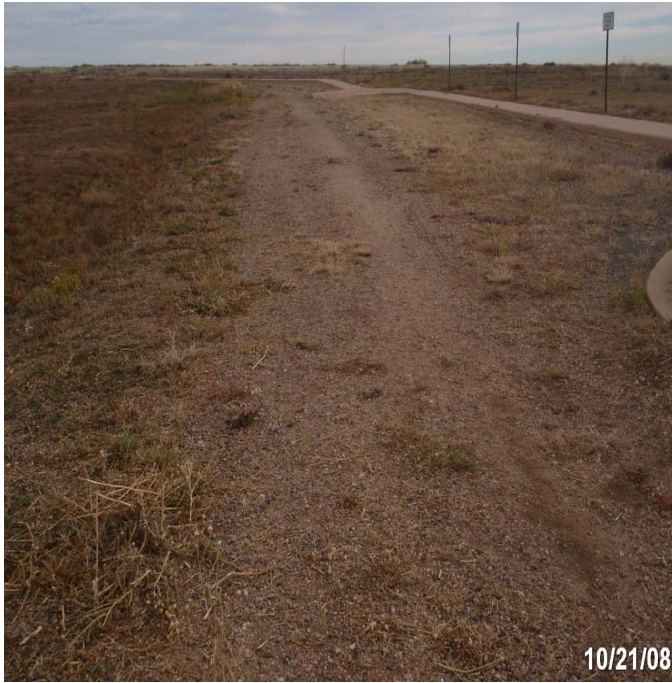
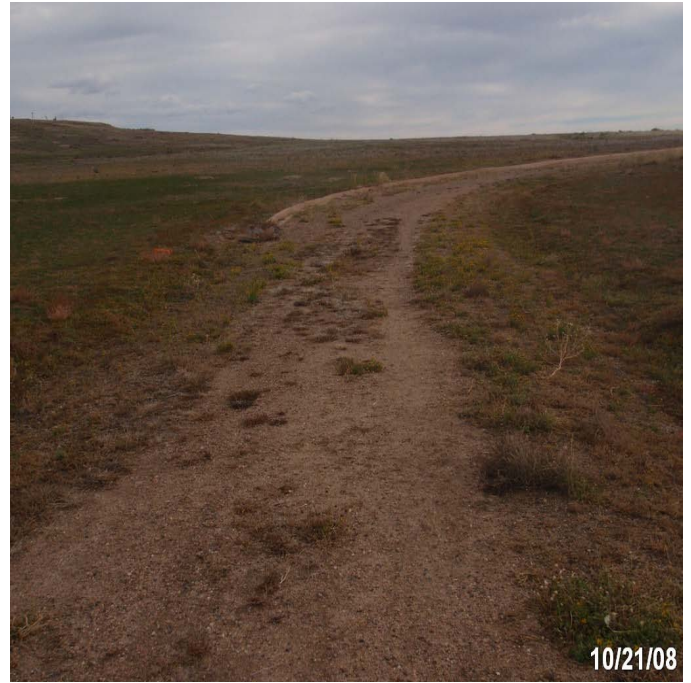
Route 904: Rattlesnake Hill Parking

Asset Number	Date Visited	Surface Type	Area (sq ft)	Condition	Cost to Improve
10050716	10/21/2008	Gravel	22392	Fair	\$6300

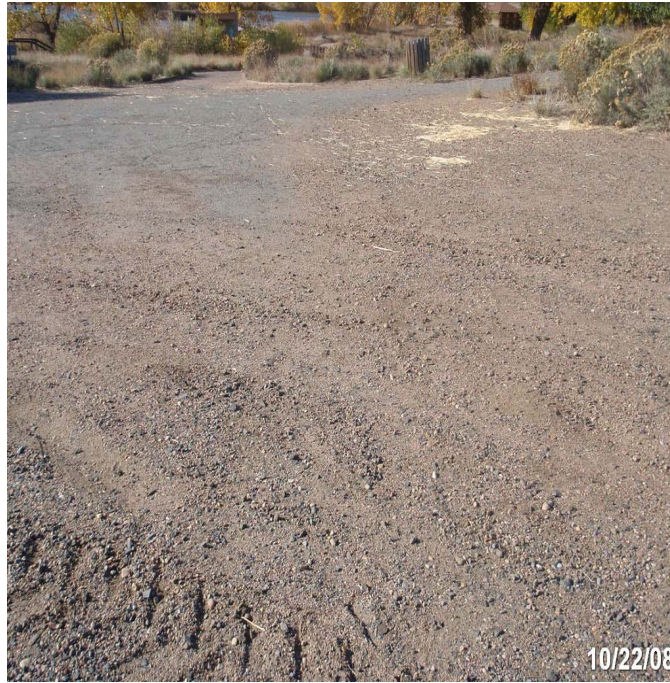
Route 905: Lake Mary Parking

Asset Number	Date Visited	Surface Type	Area (sq ft)	Condition	Cost to Improve
10053604	10/22/2008	Gravel	2509	Good	\$400

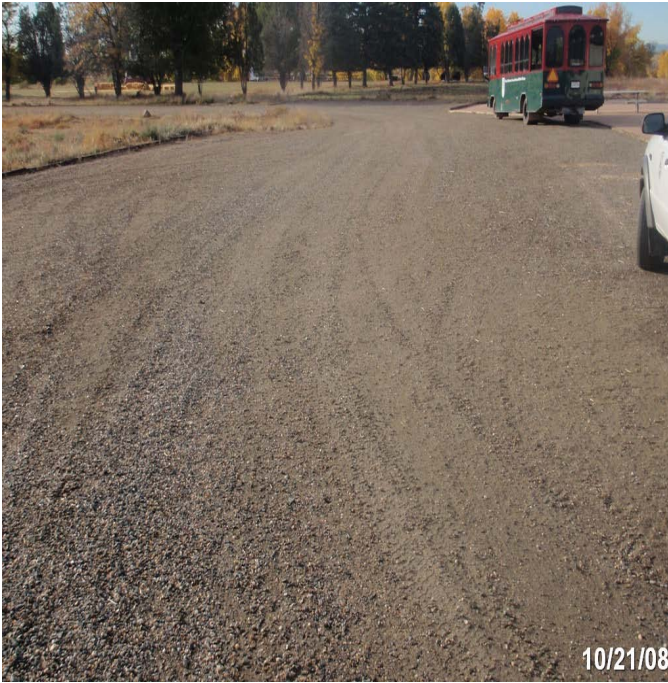
Route 906: Visitor Center East Parking

Asset Number	Date Visited	Surface Type	Area (sq ft)	Condition	Cost to Improve
10053604	10/21/2008	Gravel	18591	Good	\$3000

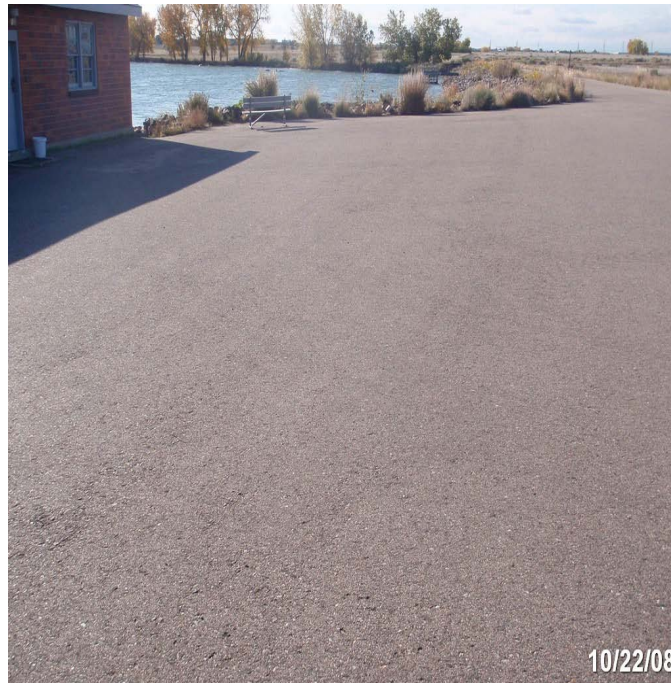
Route 908: Lake Ladora Dam Parking

Asset Number	Date Visited	Surface Type	Area (sq ft)	Condition	Cost to Improve
	10/21/2008	Asphalt	1461	Excellent	\$0

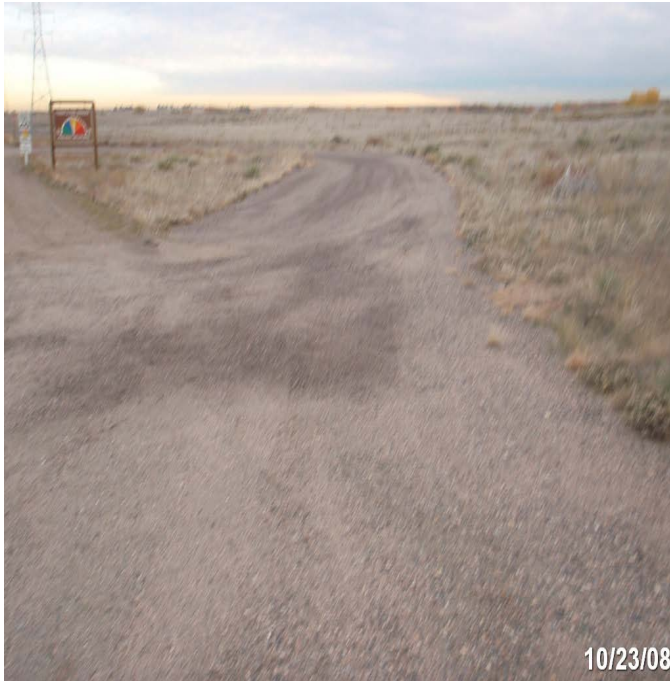
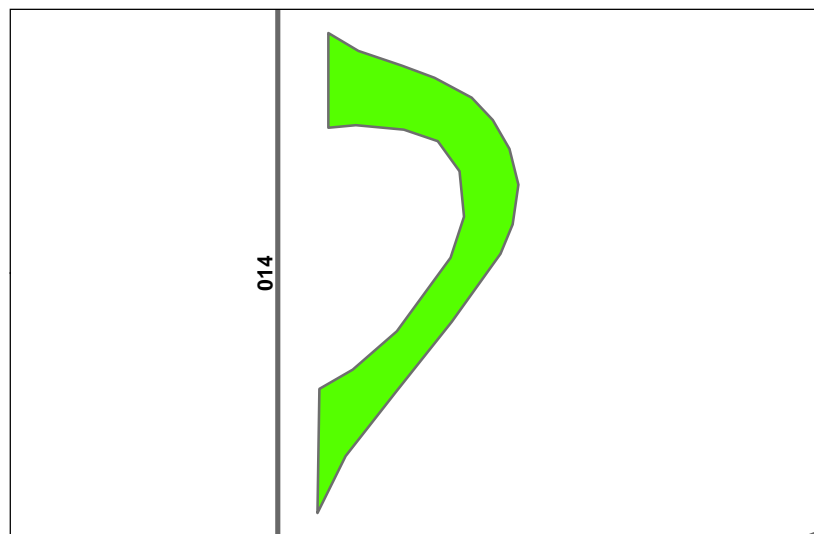
Route 909: South Entrance Truck Turnout

Asset Number	Date Visited	Surface Type	Area (sq ft)	Condition	Cost to Improve
	10/23/2008	Gravel	6920	Good	\$1100

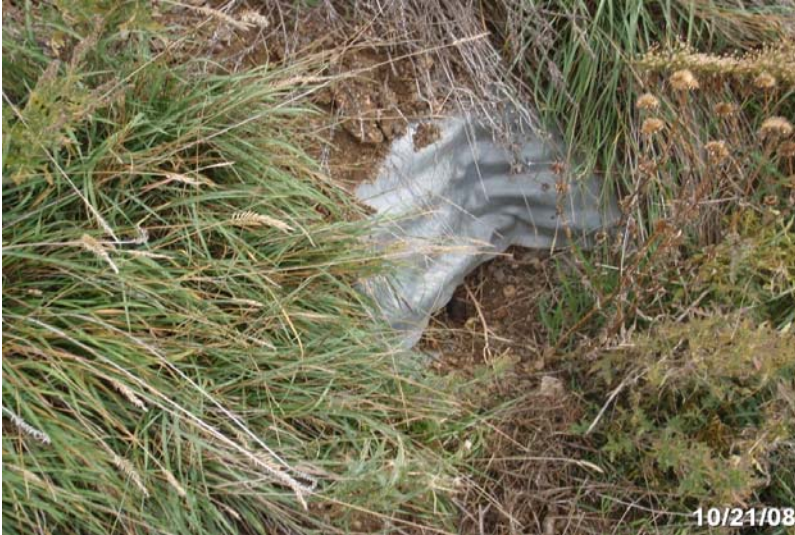
ROUTE NUMBER: 010 ROUTE NAME: Southern Tram Route

Photo # 1903 - MP 0.75 - Culvert Deficiency

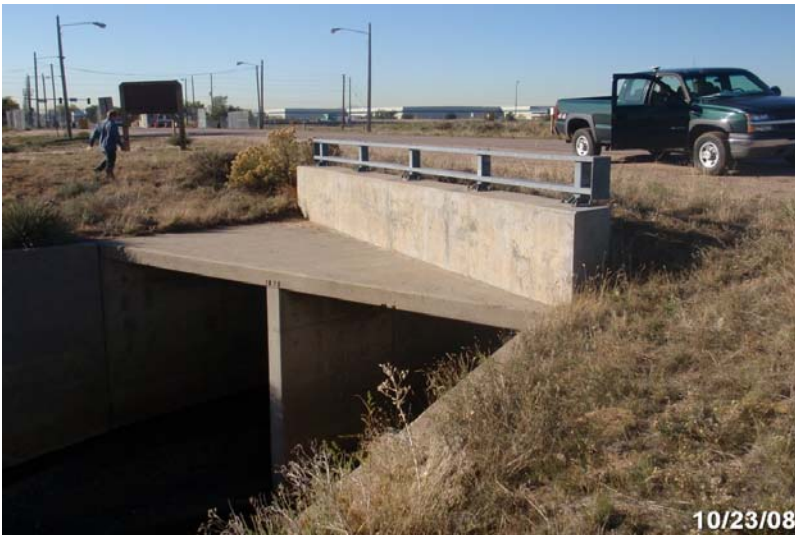
ROUTE NUMBER: 014 ROUTE NAME: South Entrance Road

Photo # 2076 - MP 0.89 - Bridge

Rocky Mountain Arsenal NWR Bridge Inventory					
Rte #	Milepost	NBIS #	Sufficiency Rating	Functionally Obsolete	Structurally Deficient
014	0.01	-	-	-	-

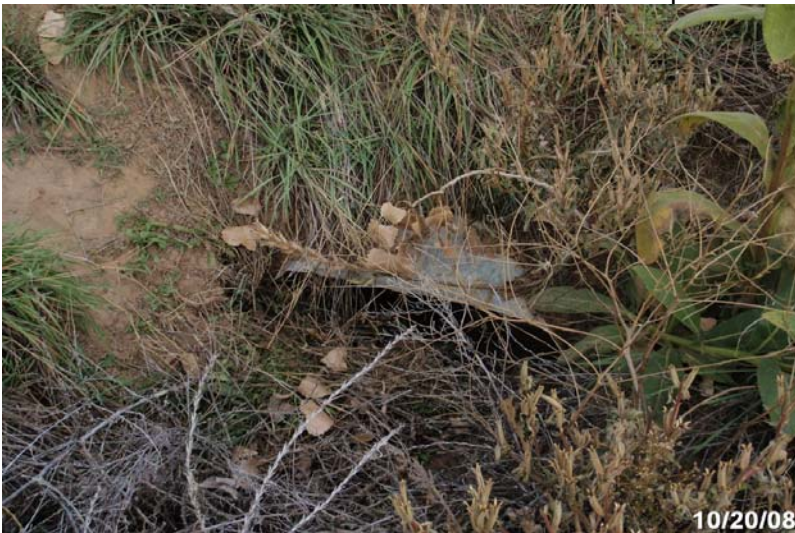
Photo # 1853 - MP 0.01 - Culvert Deficiency

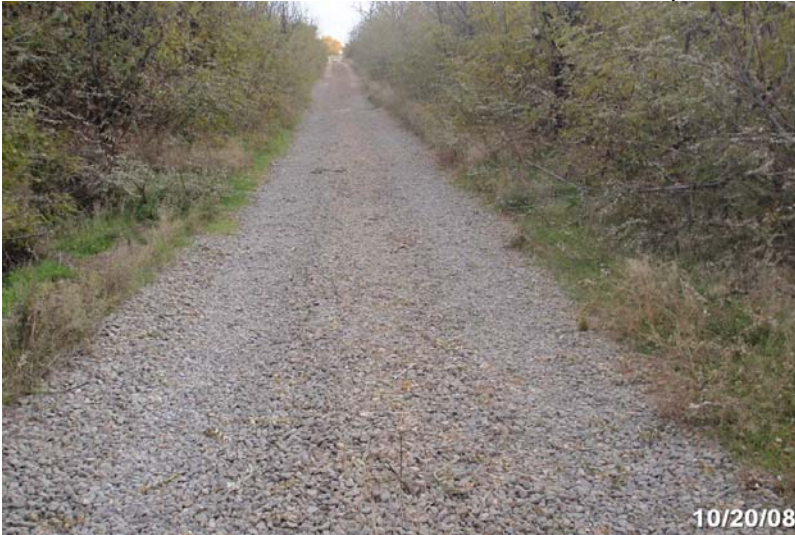
Photo # 1854 - MP 0.01 - Culvert Deficiency

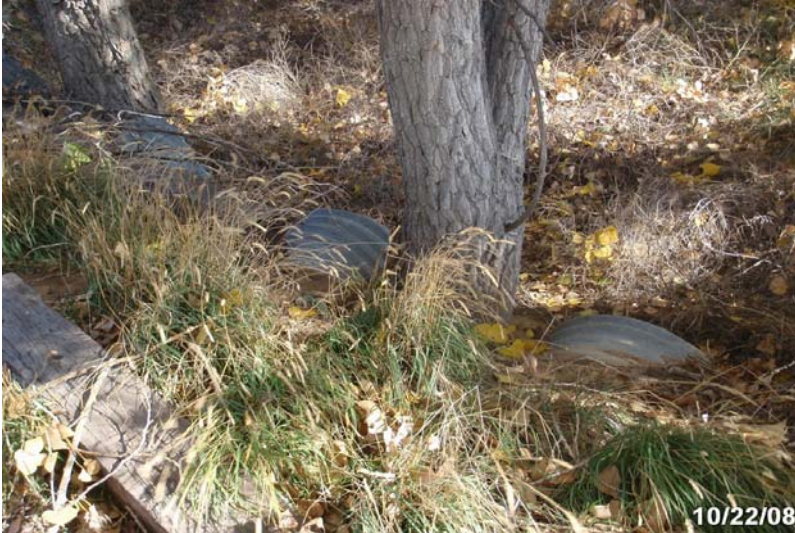
Photo # 1997 - MP 0.67 - Culvert Deficiency

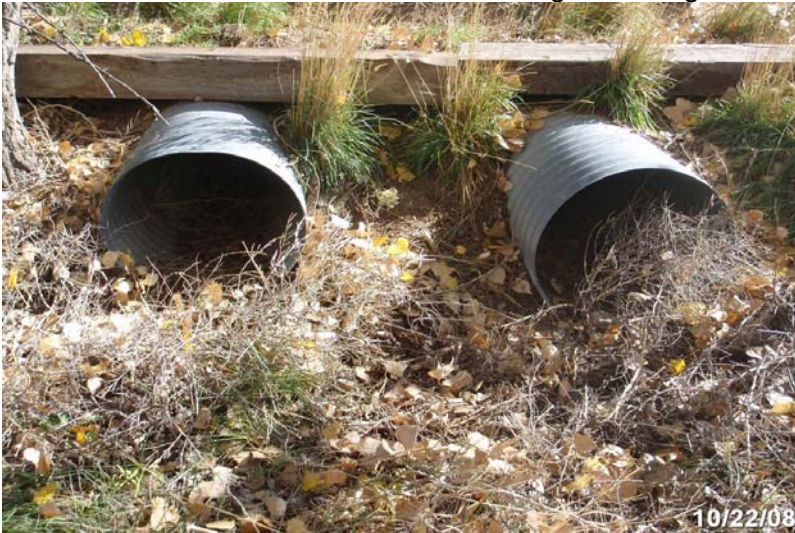
Photo # 1998 - MP 0.67 - Culvert Deficiency

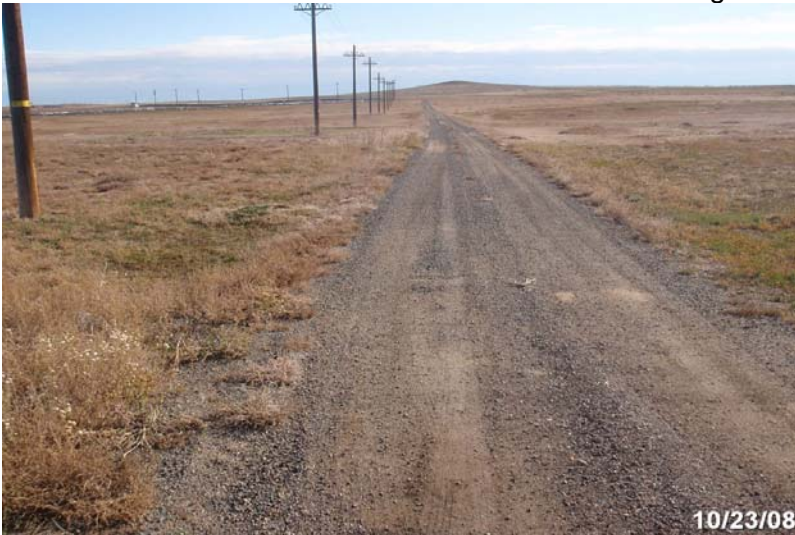
Photo # 2084 - MP 0.00 - Begin Route at Begin Section

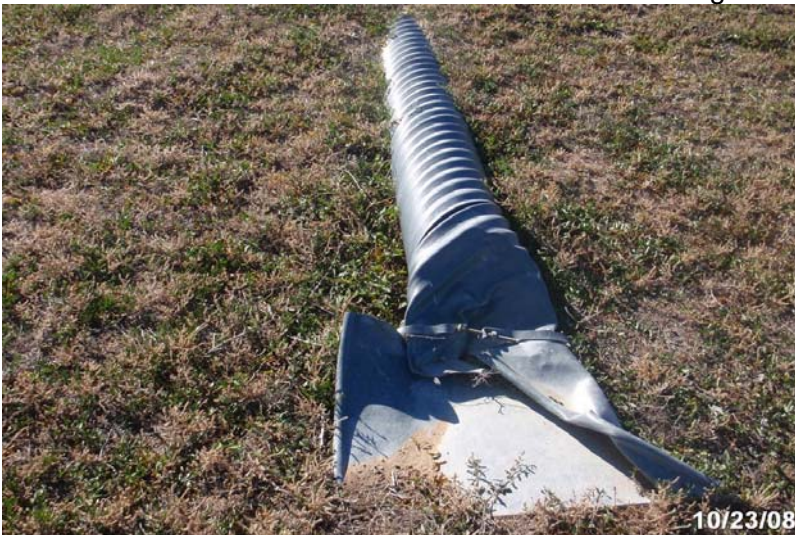
Photo # 2087 - MP 0.15 - Culvert Deficiency

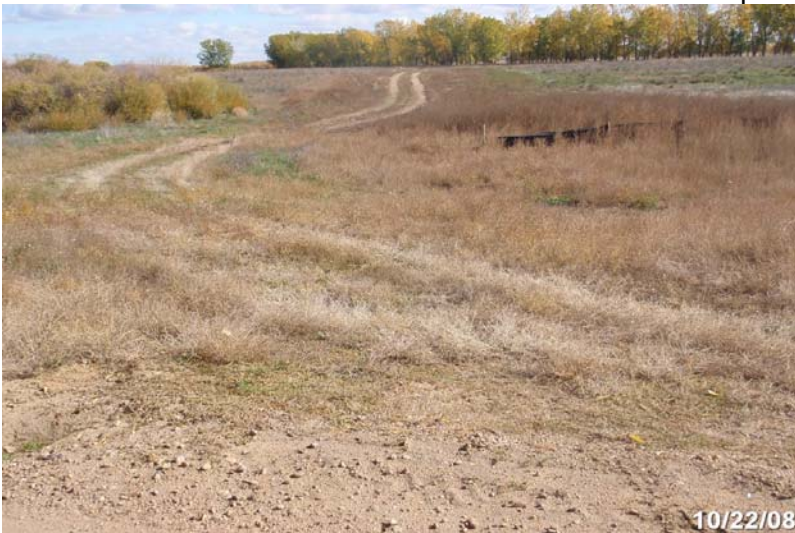
Photo # 1999 - MP 0.00 - Begin Route at Begin Section

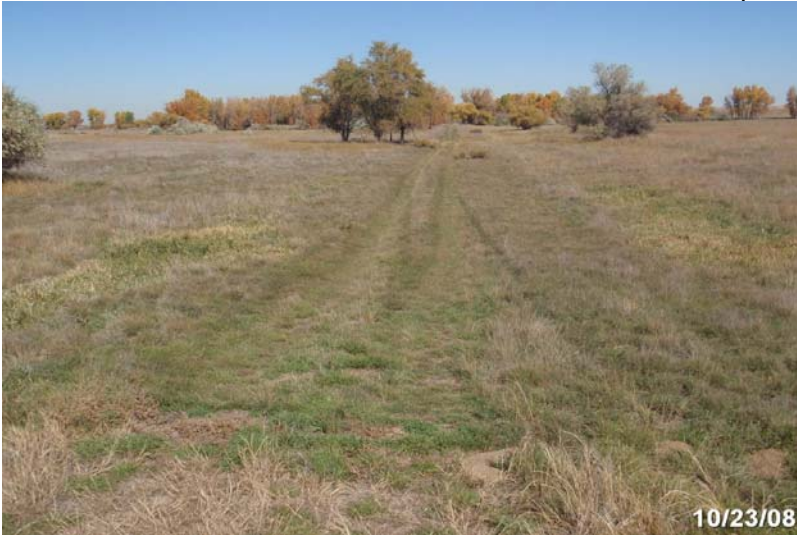
Photo # 2106 - MP 0.00 - Begin Route at Begin Section

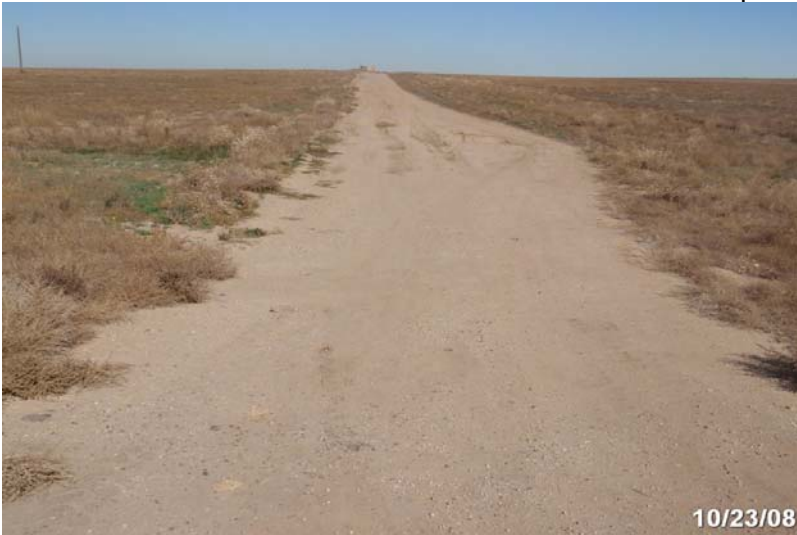
Photo # 2107 - MP 0.00 - Begin Route at Begin Section
