# The Road Inventory of Inks Dam National Fish Hatchery Burnet, TX

Prepared By: Federal Highway Administration Central Federal Lands Highway Division December 2009

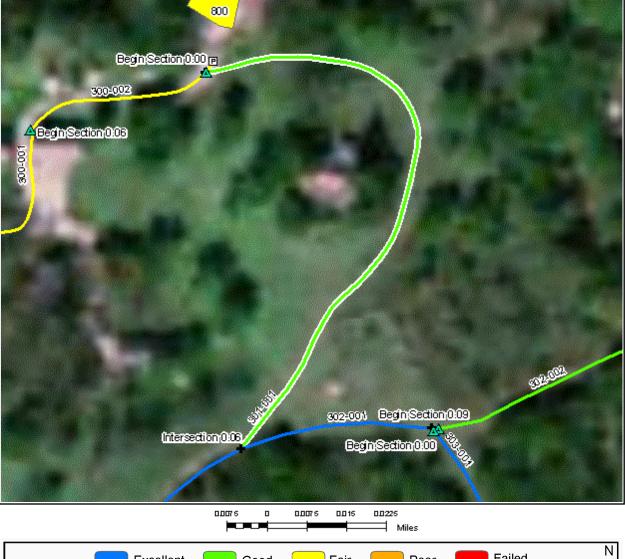
Route: 300 Office and Crew Meeting Room Access Road

Route Description: From Refuge Entrance Road (Route 011) to end of route at storage unit 6

Asset Number	10040325	10040325
Section Number	001	002
Section Length (miles)	0.06	0.03
Inspection Date	04/06/2009	04/06/2009
Section Information		
Surface Type	Asphalt	Asphalt
Number of Lanes	2	1
Roadway Width (feet)	20.00	10.00
Roadway Condition Information		
Condition	Fair	Fair
Remaining Service Life (years)	10	8
Cost Estimate	5,700	3,300
CRV	62,700.00	36,000.00

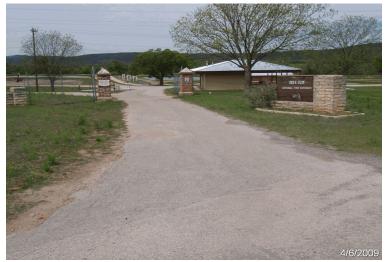
Photo # INDA\_C4\_0127 - MP 0.00 - Begin Section 001 ROUTE NUMBER: 011 ROUTE NAME: Refuge Entrance Road

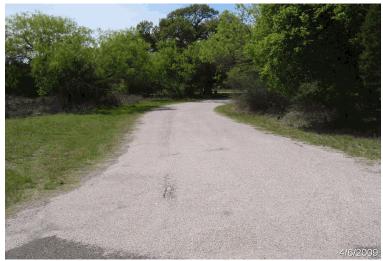
Photo # INDA\_C4\_0168 - MP 0.00 - Begin Section 001 ROUTE NUMBER: 011 ROUTE NAME: Refuge Entrance Road

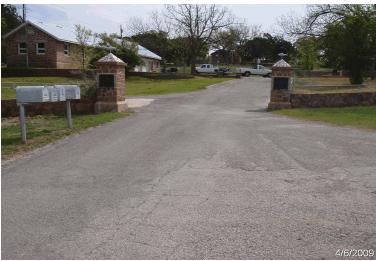
Photo # INDA\_C4\_0110 - MP 0.00 - Begin Section 001

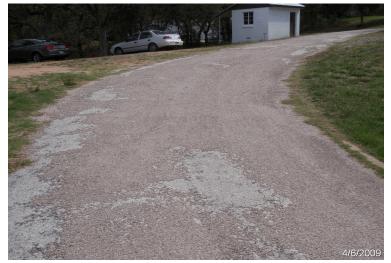
Photo # INDA\_C4\_0112 - MP 0.06 - Begin Section 002 ROUTE NUMBER: 300 ROUTE NAME: Office and Crew Meeting Room Access Road

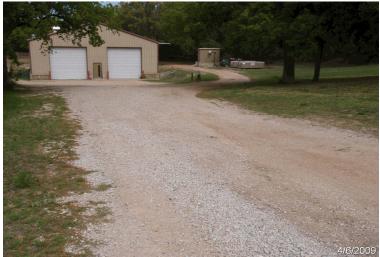
Photo # INDA\_C4\_0124 - MP 0.00 - Begin Section 001 ROUTE NUMBER: 304 ROUTE NAME: BDU Road

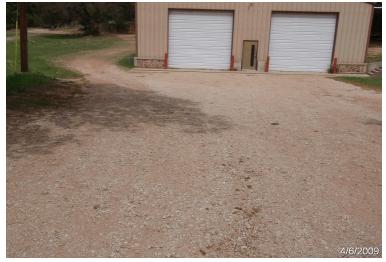
Photo # INDA\_C4\_0125 - MP 0.00 - Begin Section 001 ROUTE NUMBER: 304 ROUTE NAME: BDU Road

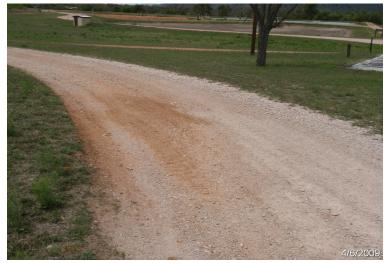
Photo # INDA\_C4\_0126 - MP 0.12 - Begin Section 002

ROUTE NUMBER: 305 ROUTE NAME: Butler Storage Unit Road

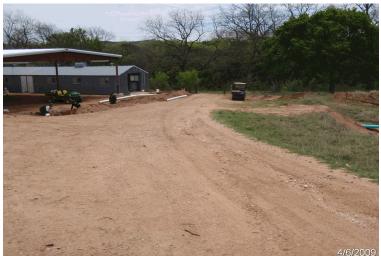
Photo # INDA\_C4\_0132 - MP 0.00 - Begin Section 001 ROUTE NUMBER: 306 ROUTE NAME: Well #P1 Access Road

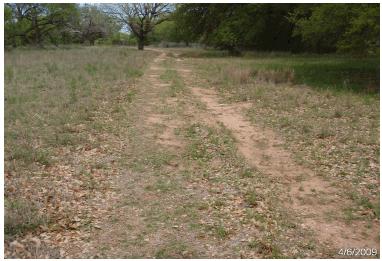
Photo # INDA\_C4\_0133 - MP 0.00 - Begin Section 001 ROUTE NUMBER: 307 ROUTE NAME: Dam Service Road

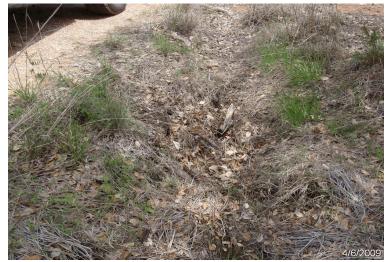
Photo # INDA\_C4\_0135 - MP 0.00 - Begin Section 001

ROUTE NUMBER: 307 ROUTE NAME: Dam Service Road

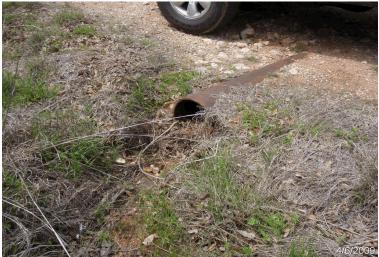
Photo # INDA\_C4\_0139 - MP 0.22 - R 001 ROUTE NUMBER: 307 ROUTE NAME: Dam Service Road

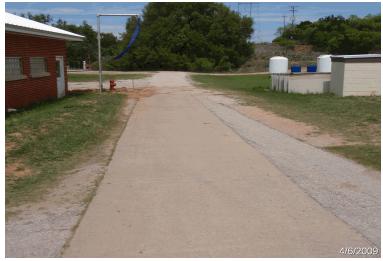
Photo # INDA\_C4\_0137 - MP 0.23 - R 001 ROUTE NUMBER: 308 ROUTE NAME: North Pond Unit Road

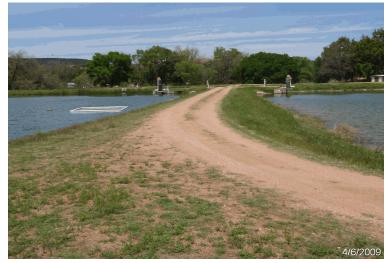
Photo # INDA\_C4\_0141 - MP 0.00 - Begin Section 001

ROUTE NUMBER: 308 ROUTE NAME: North Pond Unit Road

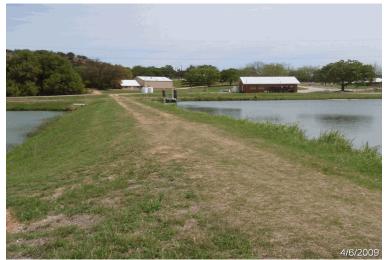
Photo # INDA\_C4\_0142 - MP 0.30 - Begin Section 002 ROUTE NUMBER: 308 ROUTE NAME: North Pond Unit Road

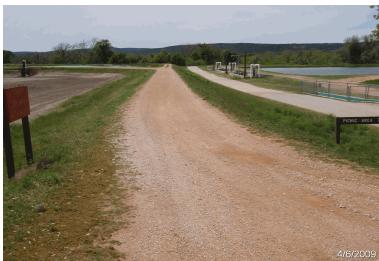
Photo # INDA\_C4\_0143 - MP 0.38 - Begin Section 003 ROUTE NUMBER: 309 ROUTE NAME: Main Pond Unit Road

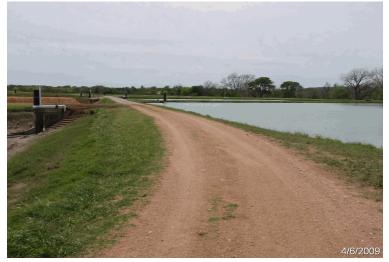
Photo # INDA\_C4\_0144 - MP 0.00 - Begin Section 001

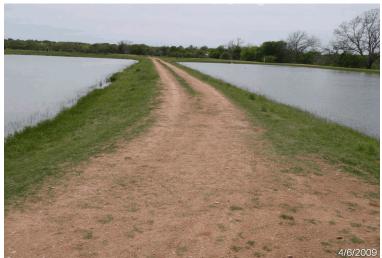
Photo # INDA\_C4\_0145 - MP 0.06 - Begin Section 002 ROUTE NUMBER: 309 ROUTE NAME: Main Pond Unit Road

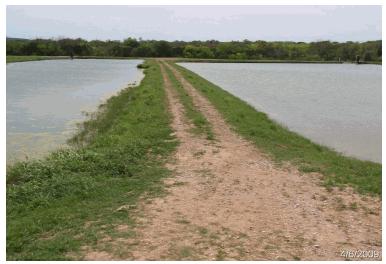
Photo # INDA\_C4\_0146 - MP 0.95 - Begin Section 003 ROUTE NUMBER: 309 ROUTE NAME: Main Pond Unit Road

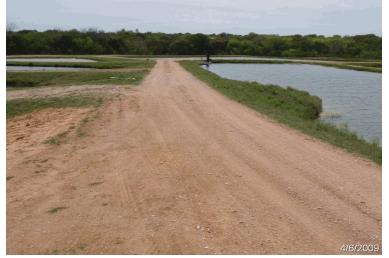
Photo # INDA\_C4\_0147 - MP 0.79 - Begin Section 004

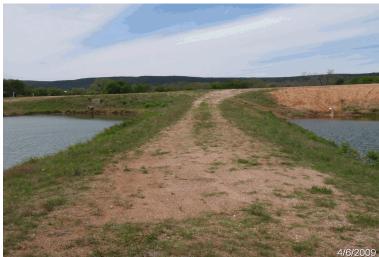
Photo # INDA\_C4\_0148 - MP 0.74 - Begin Section 005 ROUTE NUMBER: 309 ROUTE NAME: Main Pond Unit Road

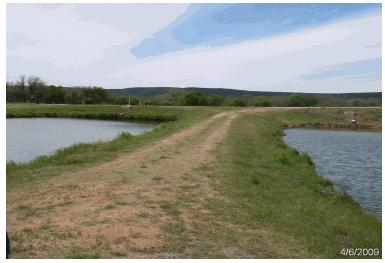
Photo # INDA\_C4\_0149 - MP 0.70 - Begin Section 006 ROUTE NUMBER: 309 ROUTE NAME: Main Pond Unit Road

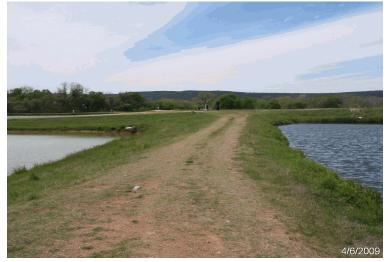
Photo # INDA\_C4\_0150 - MP 0.68 - Begin Section 007

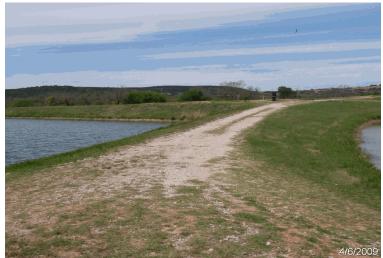
Photo # INDA\_C4\_0151 - MP 0.66 - Begin Section 008 ROUTE NUMBER: 309 ROUTE NAME: Main Pond Unit Road

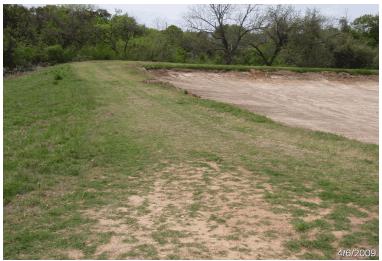
Photo # INDA\_C4\_0152 - MP 0.62 - Begin Section 009 ROUTE NUMBER: 309 ROUTE NAME: Main Pond Unit Road

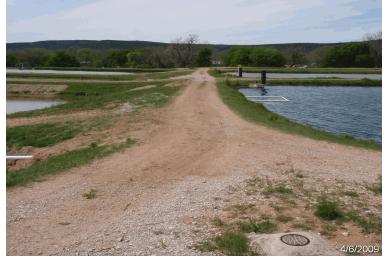
Photo # INDA\_C4\_0153 - MP 0.57 - Begin Section 010

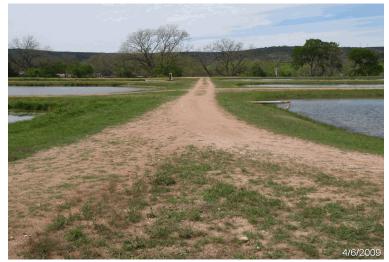
Photo # INDA\_C4\_0154 - MP 0.77 - Begin Section 011 ROUTE NUMBER: 309 ROUTE NAME: Main Pond Unit Road

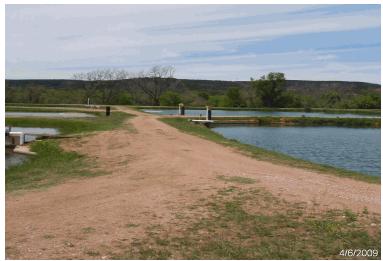
Photo # INDA\_C4\_0155 - MP 0.82 - Begin Section 012 ROUTE NUMBER: 309 ROUTE NAME: Main Pond Unit Road

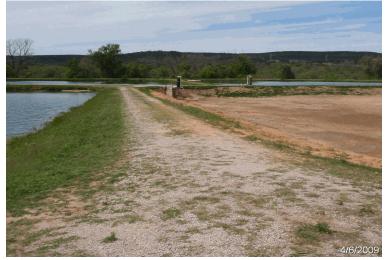
Photo # INDA\_C4\_0156 - MP 0.90 - Begin Section 013

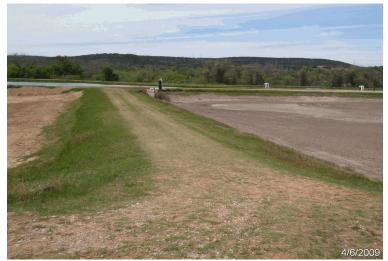
Photo # INDA\_C4\_0157 - MP 0.93 - Begin Section 014 ROUTE NUMBER: 309 ROUTE NAME: Main Pond Unit Road

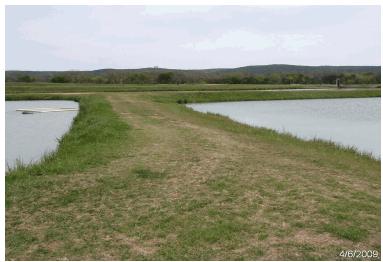
Photo # INDA\_C4\_0158 - MP 0.97 - Begin Section 015 ROUTE NUMBER: 309 ROUTE NAME: Main Pond Unit Road

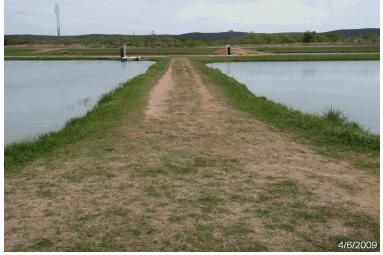
Photo # INDA\_C4\_0159 - MP 0.38 - Begin Section 016
