The Road Inventory of Stillwater National Wildlife Refuge Fallon, NV

Prepared By:
Federal Highway Administration
Central Federal Lands Highway Division
June 2012

Stillwater National Wildlife Refuge - 84590

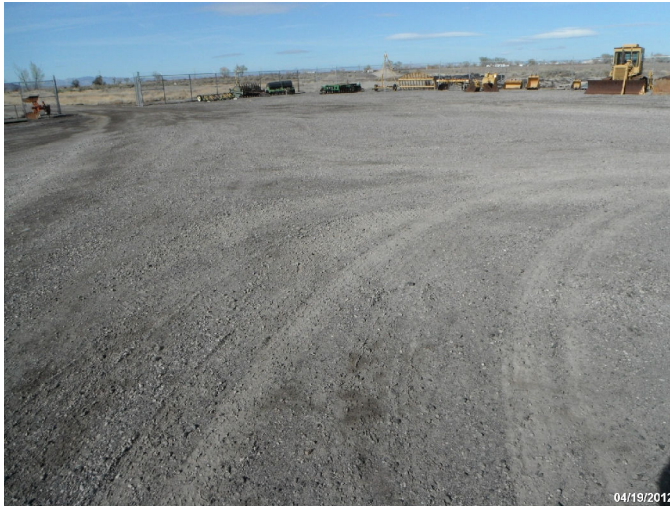
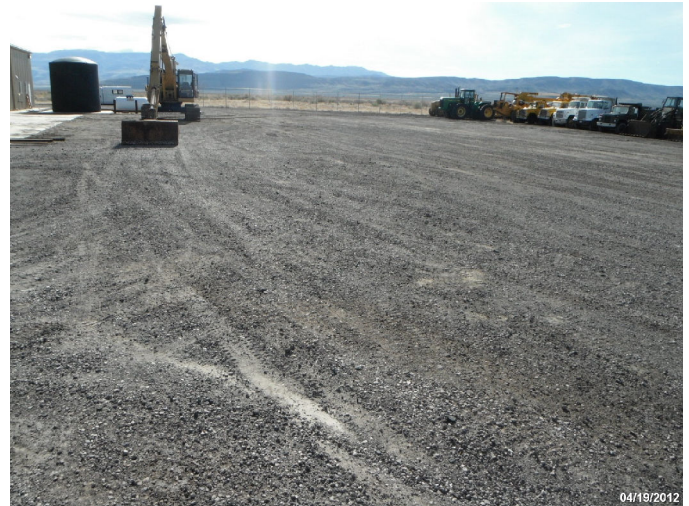
Shop Parking

From Shop Road (Route 300)

Asset Number	Area (Sq Ft)	Condition	Surface Type	Cost to Improve	Inspection Date	Current Replacement Value
10051441	139305	Good	Gravel	\$23,200	04-19-2012	\$765,900

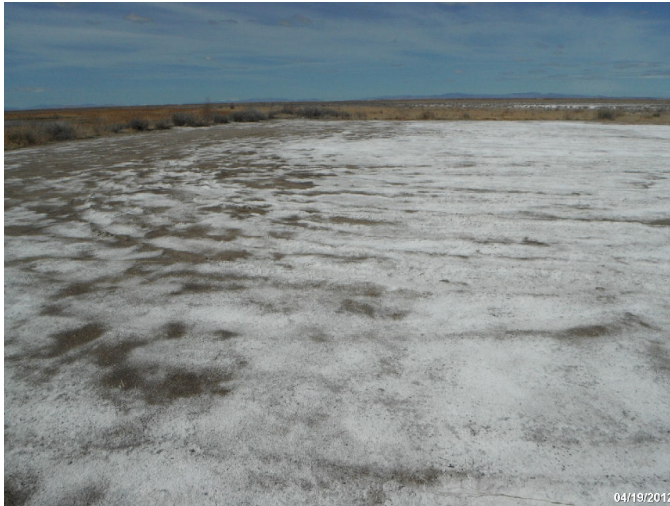
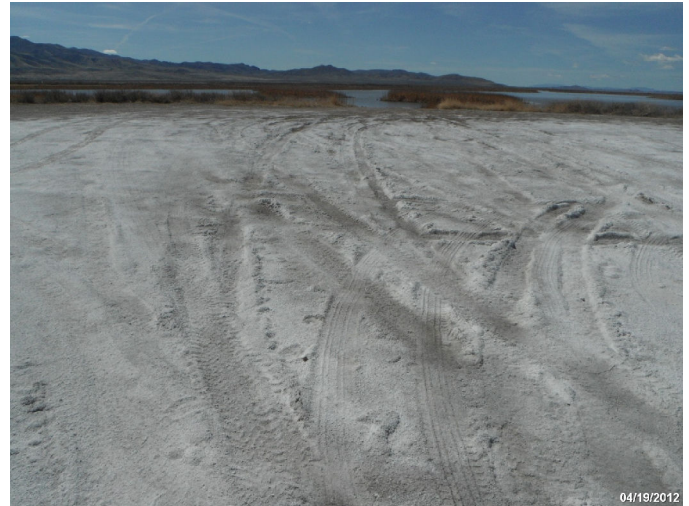
Route Number:903

From Goose Lake Landing Access Road (Route 202)

Asset Number	Area (Sq Ft)	Condition	Surface Type	Cost to Improve	Inspection Date	Current Replacement Value
10005670	14747	Poor	Gravel	\$18,100	04-19-2012	\$81,100

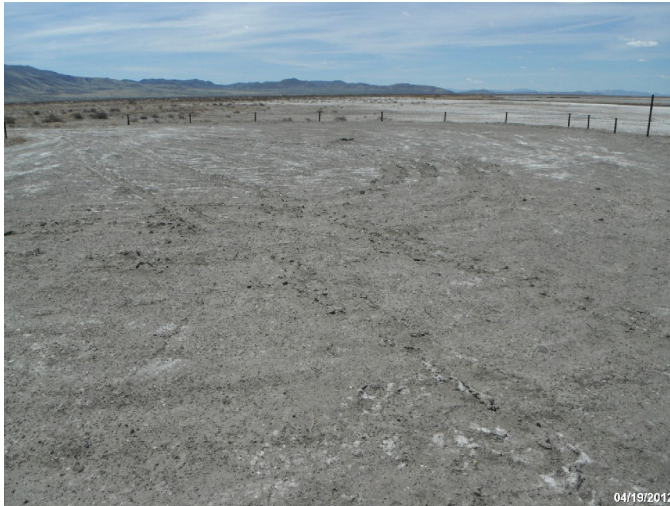
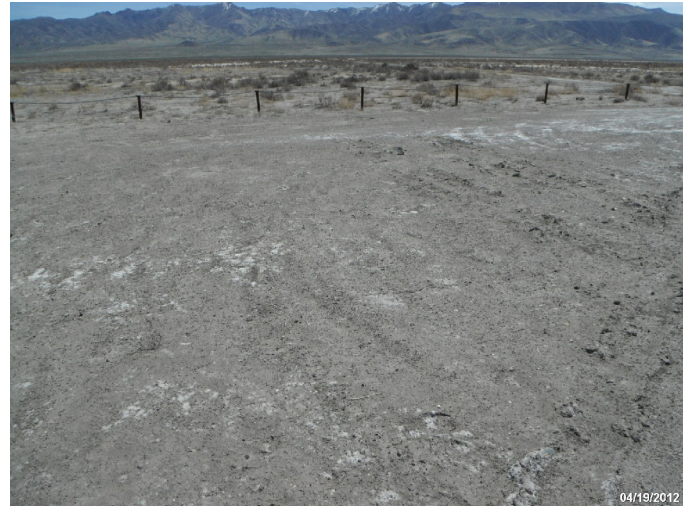
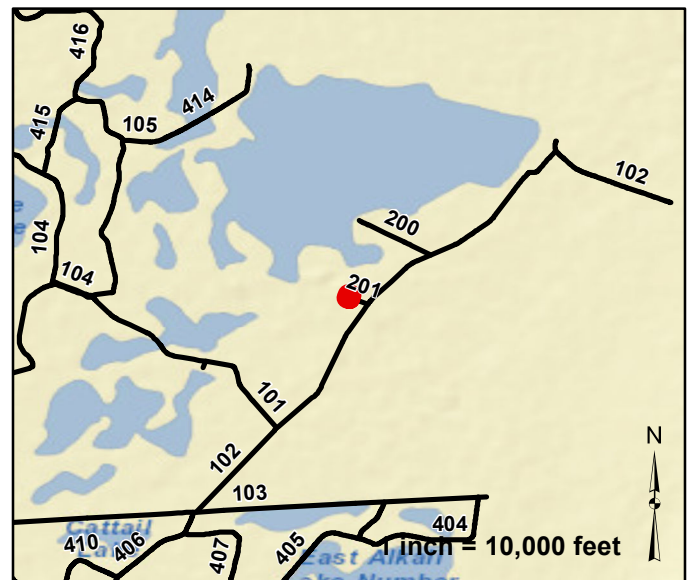
Route Number:904

From East Parking Access Road (Route 201)

Asset Number	Area (Sq Ft)	Condition	Surface Type	Cost to Improve	Inspection Date	Current Replacement Value
10005665	16464	Poor	Gravel	\$20,200	04-19-2012	\$90,500

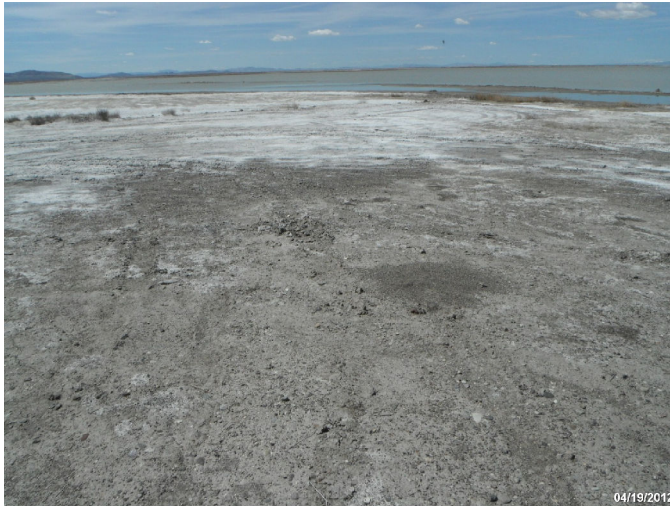
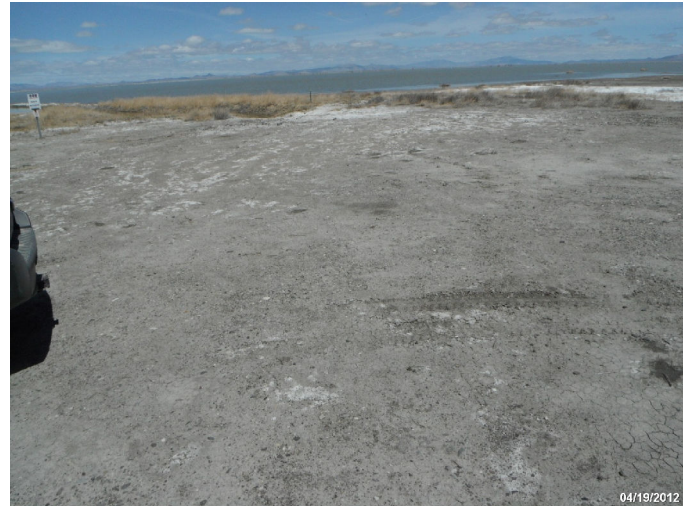
Route Number:905

From Conradt's Landing Access Road (Route 200)

Asset Number	Area (Sq Ft)	Condition	Surface Type	Cost to Improve	Inspection Date	Current Replacement Value
10005662	3788	Poor	Gravel	\$4,600	04-19-2012	\$20,800

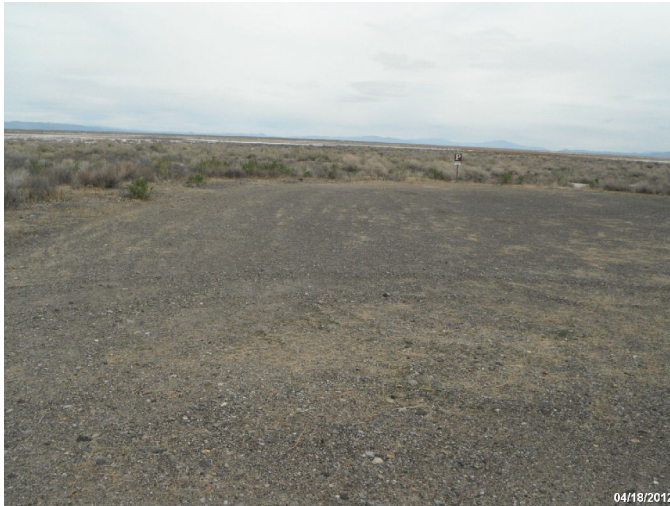
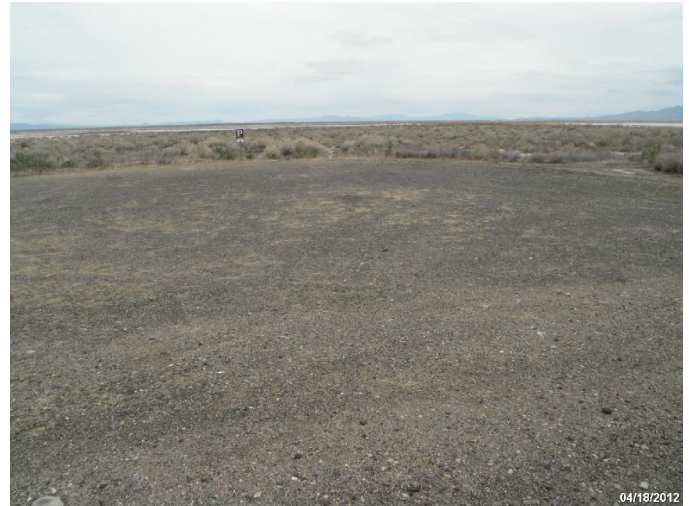
Route Number:906
Division Road East Parking Area
 From Division Road (Route 103)

Asset Number	Area (Sq Ft)	Condition	Surface Type	Cost to Improve	Inspection Date	Current Replacement Value
10005669	8901	Fair	Gravel	\$2,600	04-18-2012	\$48,900

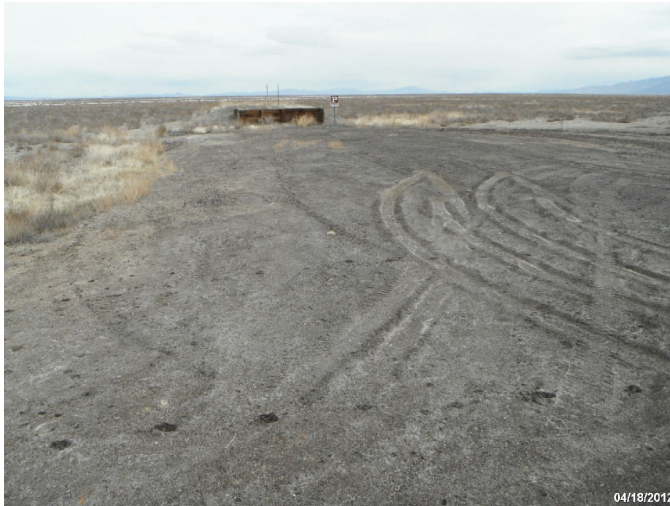
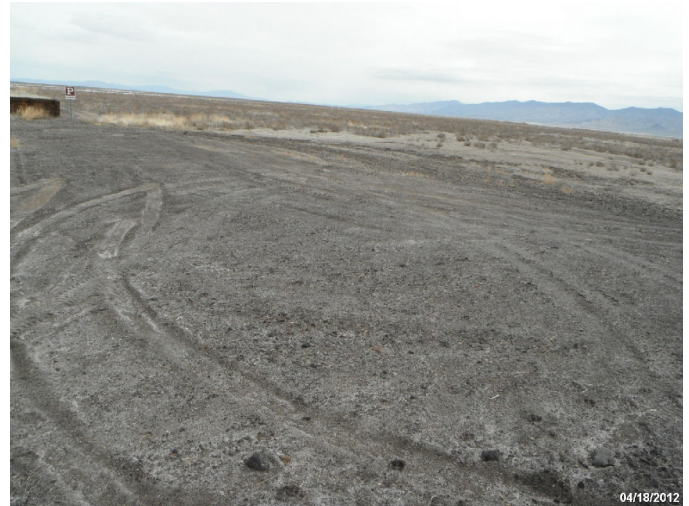
Route Number:907
Division Road West Parking Area
 From Division Road (Route 103)

Asset Number	Area (Sq Ft)	Condition	Surface Type	Cost to Improve	Inspection Date	Current Replacement Value
10005667	3937	Fair	Gravel	\$1,200	04-18-2012	\$21,600

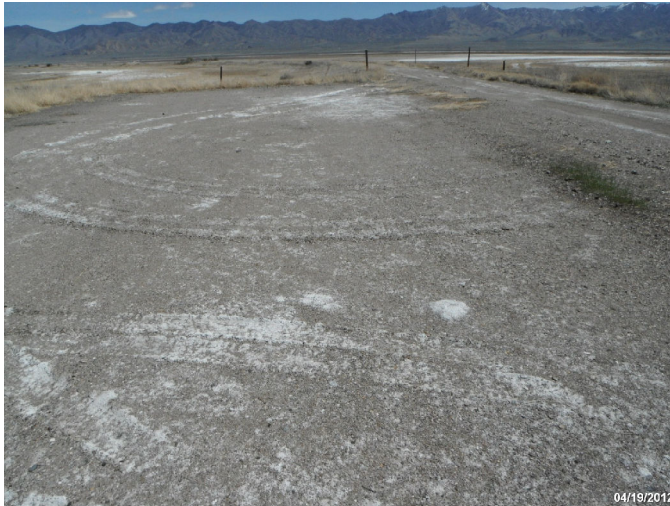
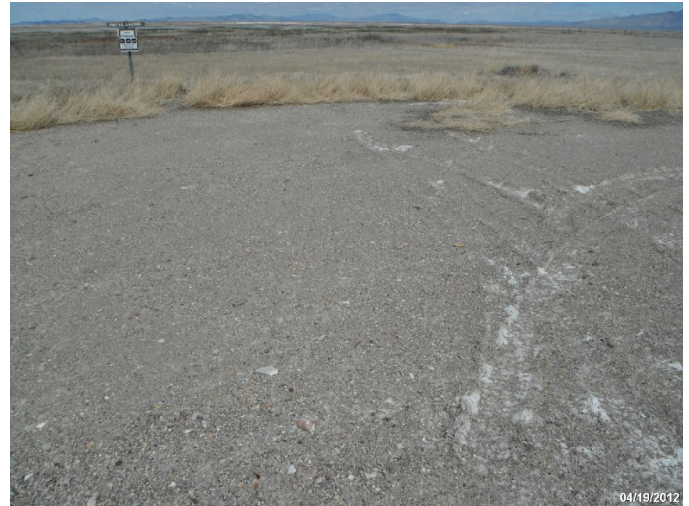
Route Number:908
Pintail Bay Landing Parking Area
From Pintail Road (Route 105)

Asset Number	Area (Sq Ft)	Condition	Surface Type	Cost to Improve	Inspection Date	Current Replacement Value
10005676	7139	Fair	Gravel	\$2,100	04-19-2012	\$39,200

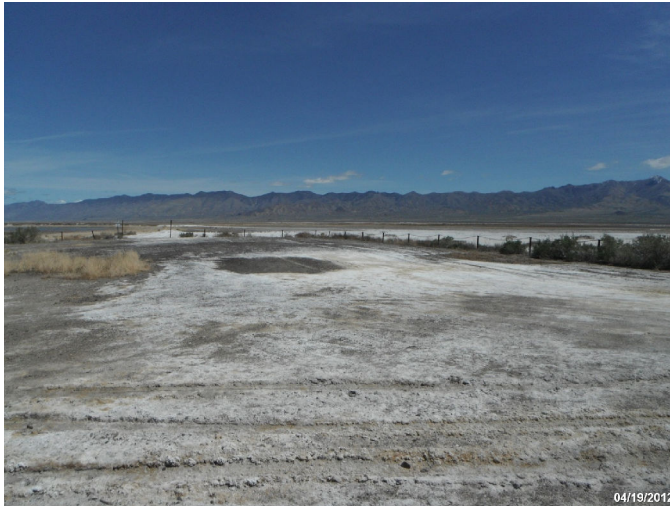
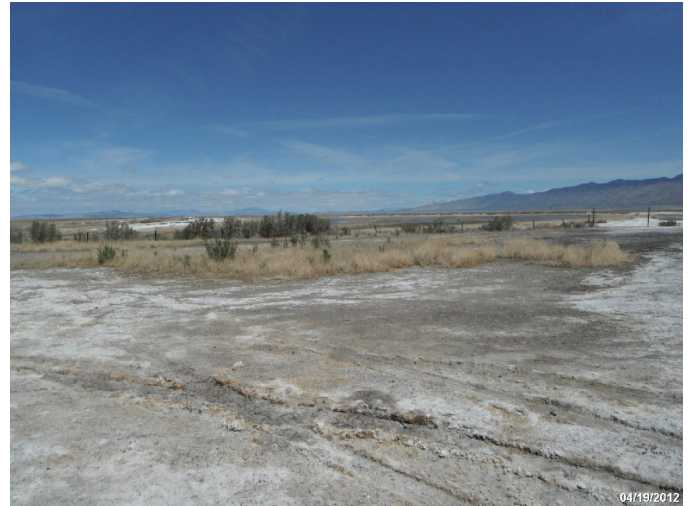
Route Number:909

From Center Road (Route 104)

Asset Number	Area (Sq Ft)	Condition	Surface Type	Cost to Improve	Inspection Date	Current Replacement Value
10005675	28224	Poor	Gravel	\$34,600	04-19-2012	\$155,200

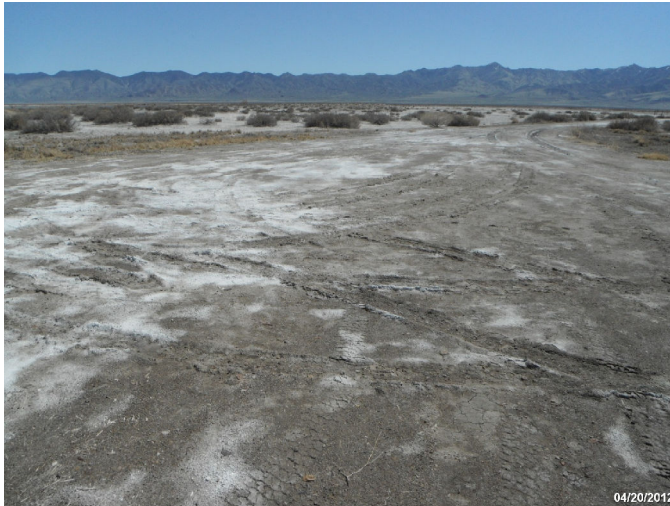
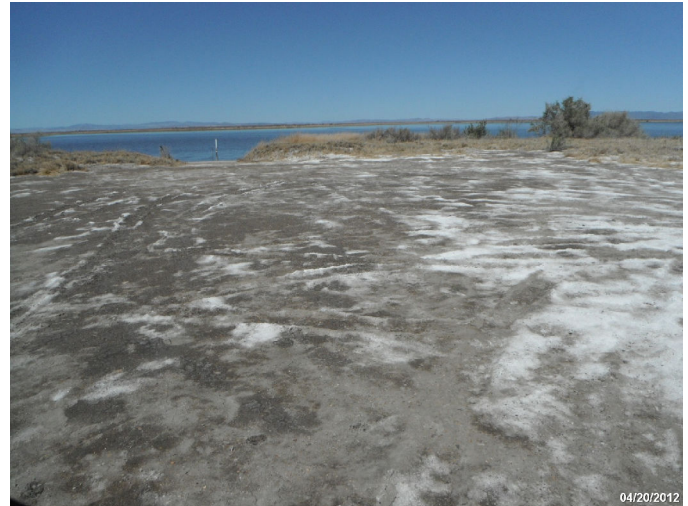
Route Number:910
South Swan Lake Landing Parking Area
 From South Swan Lake Access Road (Route 203)

Asset Number	Area (Sq Ft)	Condition	Surface Type	Cost to Improve	Inspection Date	Current Replacement Value
10005682	5939	Fair	Native	\$1,700	04-20-2012	\$14,100

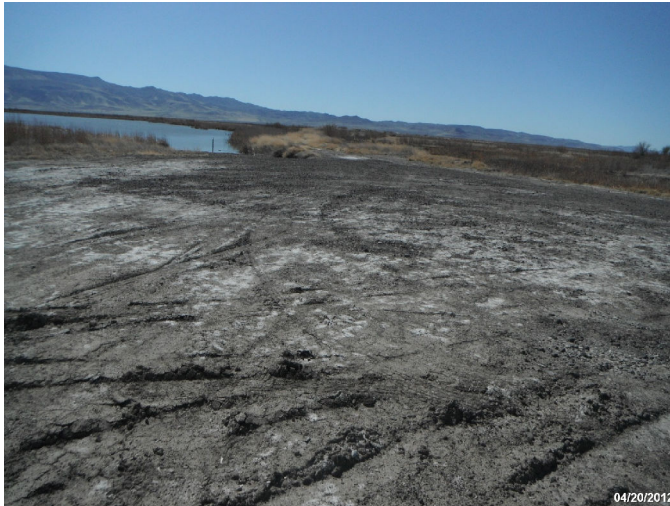
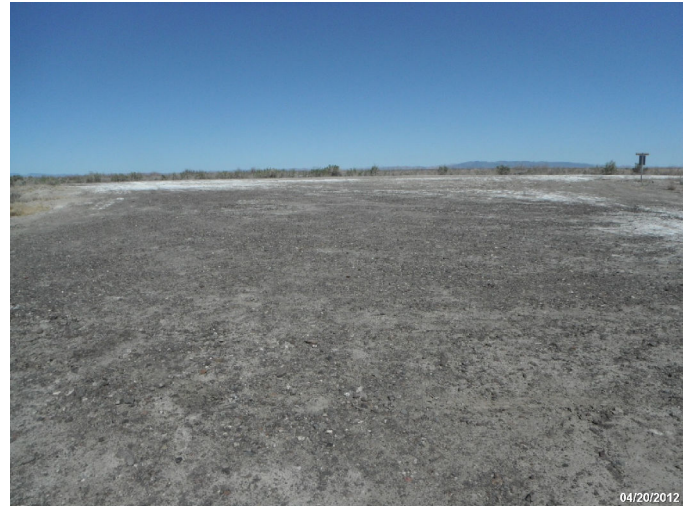
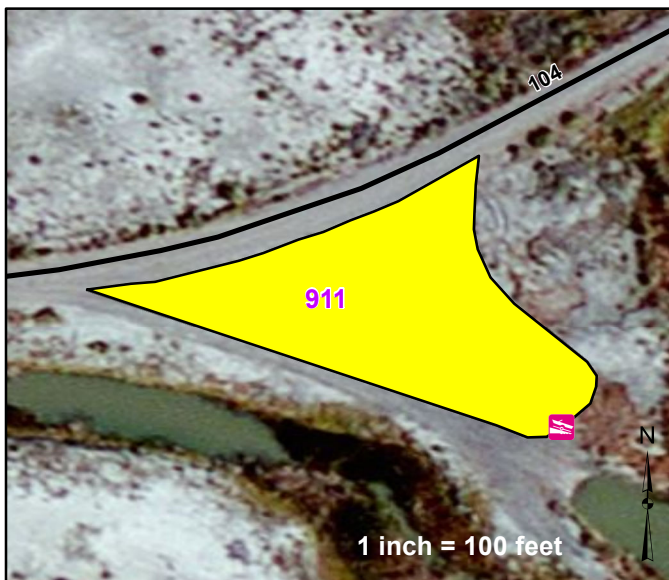
Route Number:911
Tule Lake Landing Parking Area
From Center Road (Route 104)

Asset Number	Area (Sq Ft)	Condition	Surface Type	Cost to Improve	Inspection Date	Current Replacement Value
-	11986	Fair	Gravel	\$3,500	04-20-2012	\$65,900

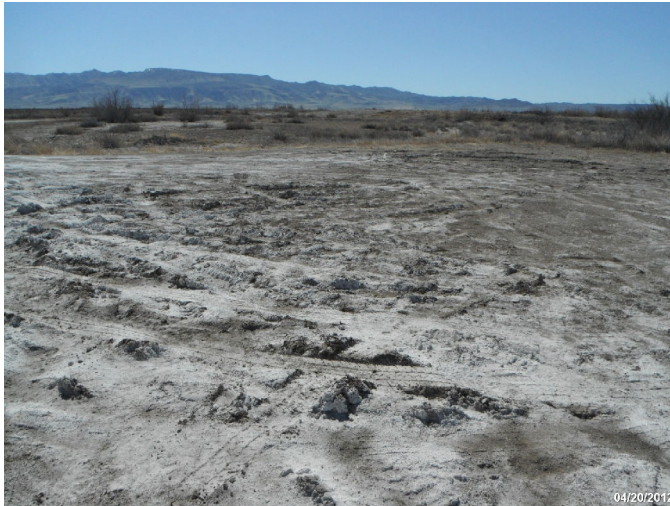
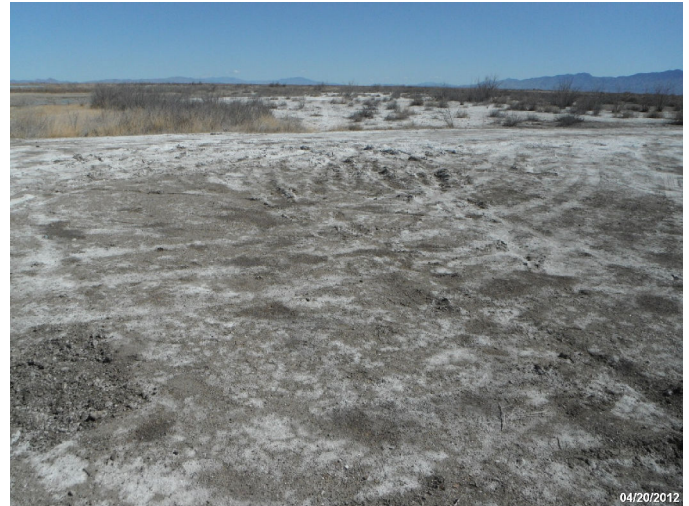
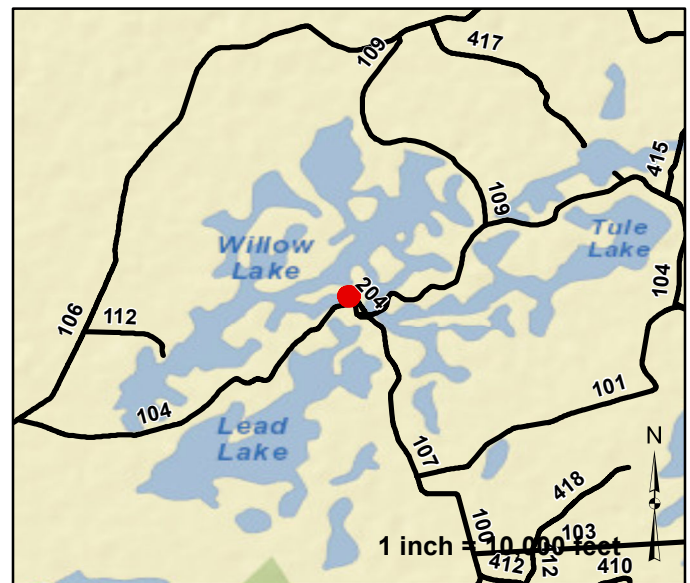
From Narrows Landing Access Road (Route 204)

Asset Number	Area (Sq Ft)	Condition	Surface Type	Cost to Improve	Inspection Date	Current Replacement Value
10005680	3535	Poor	Gravel	\$4,300	04-20-2012	\$19,400

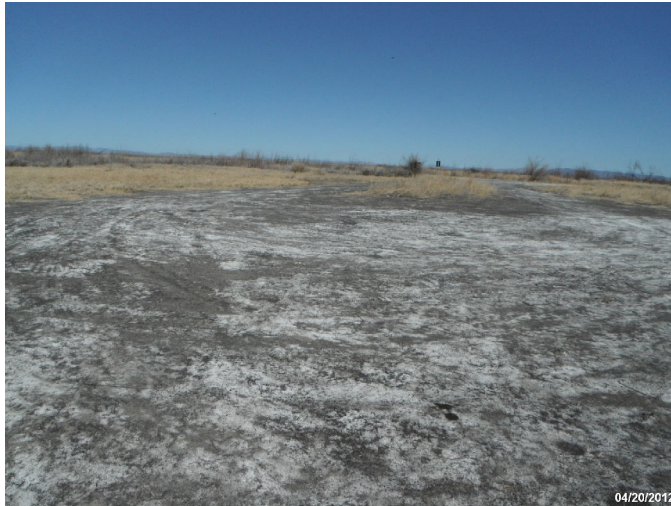
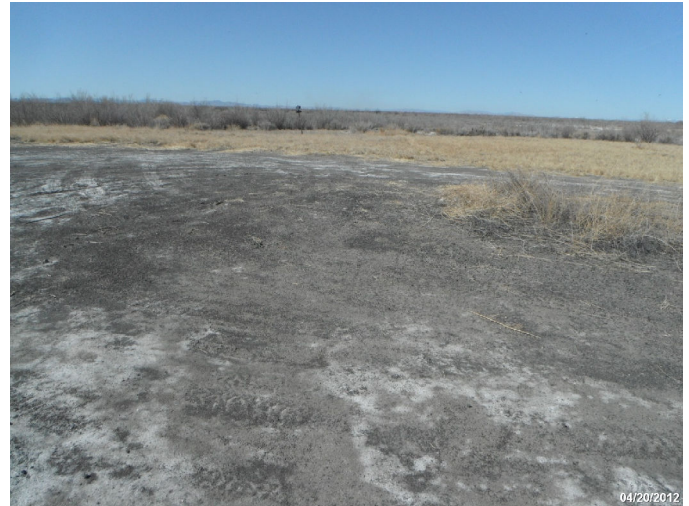
From Center Road (Route 104)

Asset Number	Area (Sq Ft)	Condition	Surface Type	Cost to Improve	Inspection Date	Current Replacement Value
10005678	8698	Fair	Gravel	\$2,600	04-20-2012	\$47,800

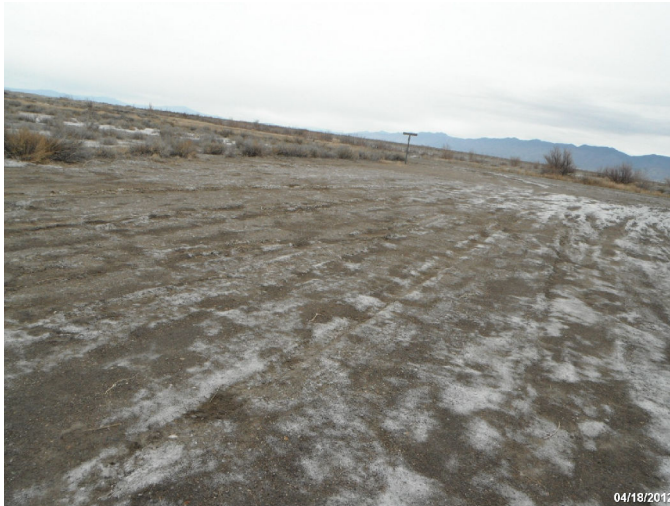
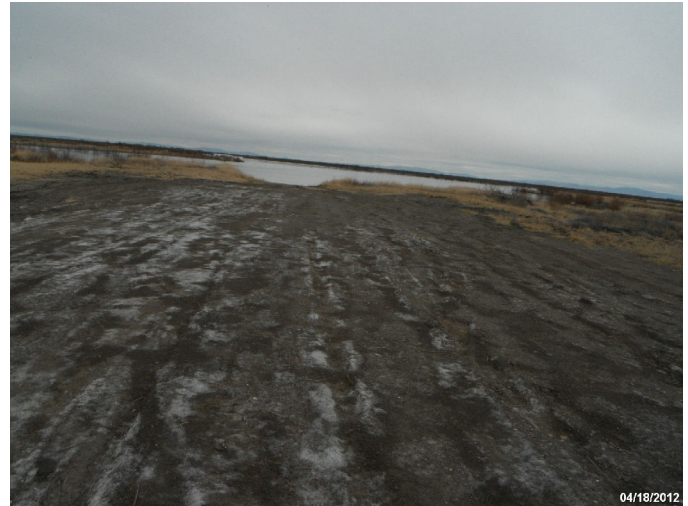
Route Number:914
Peers Landing Parking Area
From Lead Lake Road (Route 107)

Asset Number	Area (Sq Ft)	Condition	Surface Type	Cost to Improve	Inspection Date	Current Replacement Value
10005677	15294	Poor	Native	\$13,800	04-18-2012	\$36,300

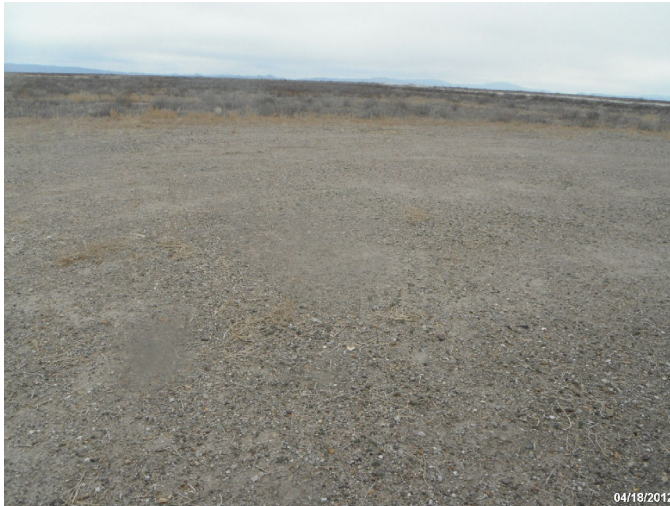
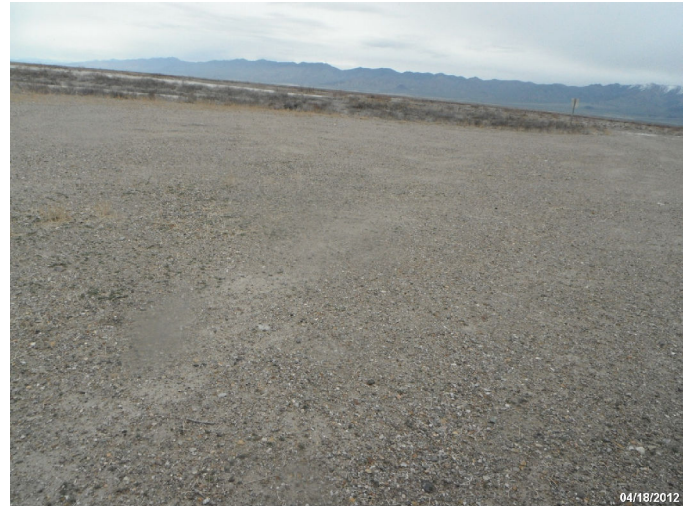
Route Number:915
Lead Lake Parking Area
From Lead Lake Road (Route 107)

Asset Number	Area (Sq Ft)	Condition	Surface Type	Cost to Improve	Inspection Date	Current Replacement Value
10005683	13356	Fair	Gravel	\$3,900	04-18-2012	\$73,400

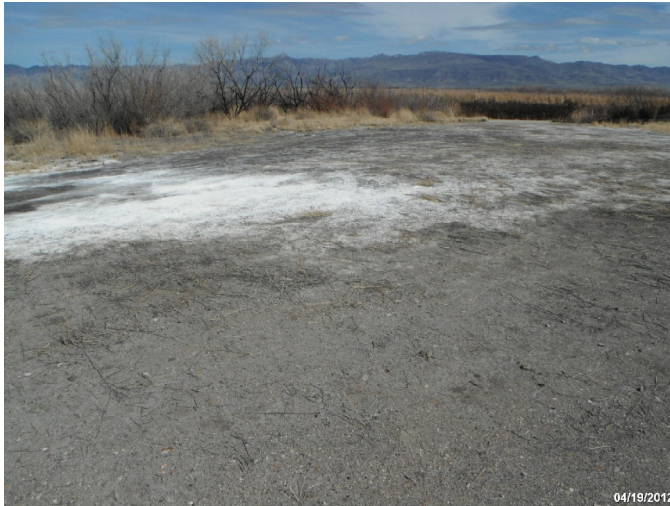
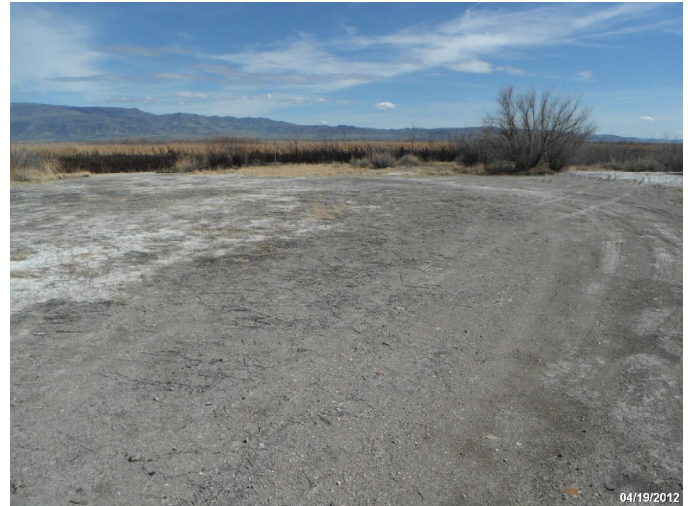
From Millen Landing Access Road (Route 112)

Asset Number	Area (Sq Ft)	Condition	Surface Type	Cost to Improve	Inspection Date	Current Replacement Value
10005679	6909	Fair	Gravel	\$2,000	04-19-2012	\$38,000

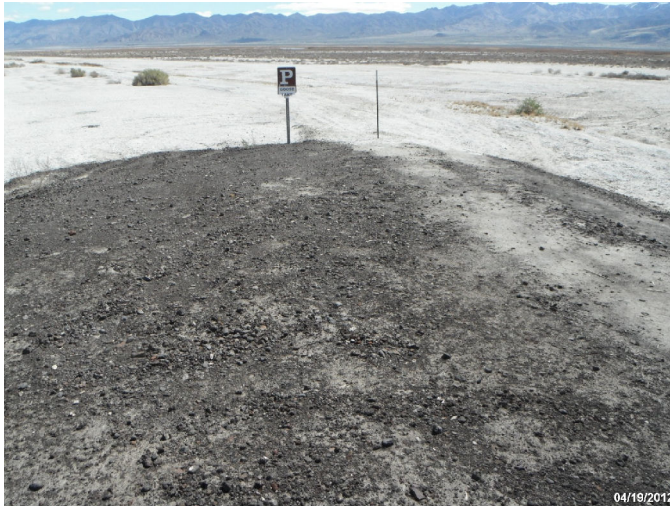
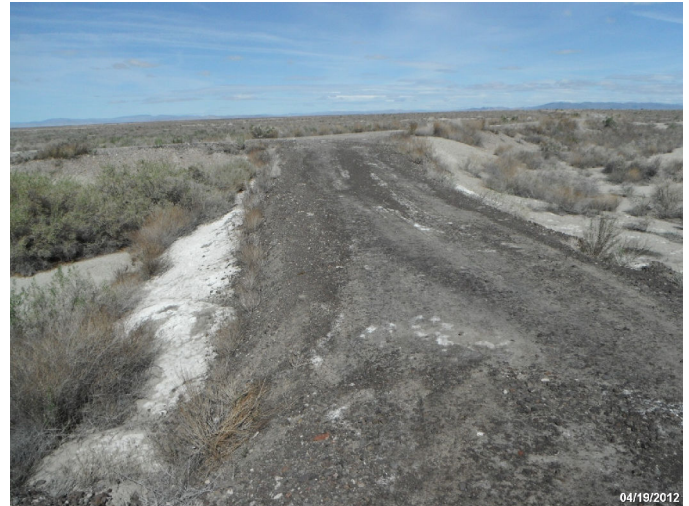
From Navy Cabin Road (Route 101)

Asset Number	Area (Sq Ft)	Condition	Surface Type	Cost to Improve	Inspection Date	Current Replacement Value
10005599	4672	Fair	Gravel	\$1,400	04-19-2012	\$25,700

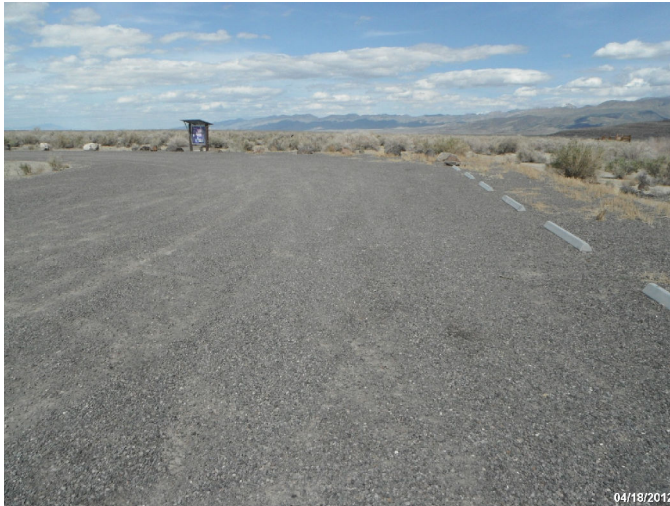
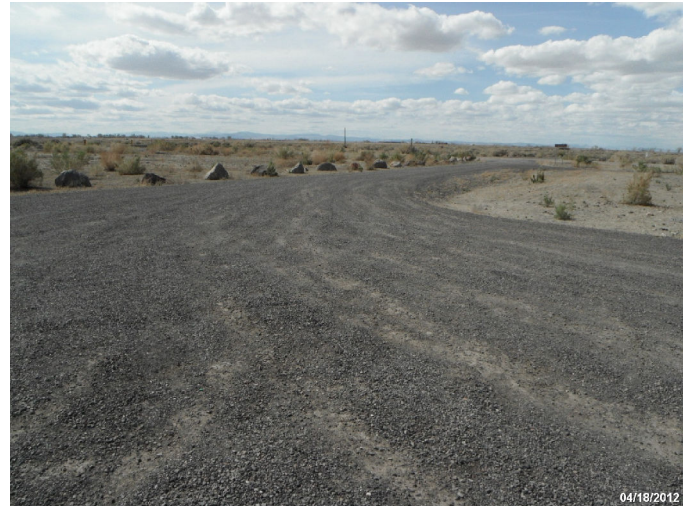
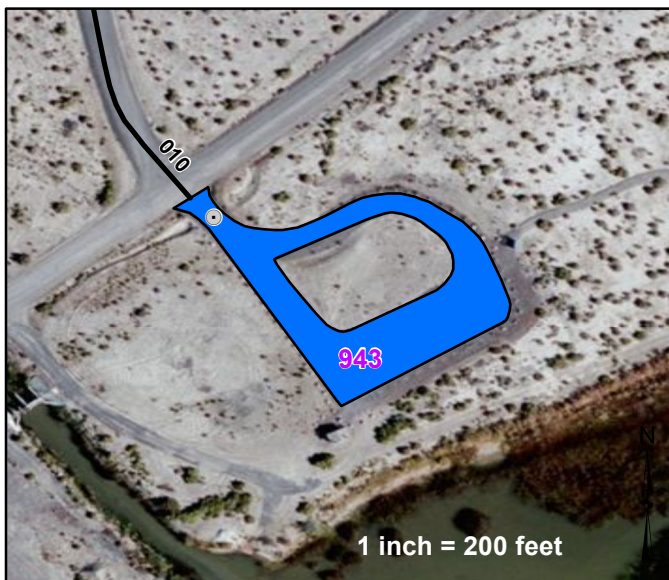
Route Number:943
Stillwater Point Parking Area
 From Auto Tour Route (Route 010)

Asset Number	Area (Sq Ft)	Condition	Surface Type	Cost to Improve	Inspection Date	Current Replacement Value
10036681	20779	Excellent	Gravel	\$0	04-18-2012	\$114,200

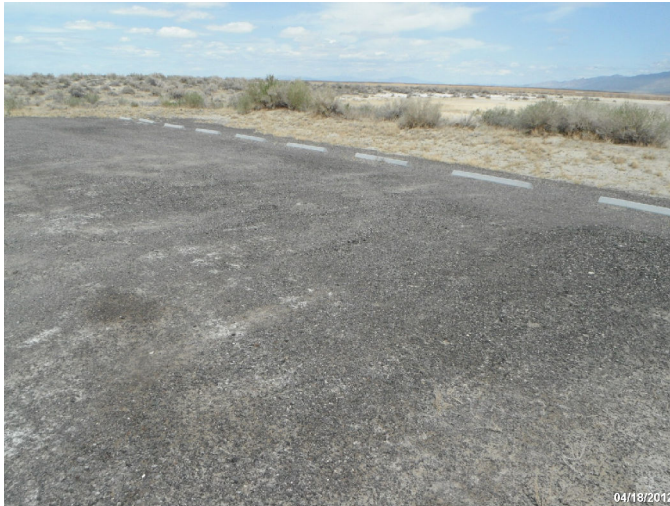
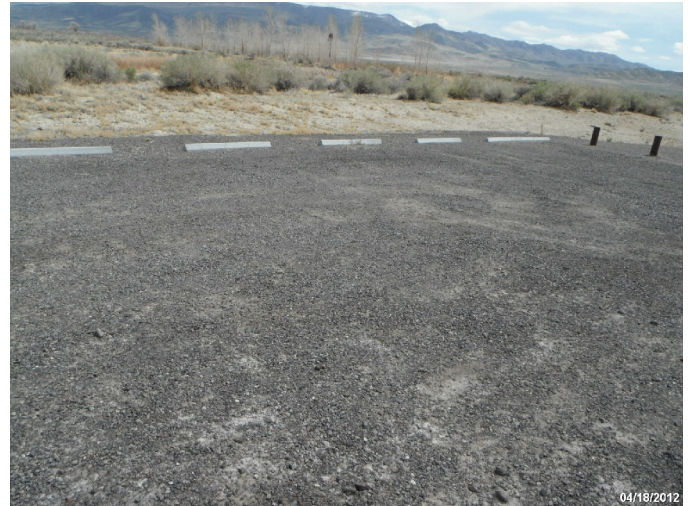
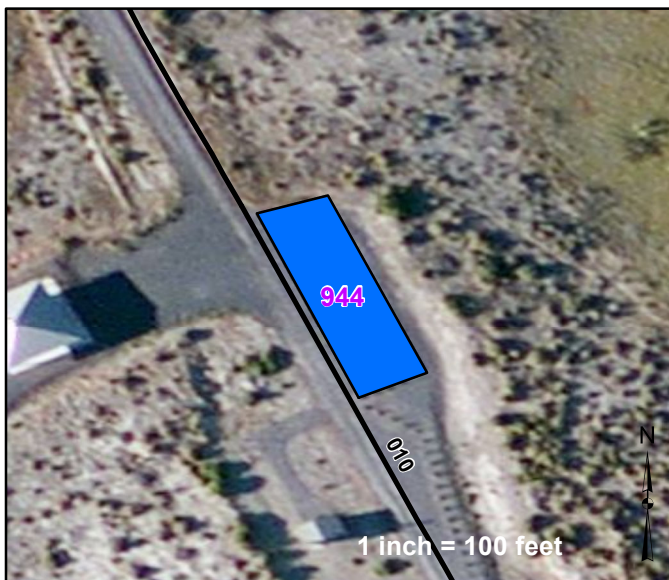
Route Number:944
Foxtail Lake Parking Area
 From Auto Tour Route (Route 010)

Asset Number	Area (Sq Ft)	Condition	Surface Type	Cost to Improve	Inspection Date	Current Replacement Value
10057202	3092	Excellent	Gravel	\$0	04-18-2012	\$17,000

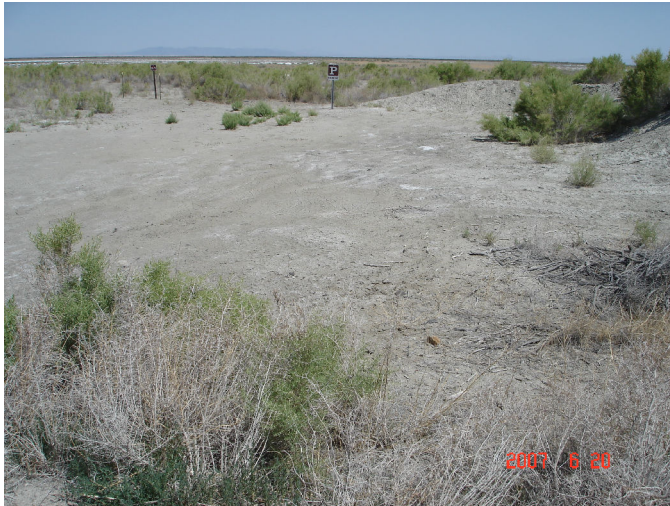
Route Number:945
Division Road Bridge Parking Area
 From Division Road (Route 103)

Asset Number	Area (Sq Ft)	Condition	Surface Type	Cost to Improve	Inspection Date	Current Replacement Value
10005600	4842	Poor	Native	\$4,400	06-20-2007	\$11,500

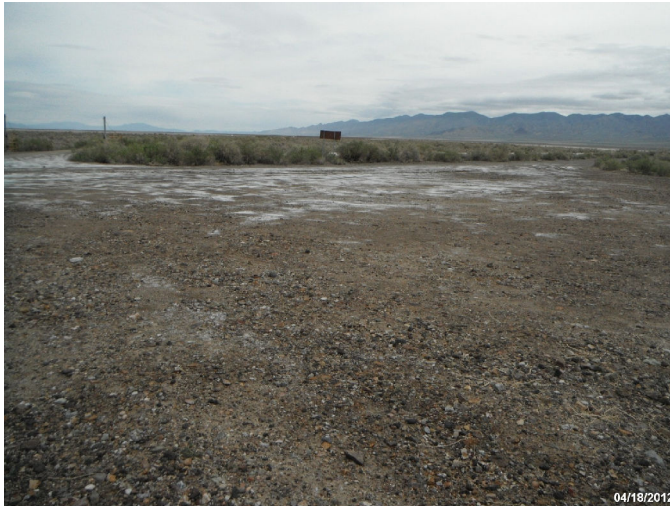
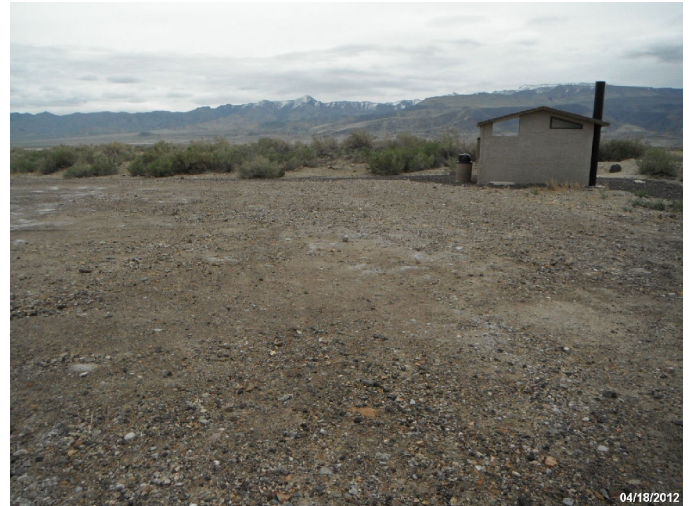
Route Number:946
Division Overnight Area Parking Area
From Division Road (Route 103)

Asset Number	Area (Sq Ft)	Condition	Surface Type	Cost to Improve	Inspection Date	Current Replacement Value
10054648	15182	Fair	Gravel	\$4,500	04-18-2012	\$83,500

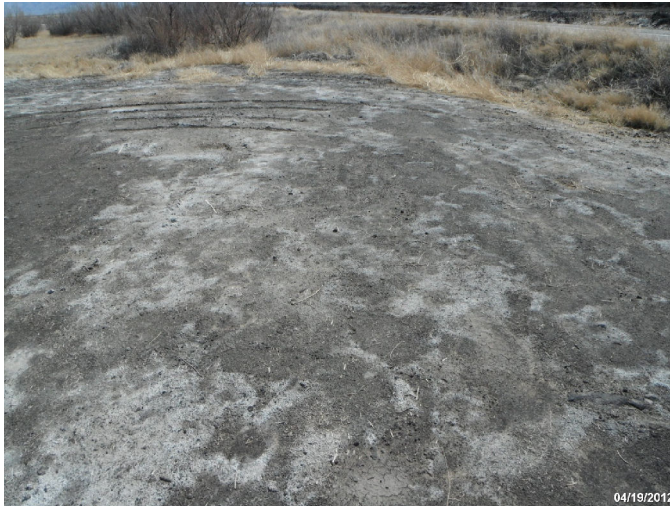
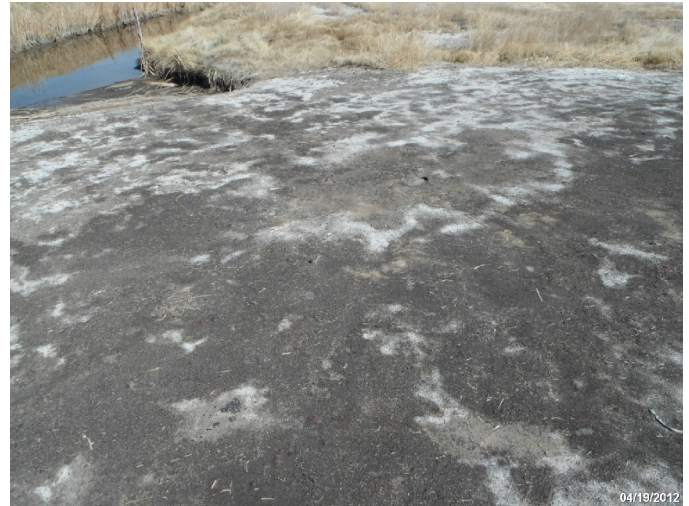
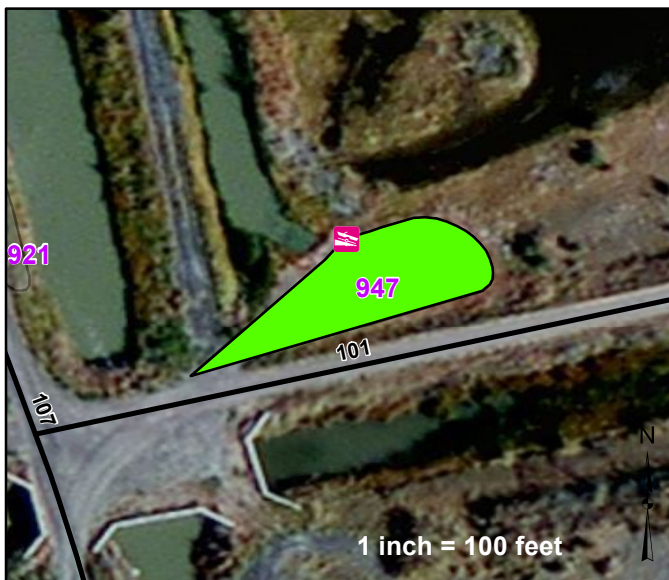
Route Number:947
Neils Landing Parking Area
 From Navy Cabin Road (Route 101)

Asset Number	Area (Sq Ft)	Condition	Surface Type	Cost to Improve	Inspection Date	Current Replacement Value
10005599	3830	Good	Native	\$600	04-19-2012	\$9,100

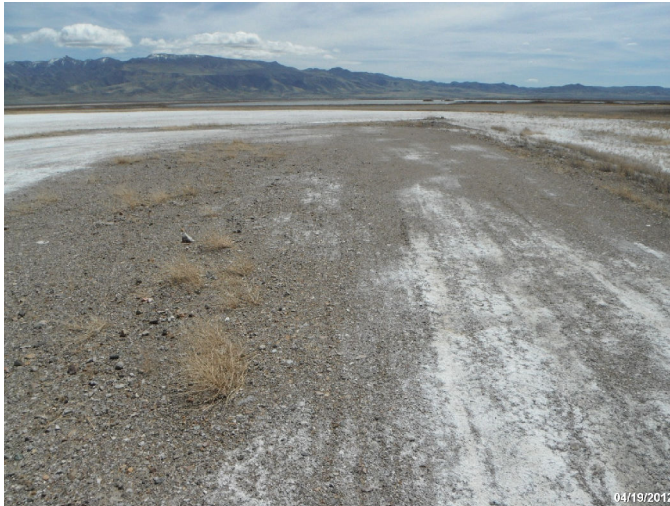
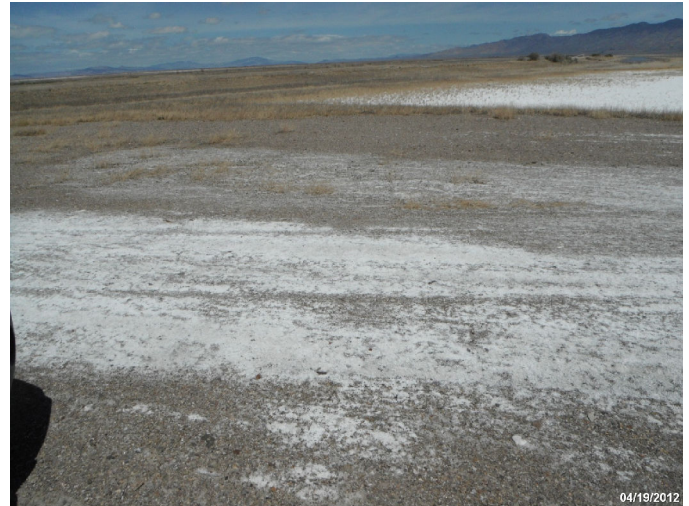
Route Number:948
West Nutgrass Parking
 From Pintail Road (Route 105)

Asset Number	Area (Sq Ft)	Condition	Surface Type	Cost to Improve	Inspection Date	Current Replacement Value
10005646	14902	Fair	Gravel	\$4,400	04-19-2012	\$81,900

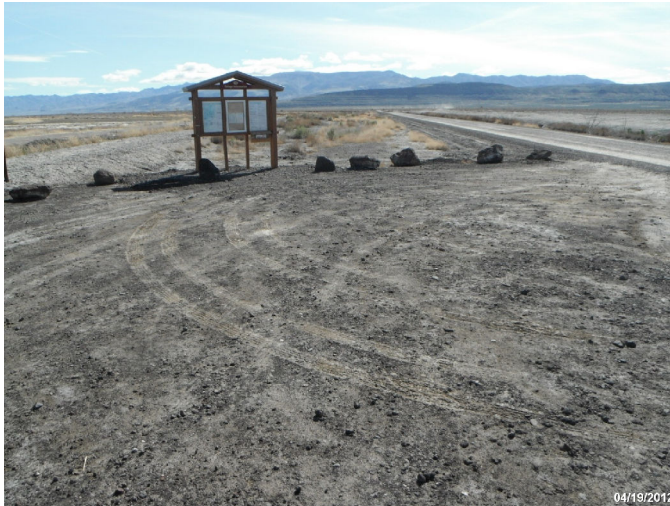
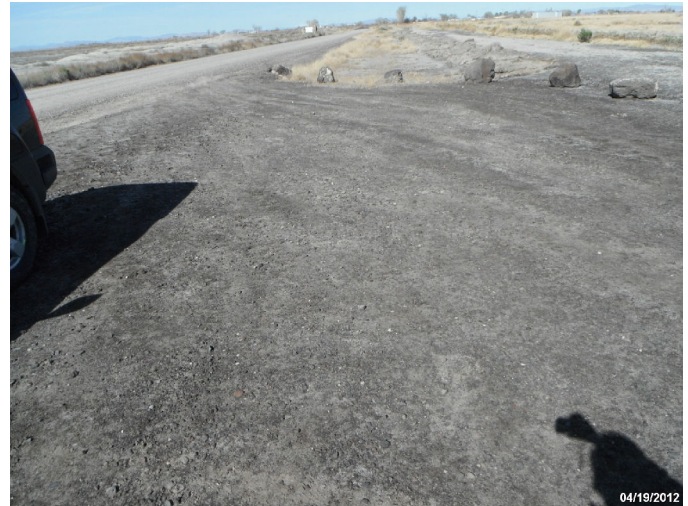
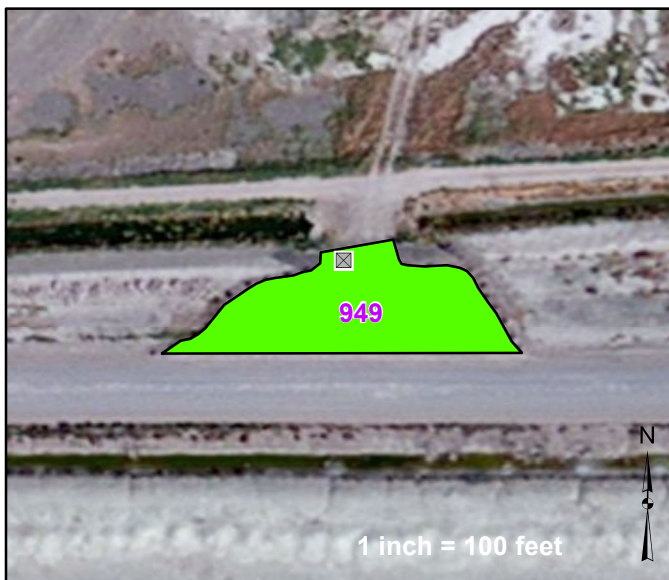
Route Number:949
Kent Wetland Visitor Area Parking
From Lawrence Lane

Asset Number	Area (Sq Ft)	Condition	Surface Type	Cost to Improve	Inspection Date	Current Replacement Value
10059599	5122	Good	Gravel	\$900	04-19-2012	\$28,200

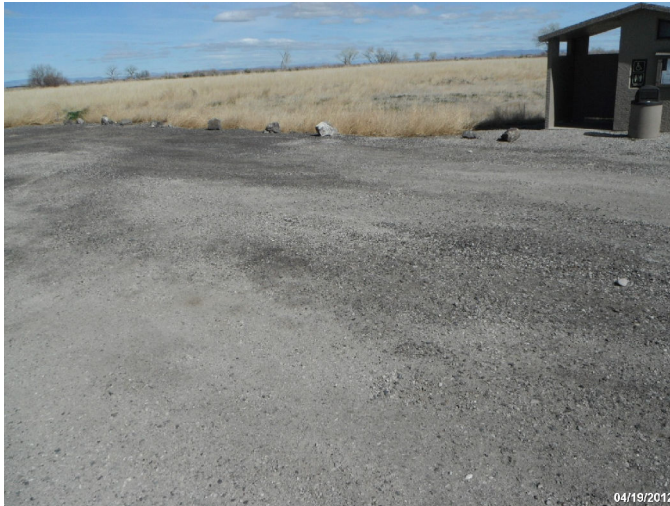
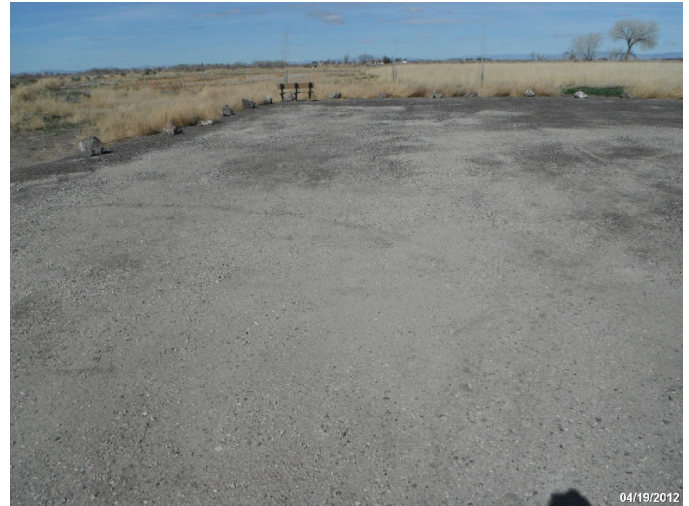
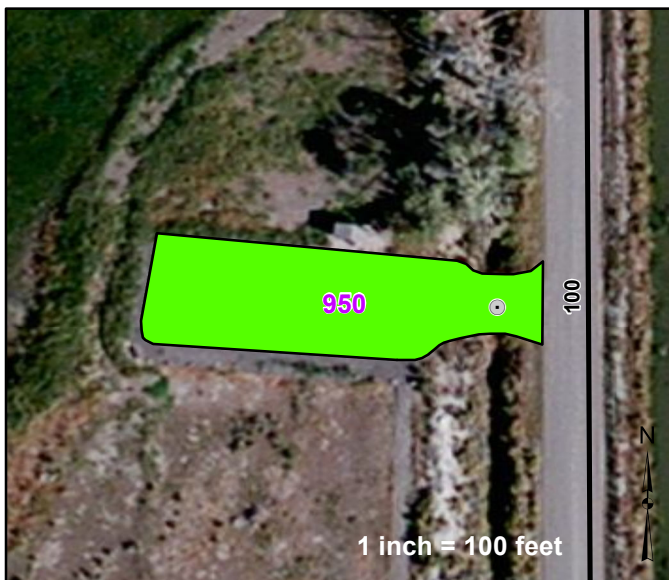
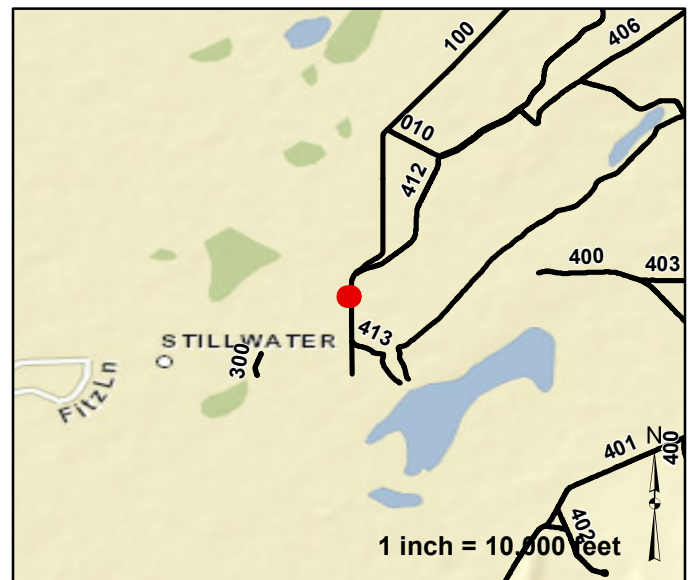
Route Number:950

Asset Number	Area (Sq Ft)	Condition	Surface Type	Cost to Improve	Inspection Date	Current Replacement Value
10061756	8003	Good	Gravel	\$1,300	04-19-2012	\$44,000

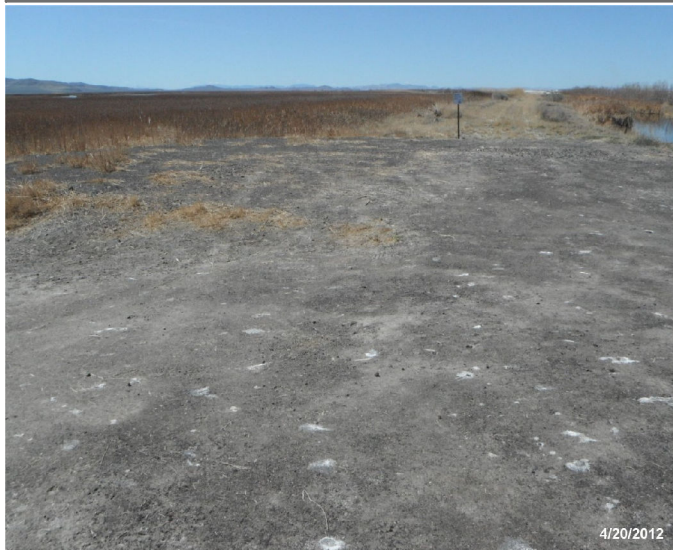
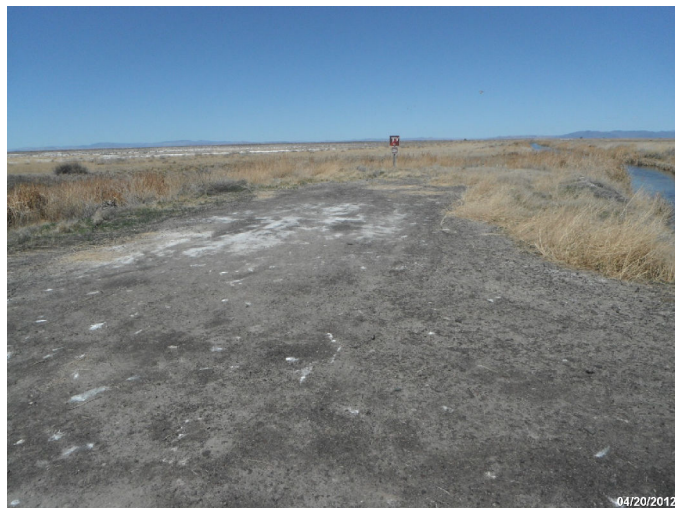
Route Number:951
Bob's Landing Parking
 From Navy Cabin Road (Route 101)

Asset Number	Area (Sq Ft)	Condition	Surface Type	Cost to Improve	Inspection Date	Current Replacement Value
-	4195	Fair	Gravel	\$1,200	04-20-2012	\$23,100

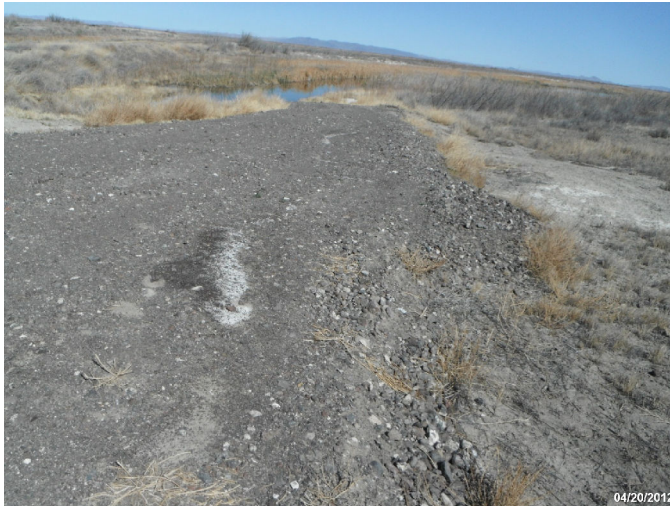
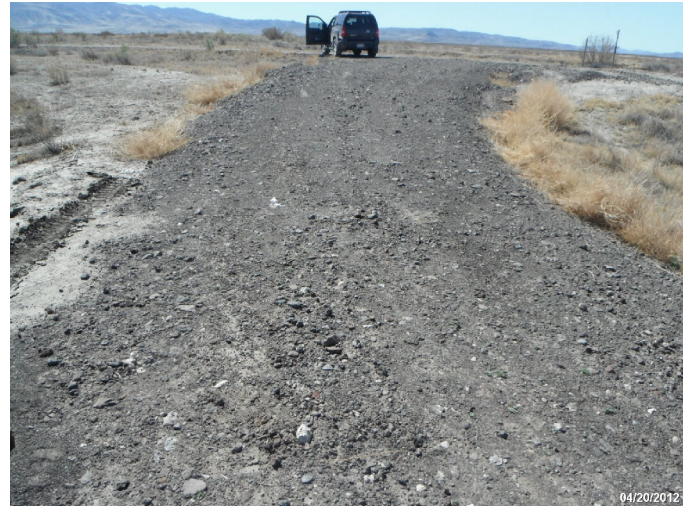
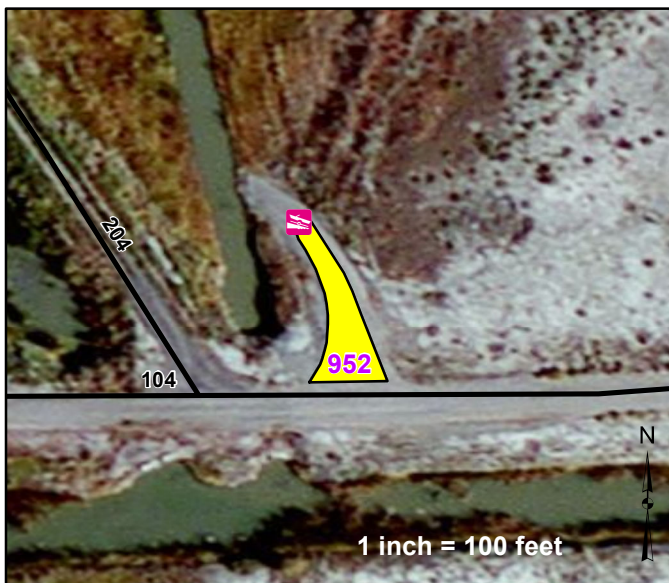
Route Number:952
Northwest Tule Lake Landing Parking Area
From Center Road (Route 104)

Asset Number	Area (Sq Ft)	Condition	Surface Type	Cost to Improve	Inspection Date	Current Replacement Value
10005681	1235	Fair	Gravel	\$400	04-20-2012	\$6,800
