The Road Inventory of Stillwater National Wildlife Refuge Fallon, NV

Prepared By:
Federal Highway Administration
Central Federal Lands Highway Division
June 2012

Stillwater National Wildlife Refuge - 84590

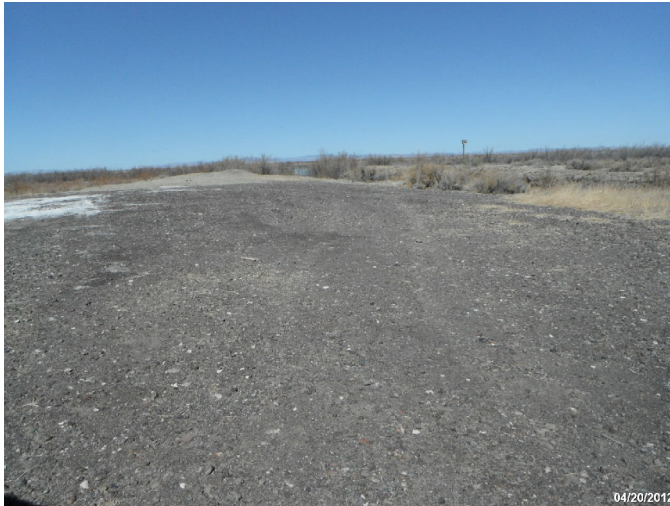
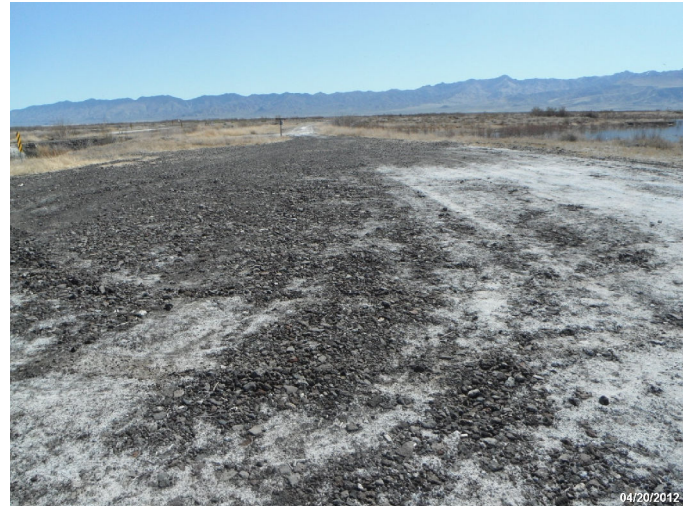
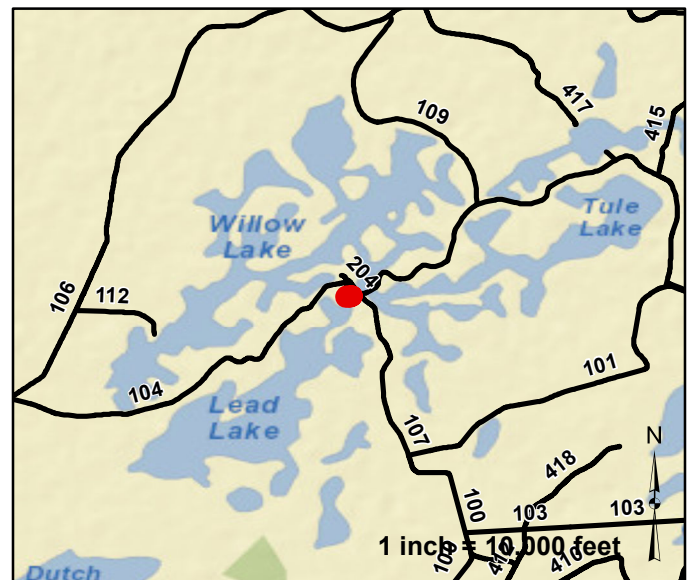
Route Number:953
Lead Line Road/ Center Road Overnight Parking Area
From Lead Lake Road (Route 107)

Asset Number	Area (Sq Ft)	Condition	Surface Type	Cost to Improve	Inspection Date	Current Replacement Value
-	10773	Fair	Gravel	\$3,200	04-20-2012	\$59,200

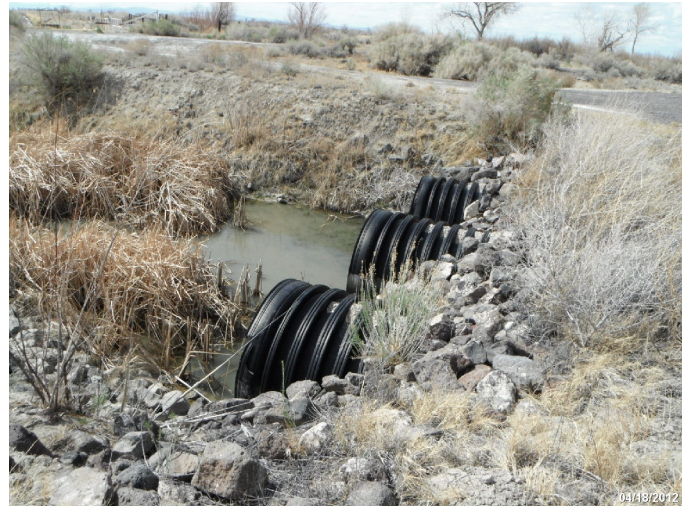
Photo: STIL_C4_1133 Route: 010-001-0.28
Plastic Culvert 40ft long 36in dia. 2ft deep
Asset# NA

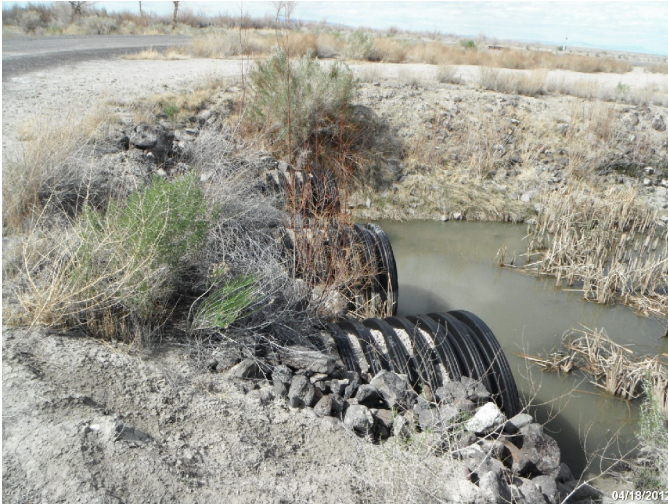
Photo: STIL_C4_1134 Route: 010-001-0.28
Plastic Culvert 40ft long 36in dia. 2ft deep
Asset# NA

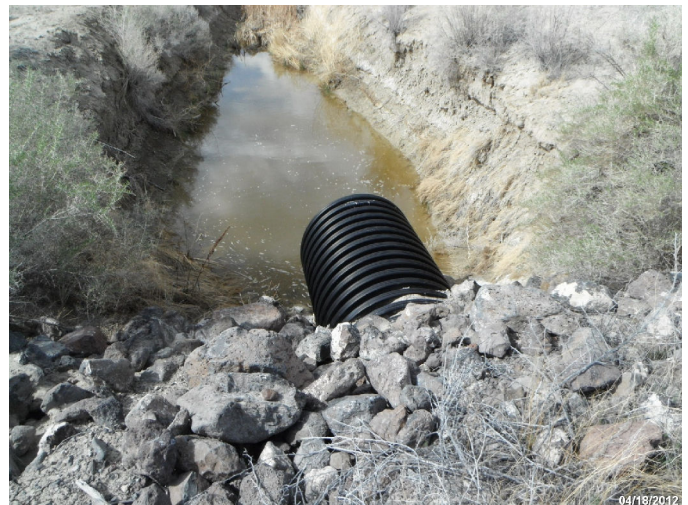
Photo: STIL_C4_1137 Route: 010-003-2.7
Plastic WCS Flap Gate/Full-Round Riser
40ft long 60in dia. 4ft deep Asset# NA

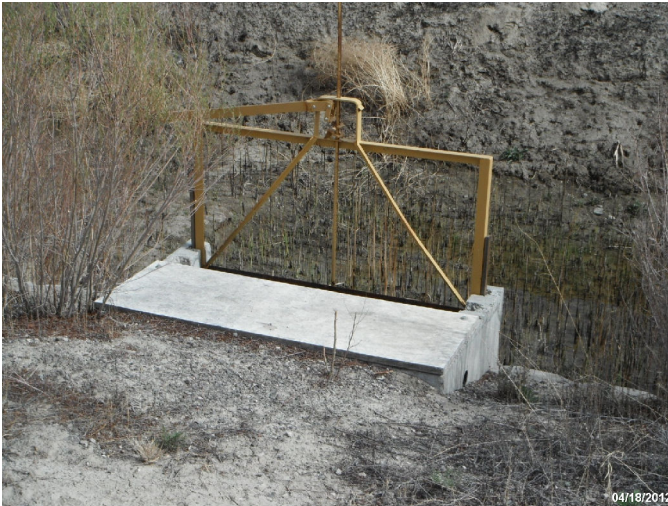
Photo: STIL_C4_1138 Route: 010-003-2.7
Plastic WCS Flap Gate/Full-Round Riser
40ft long 60in dia. 4ft deep Asset# NA

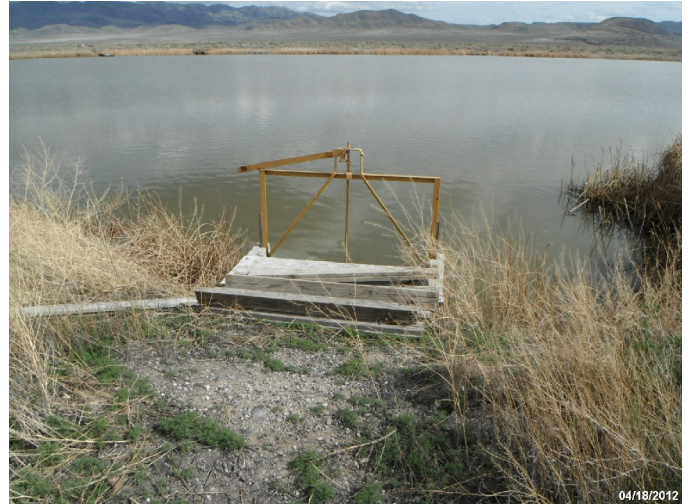
Photo: STIL_C4_1143 Route: 010-005-3.92
Plastic WCS Flap Gate/Full-Round Riser
50ft long 60in dia. 3ft deep Asset# NA

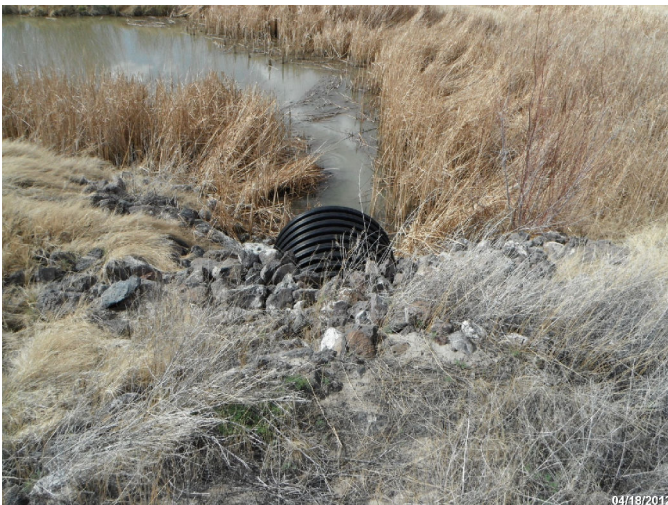
Photo: STIL_C4_1144 Route: 010-005-3.92
Plastic WCS Flap Gate/Full-Round Riser
50ft long 60in dia. 3ft deep Asset# NA

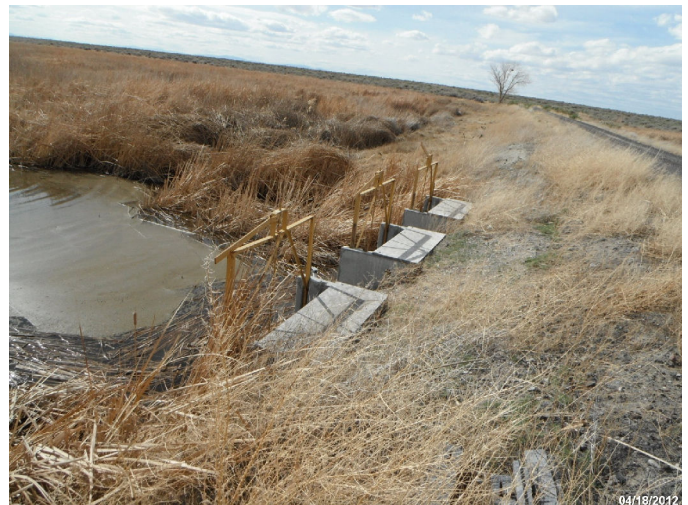
Photo: STIL_C4_1145 Route: 010-005-4.16
Plastic WCS Flap Gate/Full-Round Riser
40ft long 48in dia. 3ft deep Asset# NA

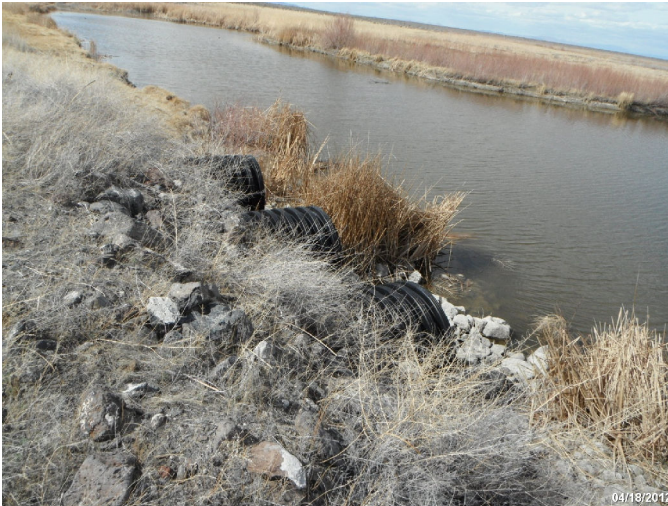
Photo: STIL_C4_1146 Route: 010-005-4.16
Plastic WCS Flap Gate/Full-Round Riser
40ft long 48in dia. 3ft deep Asset# NA

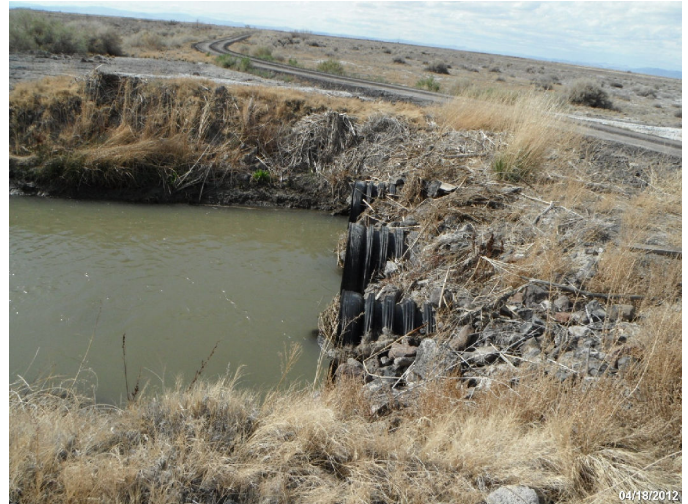
Photo: STIL_C4_1149 Route: 010-007-6.06
Plastic Culvert 40ft long 48in dia. 2ft deep
Asset# NA

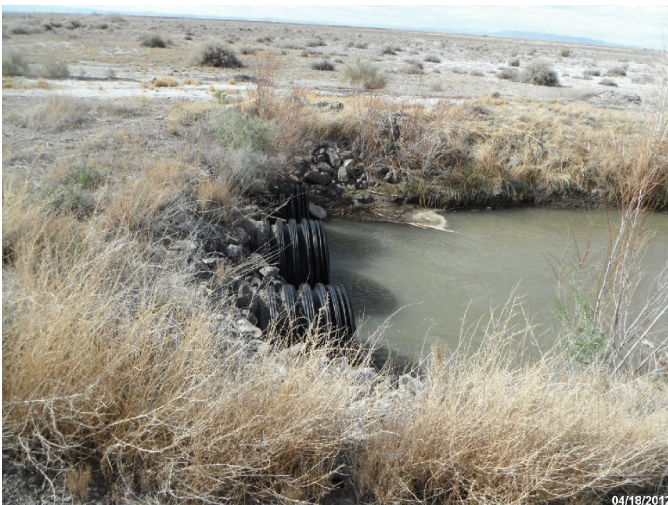
Photo: STIL_C4_1150 Route: 010-007-6.06
Plastic Culvert 40ft long 48in dia. 2ft deep
Asset# NA

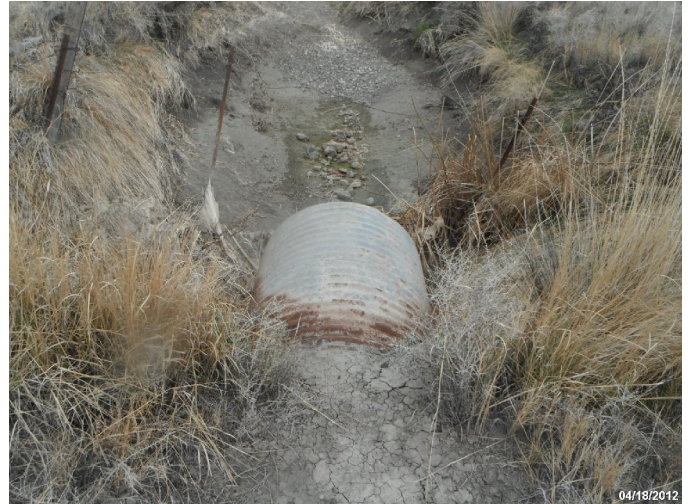
Photo: STIL_C4_1019 Route: 100-003-2.48
Metal WCS Flashboard Riser 50ft long 48in dia. 2ft deep
Asset# NA

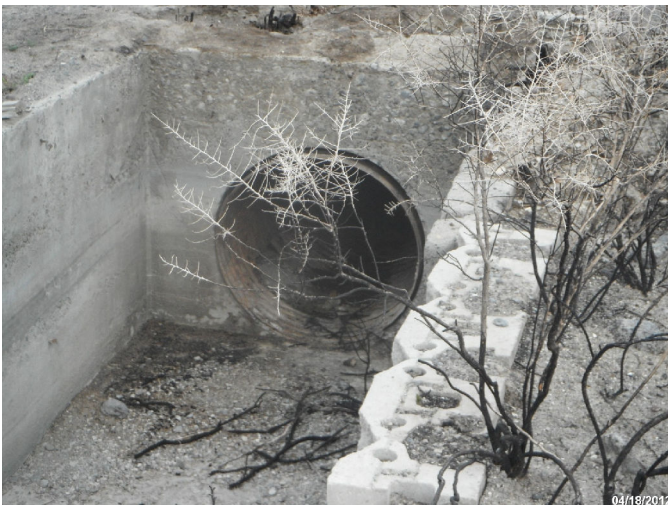
Photo: STIL_C4_1020 Route: 100-003-2.48
Metal WCS Flashboard Riser 50ft long 48in dia. 2ft deep
Asset# NA

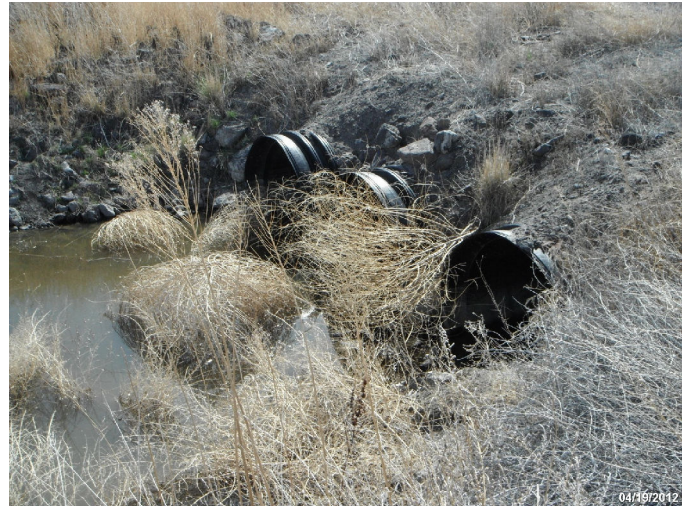
Photo: STIL_C4_1172 Route: 101-001-0.01
Plastic WCS Screw Gate 90ft long 48in dia. 3ft deep
Asset# NA

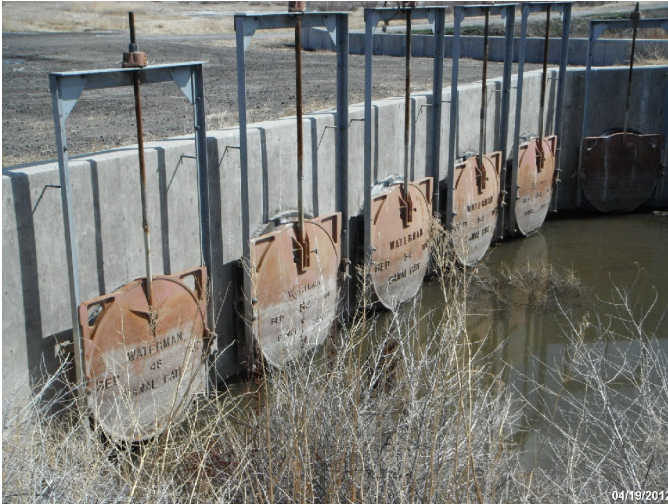
Photo: STIL_C4_1173 Route: 101-001-0.01
Plastic WCS Screw Gate 90ft long 48in dia. 3ft deep
Asset# NA

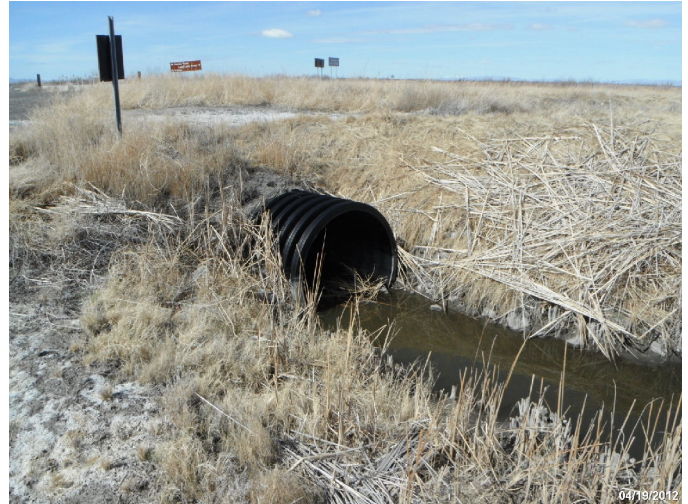
Photo: STIL_C4_1170 Route: 101-001-0.01
Plastic WCS Screw Gate 100ft long 36in dia. 3ft deep
Asset# NA

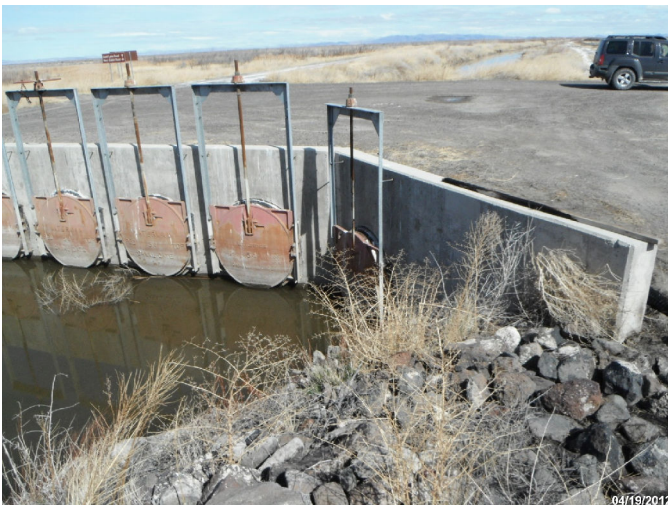
Photo: STIL_C4_1174 Route: 101-001-0.01
Plastic WCS Screw Gate 100ft long 36in dia. 3ft deep
Asset# NA

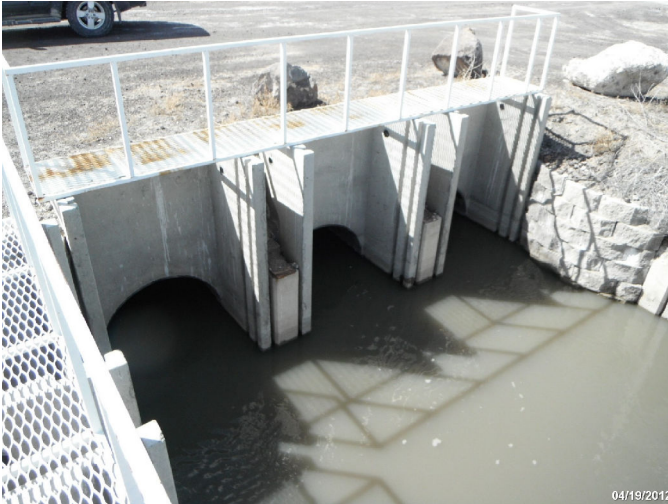
Photo: STIL_C4_1180 Route: 101-004-3.35
Plastic WCS Flashboard Riser 60ft long 36in dia. 3ft deep
Asset# NA

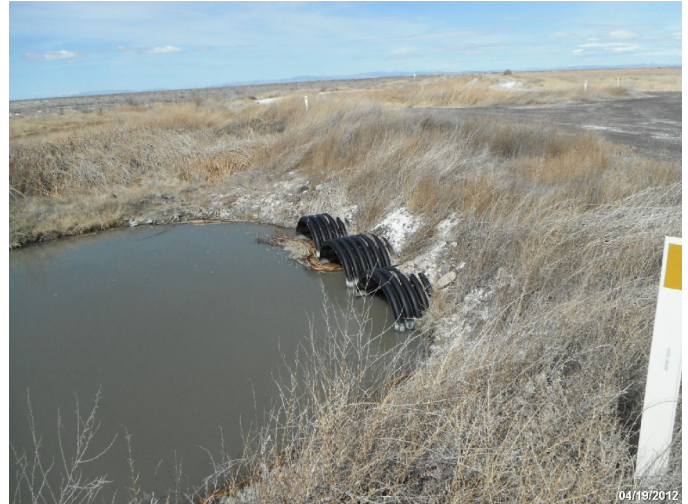
Photo: STIL_C4_1181 Route: 101-004-3.35
Plastic WCS Flashboard Riser 60ft long 36in dia. 3ft deep
Asset# NA

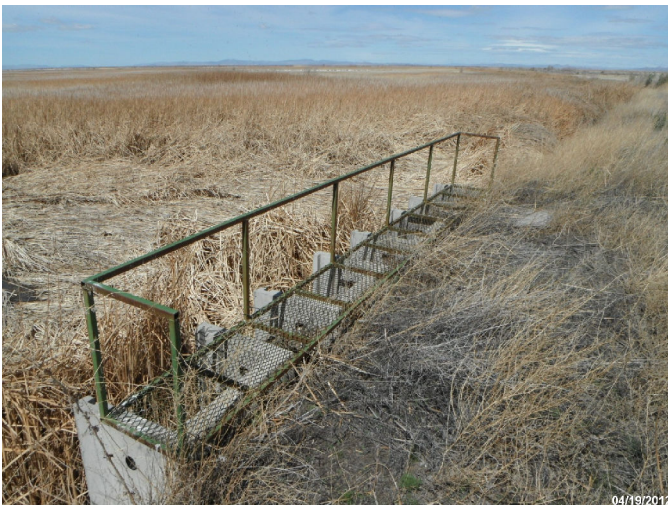
Photo: STIL_C4_1184 Route: 101-004-3.98
Plastic WCS Flashboard Riser 25ft long 24in dia. 2ft deep
Asset# NA

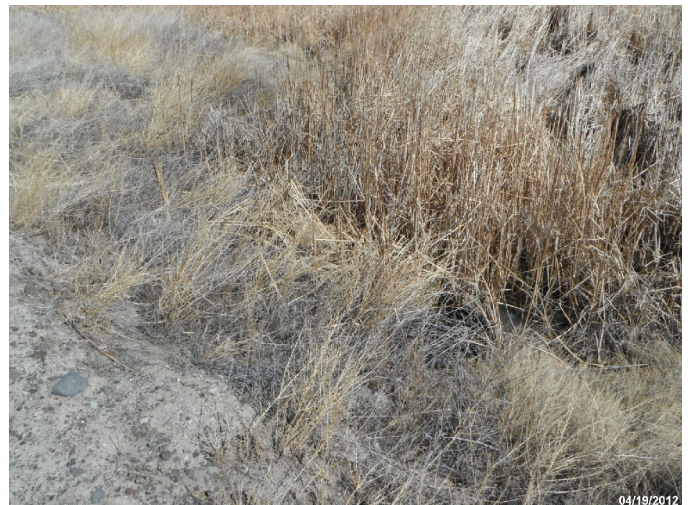
Photo: STIL_C4_1185 Route: 101-004-3.98
Plastic WCS Flashboard Riser 25ft long 24in dia. 2ft deep
Asset# NA 8-007

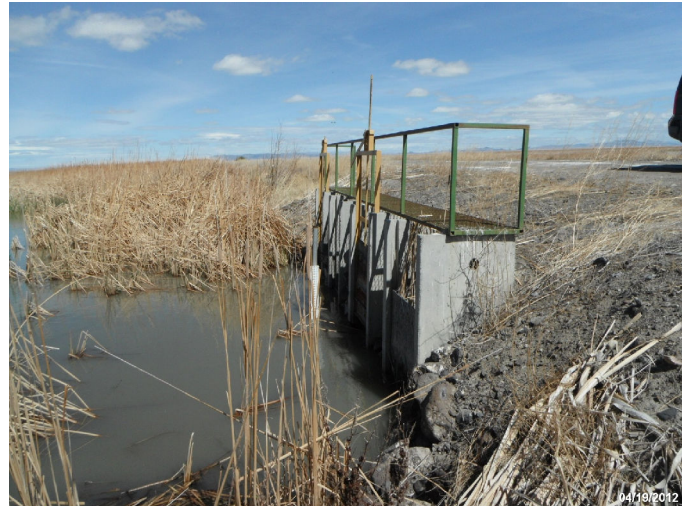
Photo: STIL_C4_1187 Route: 101-005-4.06
Plastic WCS Flap Gate/Full-Round Riser
30ft long 24in dia. 4ft deep Asset# NA

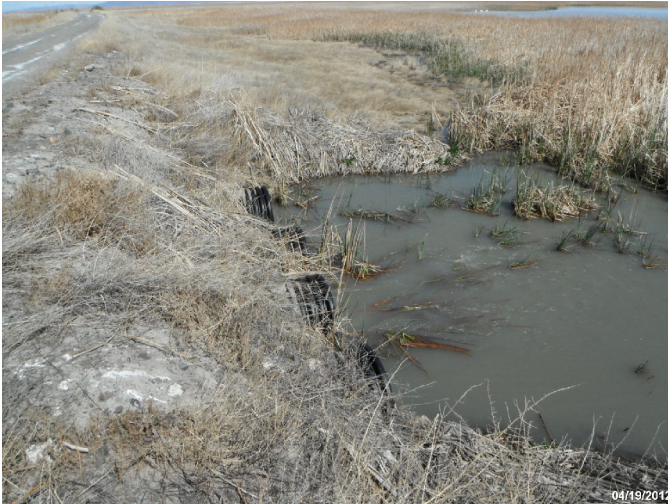
Photo: STIL_C4_1188 Route: 101-005-4.06
Plastic WCS Flap Gate/Full-Round Riser
30ft long 24in dia. 4ft deep Asset# NA

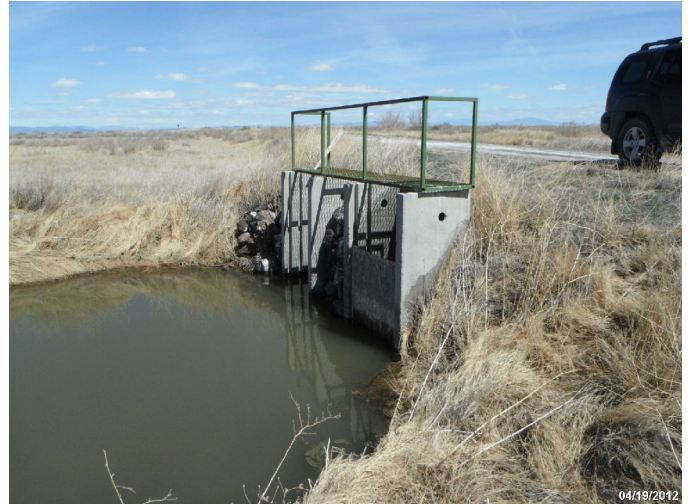
Photo: STIL_C4_1192 Route: 101-005-4.79
Plastic WCS Flashboard Riser 40ft long 24in dia. 4ft deep
Asset# NA

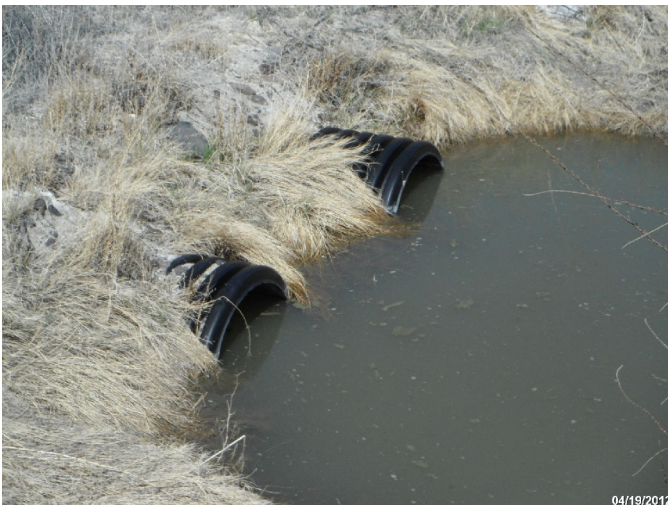
Photo: STIL_C4_1193 Route: 101-005-4.79
Plastic WCS Flashboard Riser 40ft long 24in dia. 4ft deep
Asset# NA

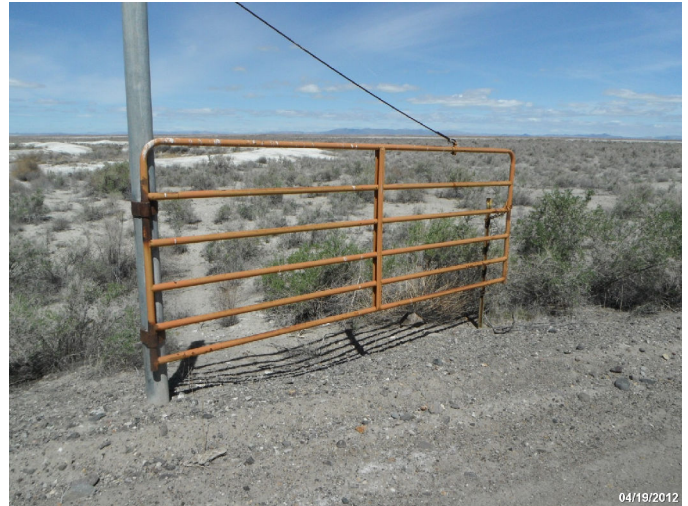
Photo: STIL_C4_1196 Route: 102-001-0.01
Metal Open Rail Gate
Asset# 10005729

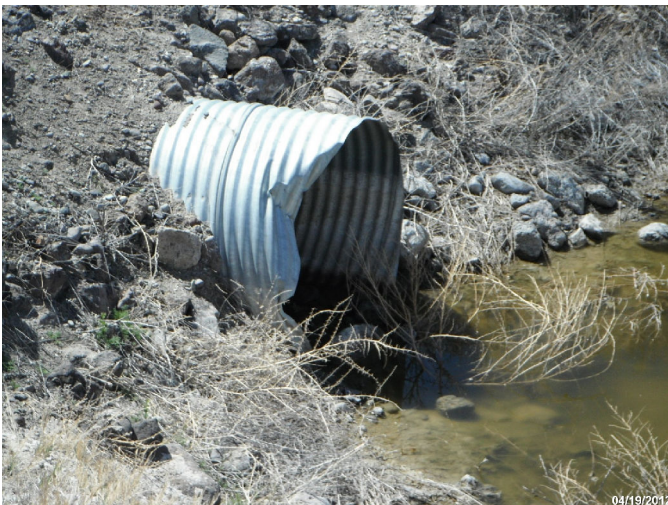
Photo: STIL_C4_1199 Route: 102-003-2.12
Metal Culvert 40ft long 48in dia. 6ft deep
Asset# NA

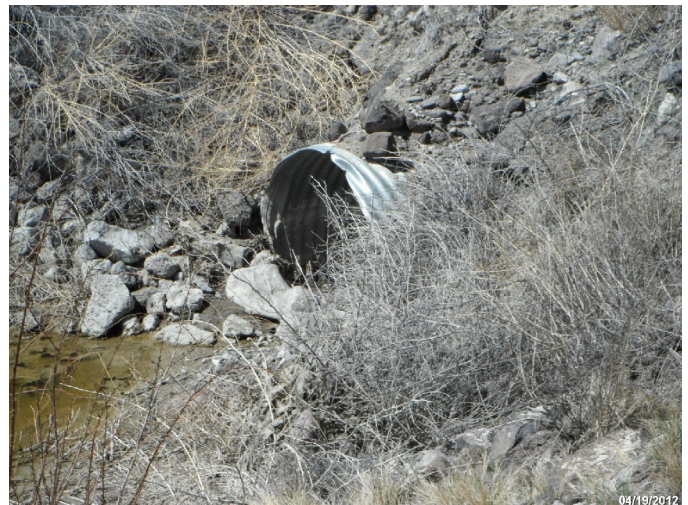
Photo: STIL_C4_1200 Route: 102-003-2.12
Metal Culvert 40ft long 48in dia. 6ft deep
Asset# NA

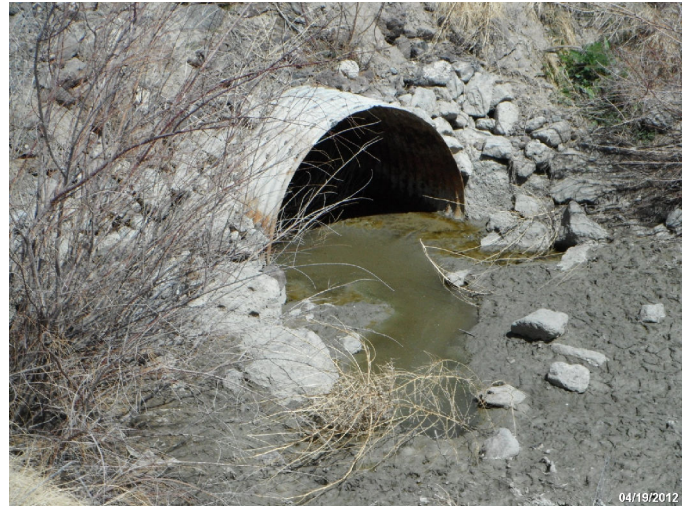
Photo: STIL_C4_1202 Route: 102-004-3.55
Metal Culvert 40ft long 48in dia. 3ft deep
Asset# NA

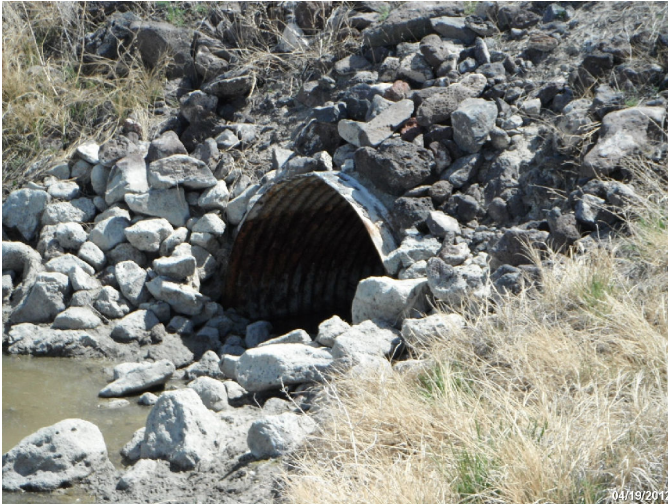
Photo: STIL_C4_1203 Route: 102-004-3.55
Metal Culvert 40ft long 48in dia. 3ft deep
Asset# NA

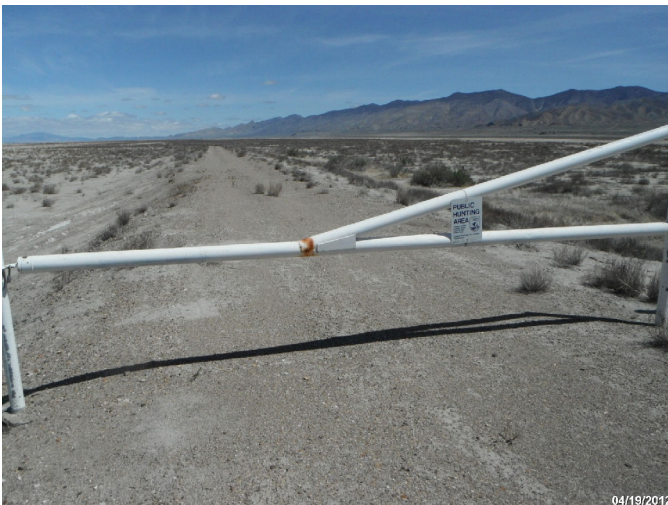
Photo: STIL_C4_1204 Route: 102-005-4.68
Metal Open Rail Gate
Asset# 10005729

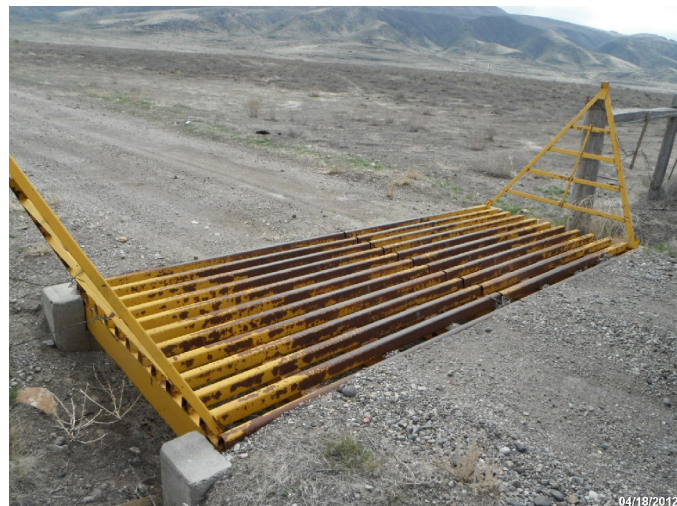
Photo: STIL_C4_1057 Route: 103-001-0.0
Metal Cattle Guard
Asset# NA

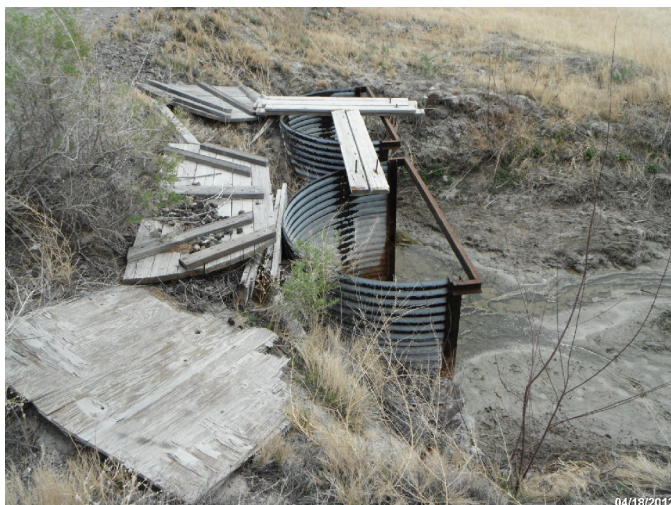
Photo: STIL_C4_1054 Route: 103-003-2.01
Metal WCS Flashboard Riser 40ft long 48in dia. 4ft deep
Asset# NA

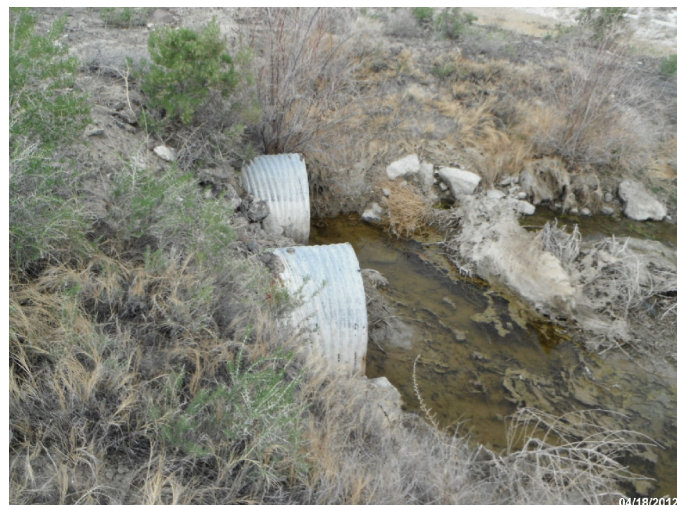
Photo: STIL_C4_1055 Route: 103-003-2.01
Metal WCS Flashboard Riser 40ft long 48in dia. 4ft deep
Asset# NA 8-011

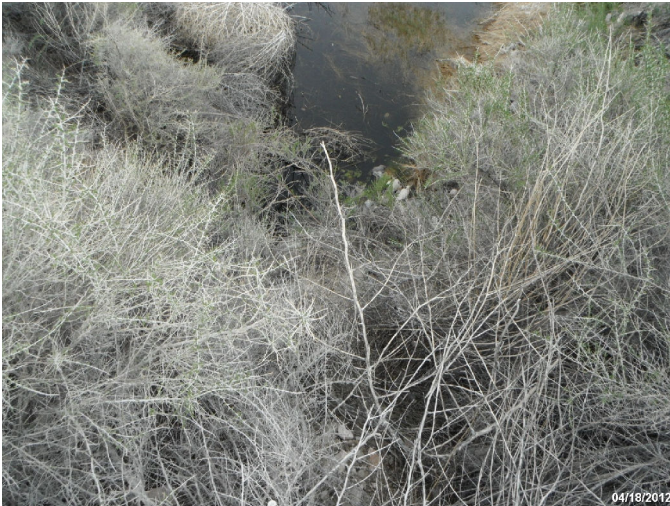
Photo: STIL_C4_1049 Route: 103-003-2.23
Metal WCS Flashboard Riser 35ft long 48in dia. 7ft deep
Asset# NA

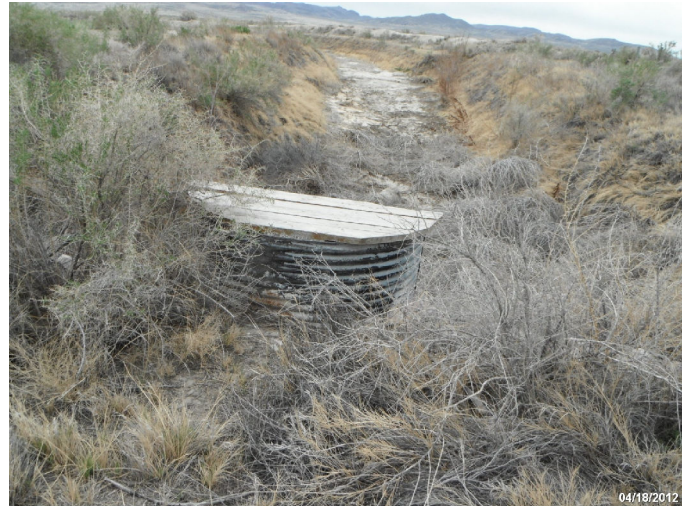
Photo: STIL_C4_1050 Route: 103-003-2.23
Metal WCS Flashboard Riser 35ft long 48in dia. 7ft deep
Asset# NA

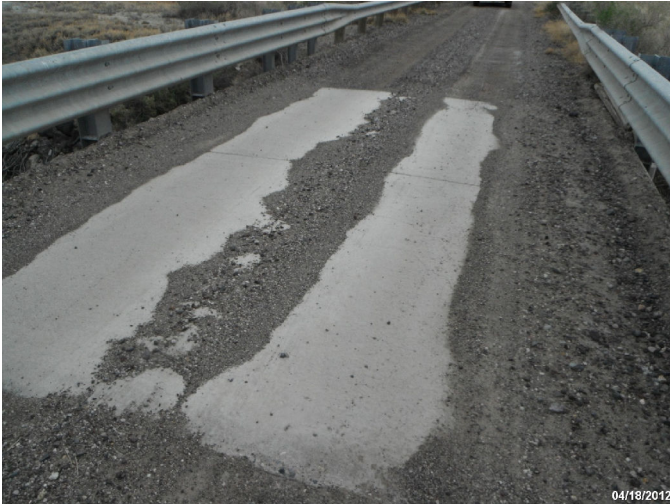
Photo: STIL_C4_1048 Route: 103-003-2.41
Concrete Bridge NBIS Number Unknown
Asset# NA

Stillwater National Wildlife Refuge - 84590 - Bridge Inventory					
Rte #	Milepost	NBIS #	Sufficiency Rating	Functionally Obsolete	Structurally Deficient
103	2.41	N/A	N/A	N/A	N/A
406	1.28	N/A	N/A	N/A	N/A

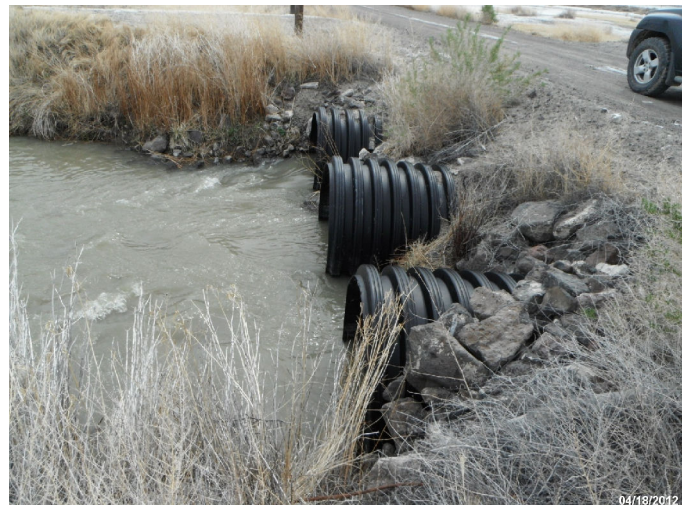
Photo: STIL_C4_1042 Route: 103-005-4.4
Plastic Culvert 35ft long 60in dia. 2ft deep
Asset# NA

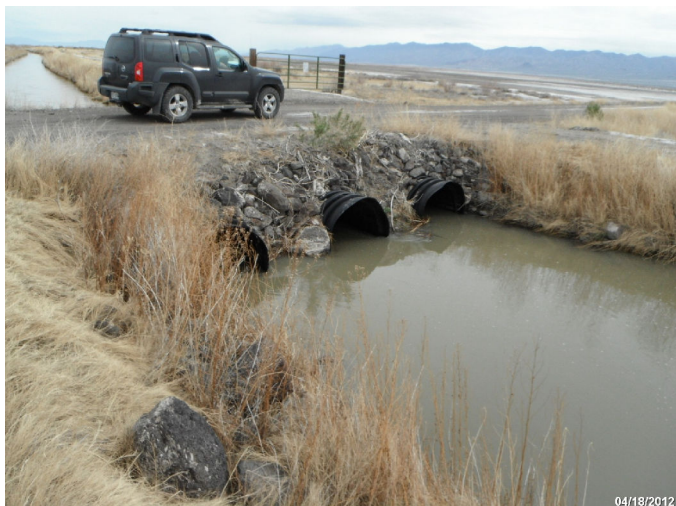
Photo: STIL_C4_1043 Route: 103-005-4.4
Plastic Culvert 35ft long 60in dia. 2ft deep
Asset# NA

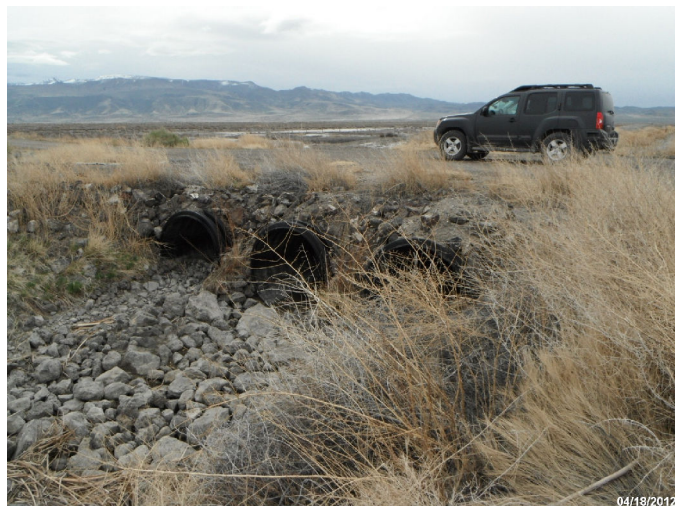
Photo: STIL_C4_1038 Route: 103-005-4.85
Plastic Culvert 40ft long 60in dia. 1ft deep
Asset# NA

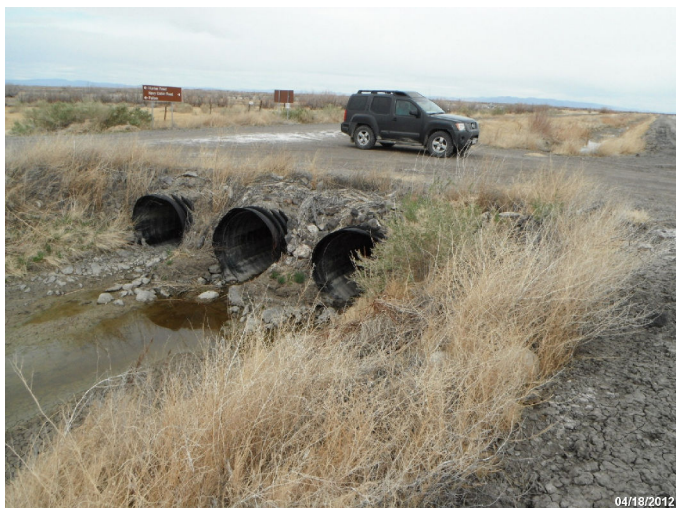
Photo: STIL_C4_1039 Route: 103-005-4.85
Plastic Culvert 40ft long 60in dia. 1ft deep
Asset# NA

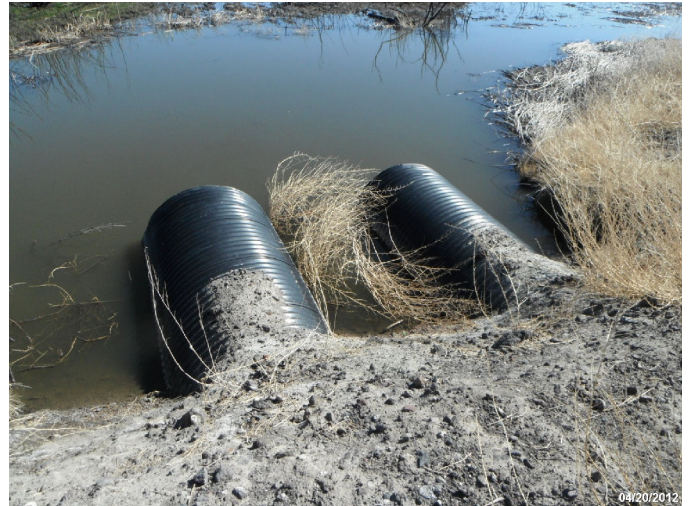
Photo: STIL_C4_1267 Route: 104-001-0.27
Metal WCS Flashboard Riser 35ft long 48in dia. 2ft deep
Asset# NA

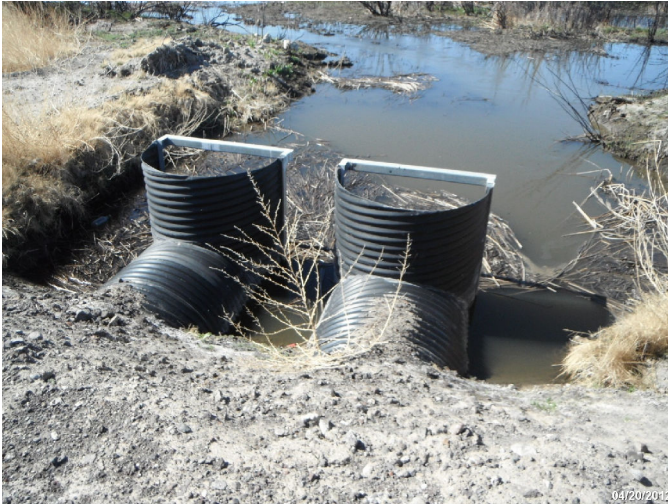
Photo: STIL_C4_1268 Route: 104-001-0.27
Metal WCS Flashboard Riser 35ft long 48in dia. 2ft deep
Asset# NA

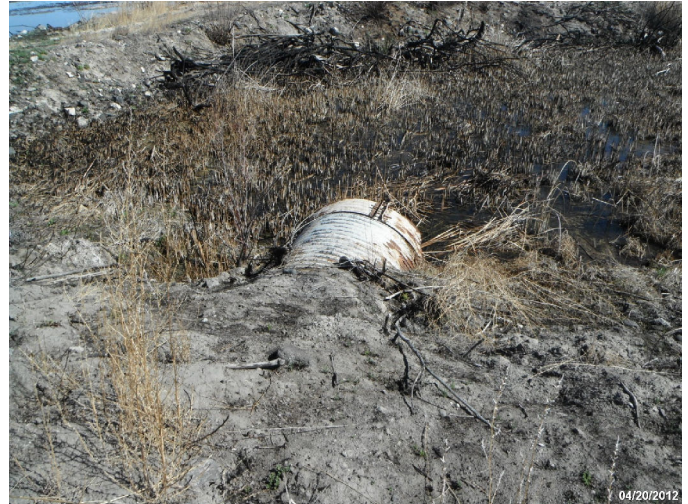
Photo: STIL_C4_1269 Route: 104-001-0.31
Metal WCS Flashboard Riser 35ft long 48in dia. 2ft deep
Asset# NA

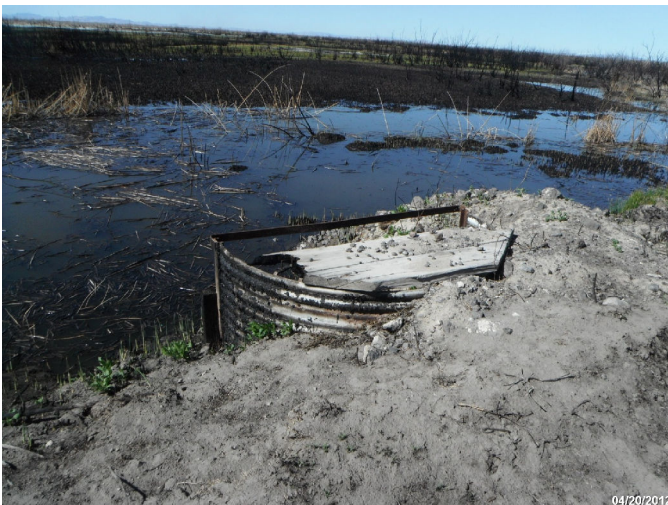
Photo: STIL_C4_1270 Route: 104-001-0.31
Metal WCS Flashboard Riser 35ft long 48in dia. 2ft deep
Asset# NA

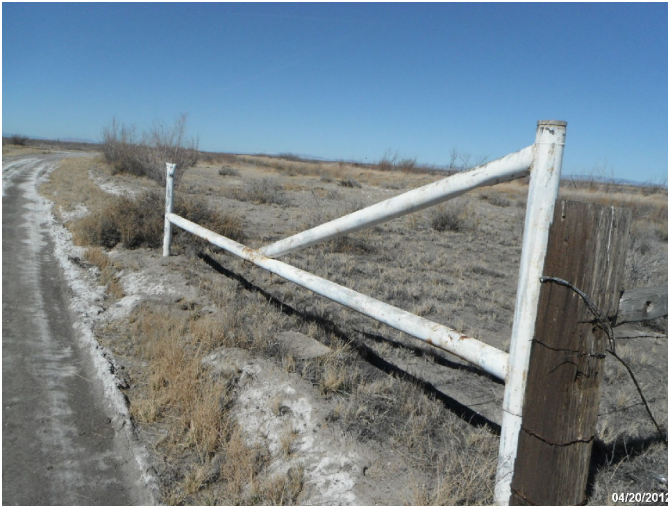
Photo: STIL_C4_1274 Route: 104-002-1.34
Metal Open Rail Gate
Asset# 10005729

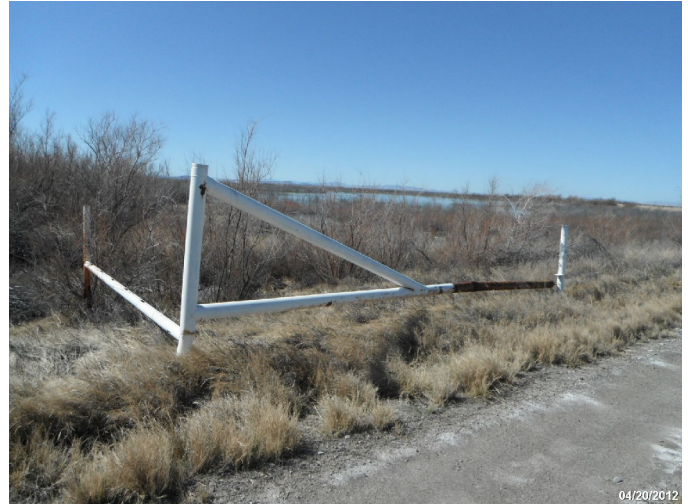
Photo: STIL_C4_1277 Route: 104-004-3.18
Metal Open Rail Gate
Asset# 10005729

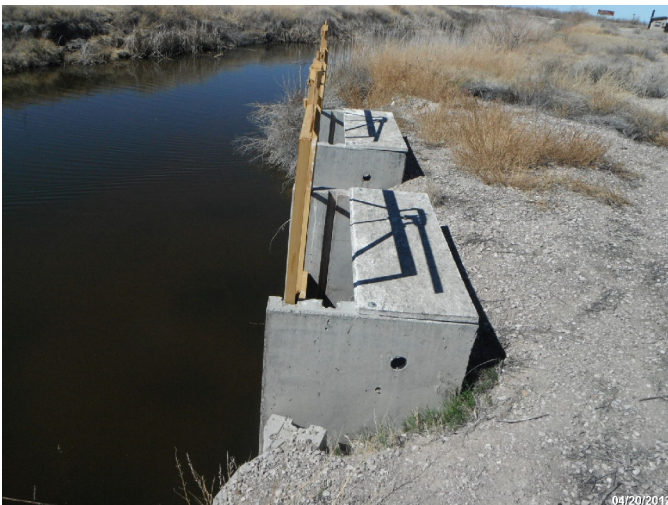
Photo: STIL_C4_1283 Route: 104-004-3.4
Plastic WCS Flap Gate/Full-Round Riser
50ft long 48in dia. 2ft deep Asset# NA

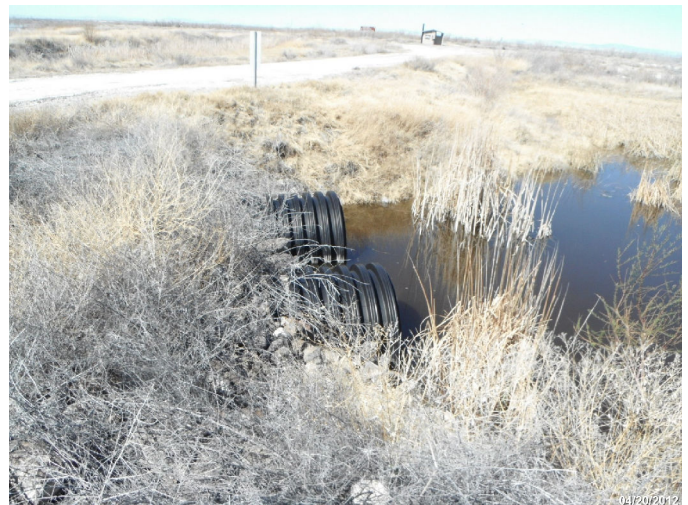
Photo: STIL_C4_1286 Route: 104-004-3.4
Plastic WCS Flap Gate/Full-Round Riser
50ft long 48in dia. 2ft deep Asset# NA

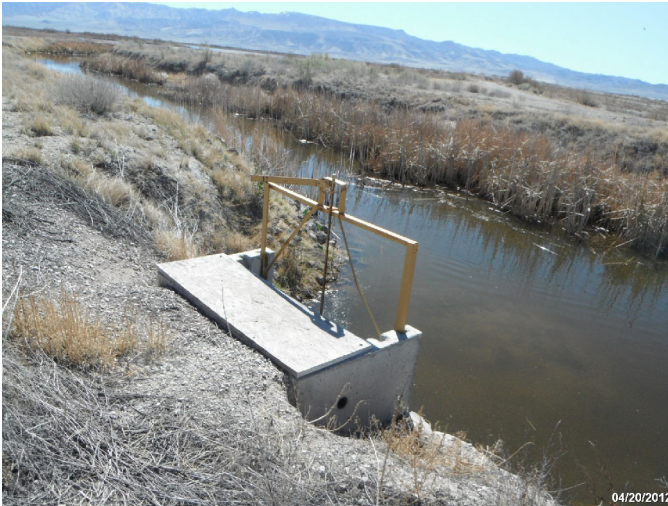
Photo: STIL_C4_1284 Route: 104-004-3.41
Plastic WCS Flap Gate/Full-Round Riser
40ft long 48in dia. 2ft deep Asset# NA

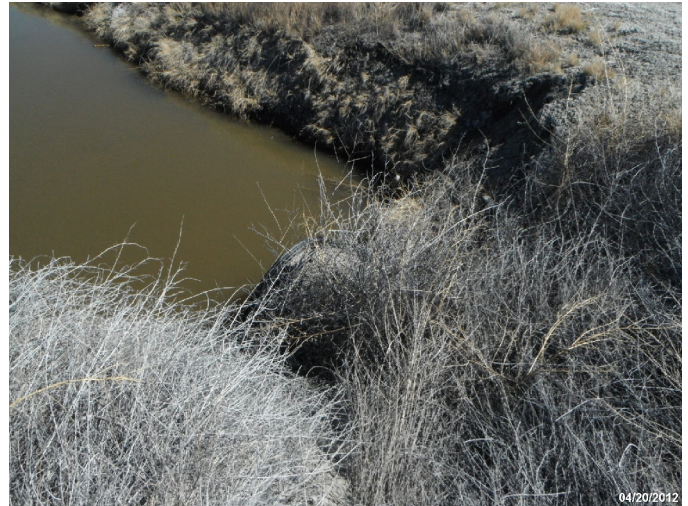
Photo: STIL_C4_1285 Route: 104-004-3.41
Plastic WCS Flap Gate/Full-Round Riser
40ft long 48in dia. 2ft deep Asset# NA

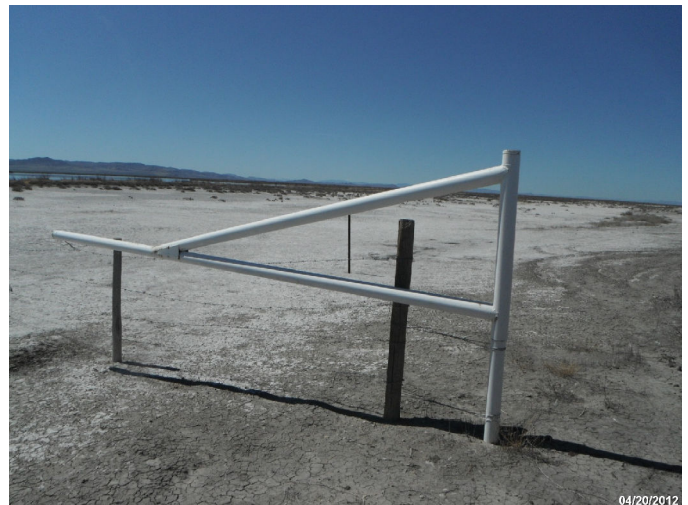
Photo: STIL_C4_1304 Route: 104-007-6.18
Metal Open Rail Gate
Asset# 10005729

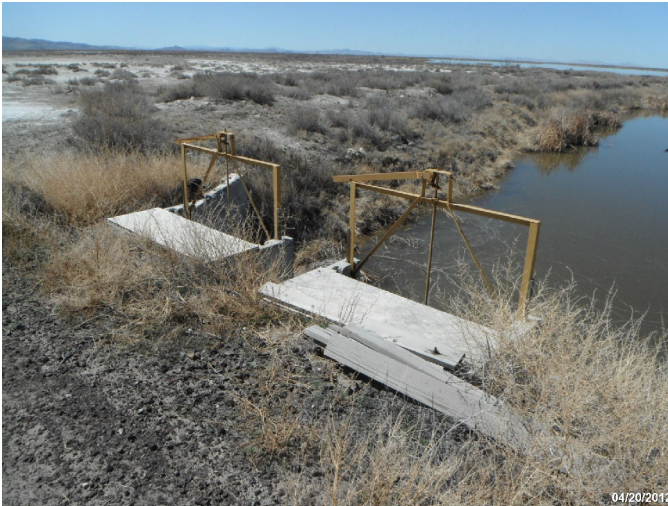
Photo: STIL_C4_1305 Route: 104-007-6.82
Plastic WCS Flap Gate/Full-Round Riser
40ft long 48in dia. 2ft deep Asset# NA

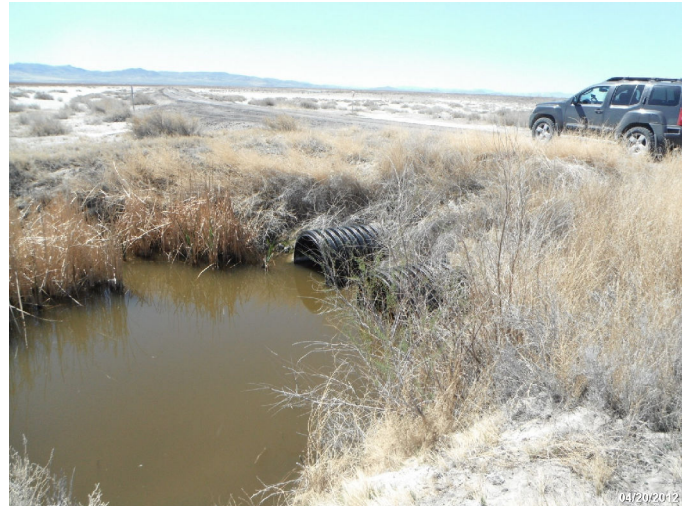
Photo: STIL_C4_1306 Route: 104-007-6.82
Plastic WCS Flap Gate/Full-Round Riser
40ft long 48in dia. 2ft deep Asset# NA

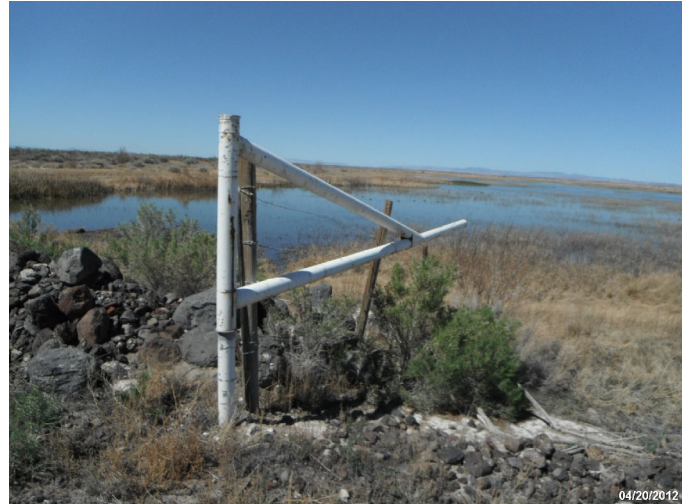
Photo: STIL_C4_1308 Route: 104-008-7.68
Metal Open Rail Gate
Asset# 10005729

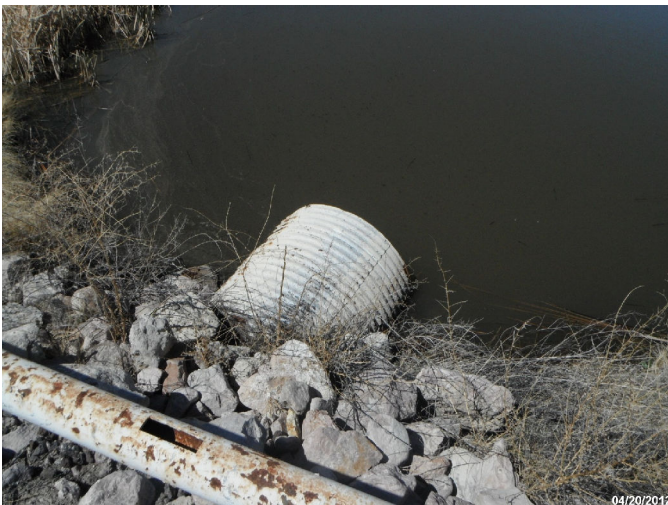
Photo: STIL_C4_1309 Route: 104-008-7.7
Metal Culvert 40ft long 48in dia. 4ft deep
Asset# NA

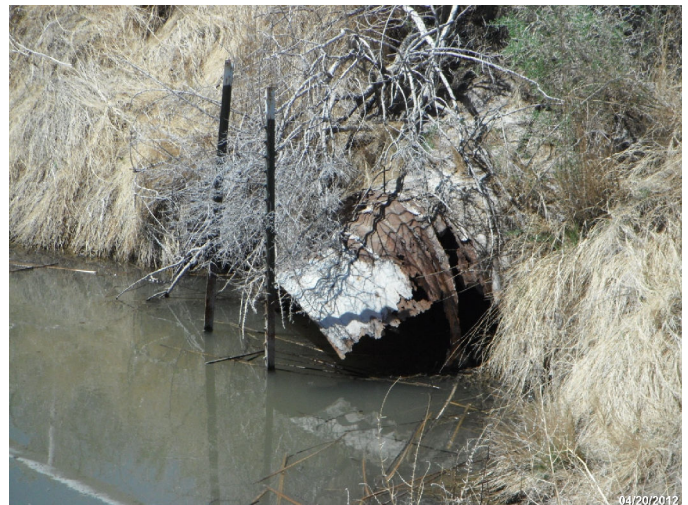
Photo: STIL_C4_1310 Route: 104-008-7.7
Metal Culvert 40ft long 48in dia. 4ft deep
Asset# NA

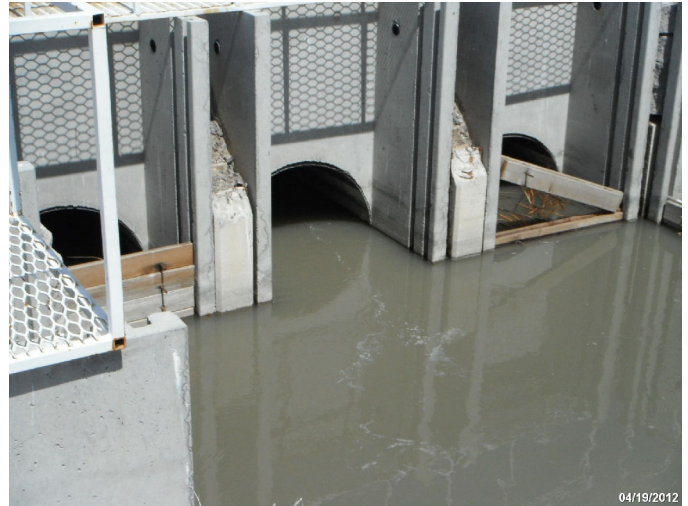
Photo: STIL_C4_1215 Route: 104-009-8.07
Plastic WCS Flashboard Riser 60ft long 36in dia. 2ft deep
Asset# NA

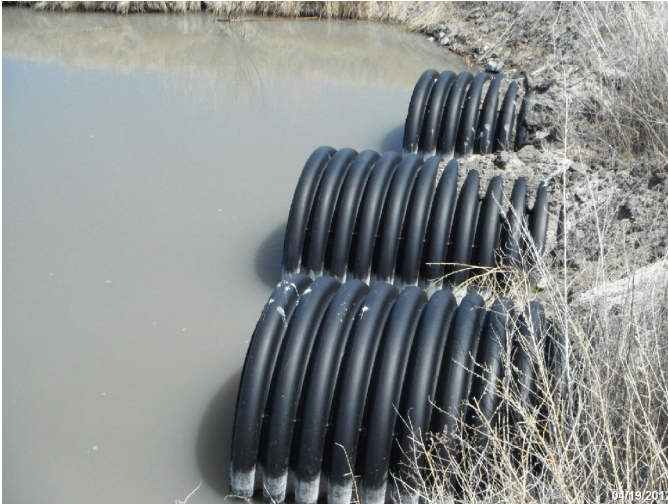
Photo: STIL_C4_1216 Route: 104-009-8.07
Plastic WCS Flashboard Riser 60ft long 36in dia. 2ft deep
Asset# NA

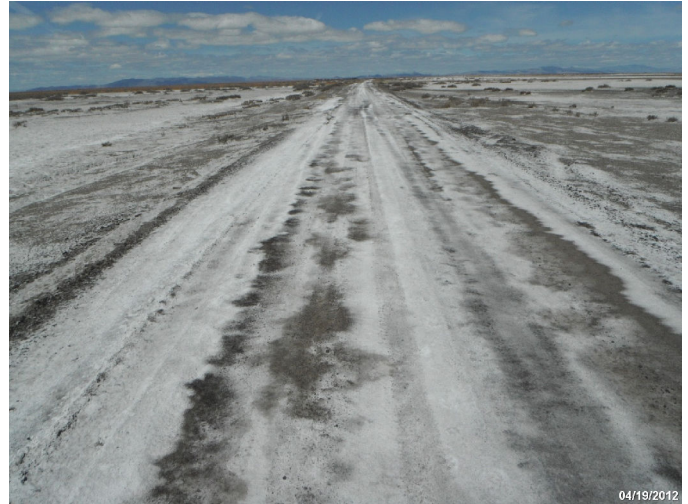
Photo: STIL_C4_1217 Route: 104-009-8.47 Other 1218
Problem area 2 road needs to be built up to prevent wind
and water from washing it out
