The Road Inventory of Stillwater National Wildlife Refuge Fallon, NV

Prepared By:
Federal Highway Administration
Central Federal Lands Highway Division
June 2012

Stillwater National Wildlife Refuge - 84590

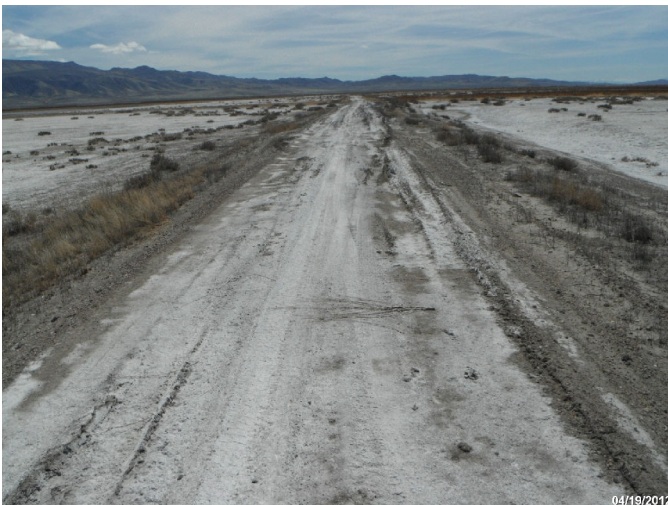
Photo: STIL_C4_1219 Route: 104-009-8.7
Other 1220, Problem area 2 road needs to be built up

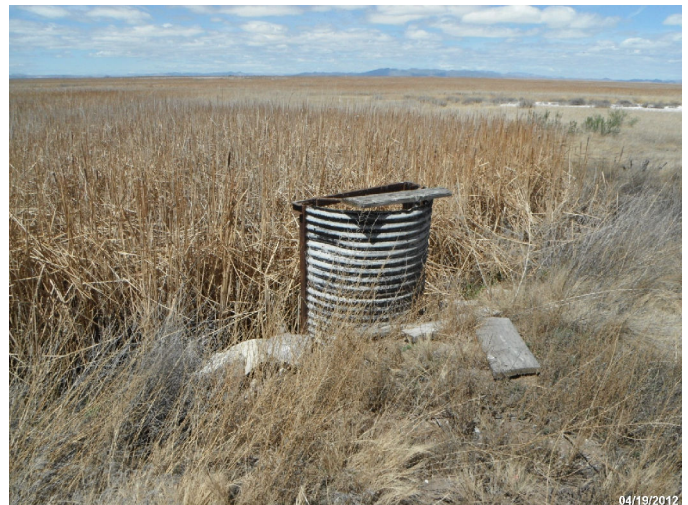
Photo: STIL_C4_1223 Route: 104-009-8.83
Metal WCS Flashboard Riser 35ft long 36in dia. 3ft deep
Asset# NA 8-018

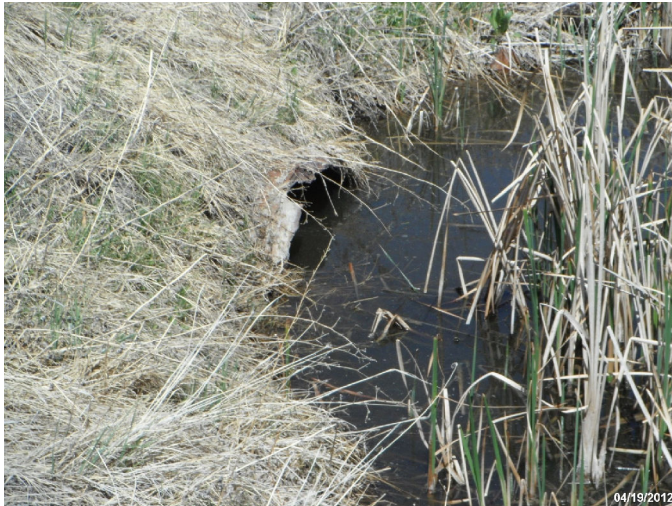
Photo: STIL_C4_1224 Route: 104-009-8.83
Metal WCS Flashboard Riser 35ft long 36in dia. 3ft deep
Asset# NA

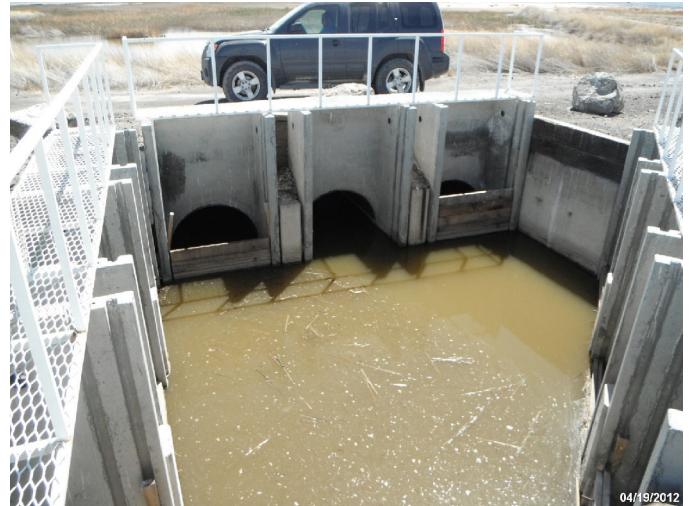
Photo: STIL_C4_1227 Route: 105-001-0.0
Plastic WCS Flashboard Riser 50ft long 36in dia. 3ft deep
Asset# NA

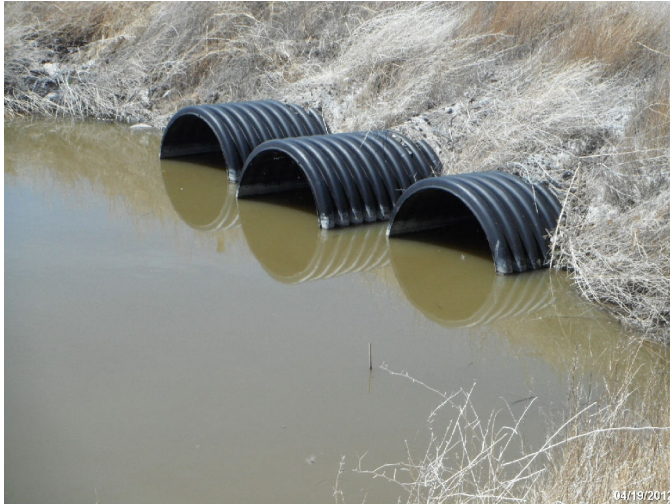
Photo: STIL_C4_1228 Route: 105-001-0.0
Plastic WCS Flashboard Riser 50ft long 36in dia. 3ft deep
Asset# NA

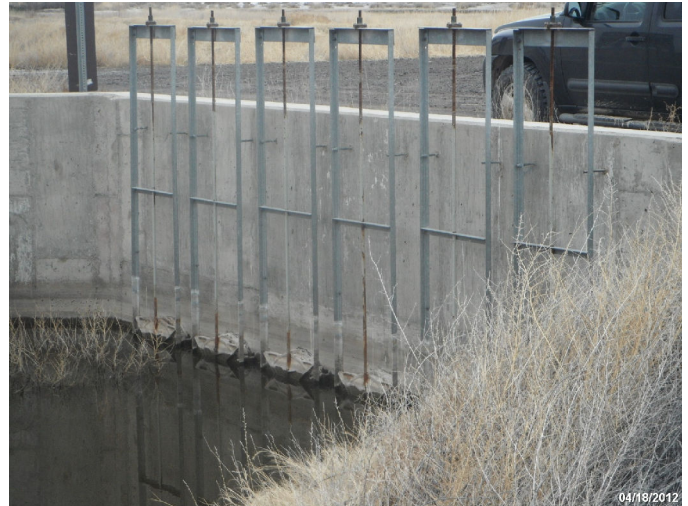
Photo: STIL_C4_1026 Route: 107-001-0.19
Metal WCS Screw Gate 65ft long 24in dia. 8ft deep
Asset# NA

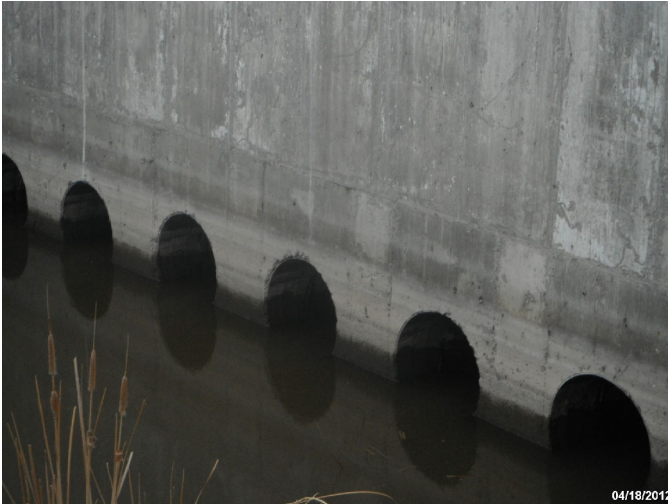
Photo: STIL_C4_1027 Route: 107-001-0.19
Metal WCS Screw Gate 65ft long 24in dia. 8ft deep
Asset# NA

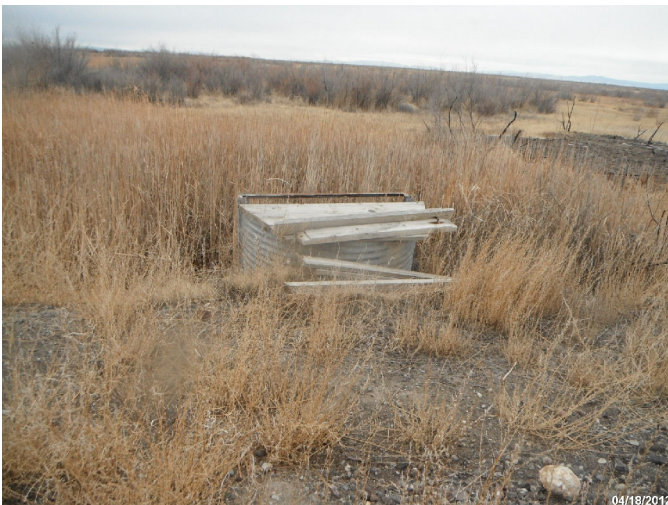
Photo: STIL_C4_1029 Route: 107-002-0.29
Metal WCS Flashboard Riser 40ft long 36in dia. 2ft deep
Asset# NA

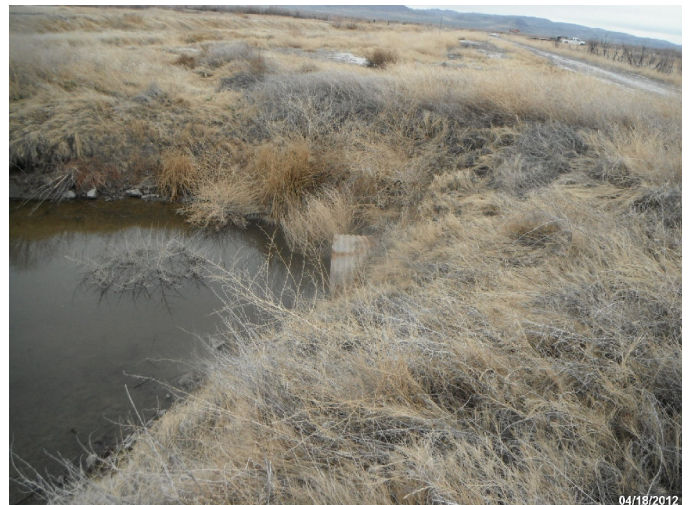
Photo: STIL_C4_1030 Route: 107-002-0.29
Metal WCS Flashboard Riser 40ft long 36in dia. 2ft deep
Asset# NA 8-023

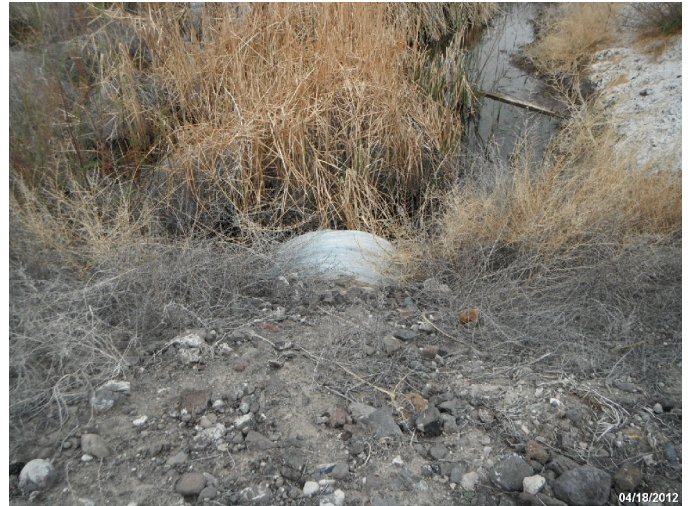
Photo: STIL_C4_1036 Route: 107-003-1.96
Metal Culvert 40ft long 60in dia. 2ft deep
Asset# NA

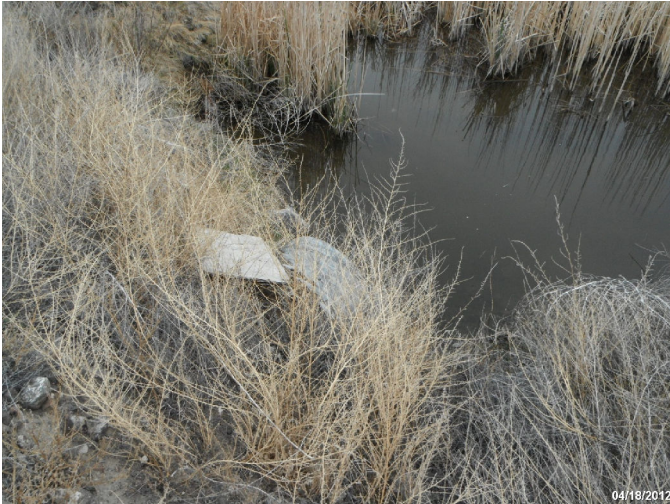
Photo: STIL_C4_1037 Route: 107-003-1.96
Metal Culvert 40ft long 60in dia. 2ft deep
Asset# NA

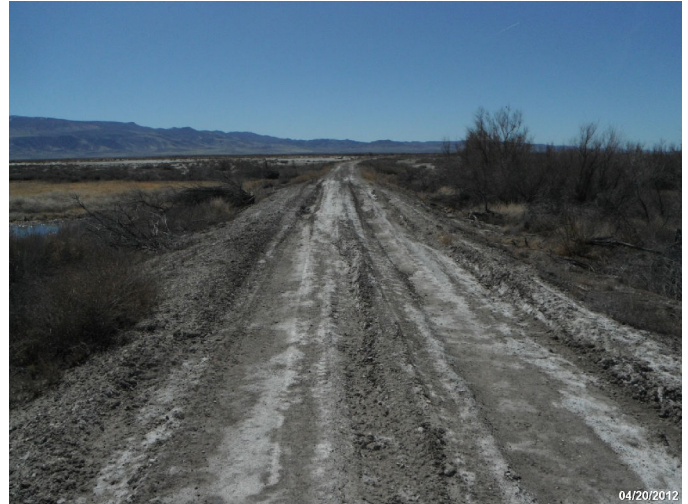
Photo: STIL_C4_1297 Route: 109-003-2.11 Other this is one of the problem areas. The alkali is flowing up and making the road impassable in wet weather photos 1297 - 1298

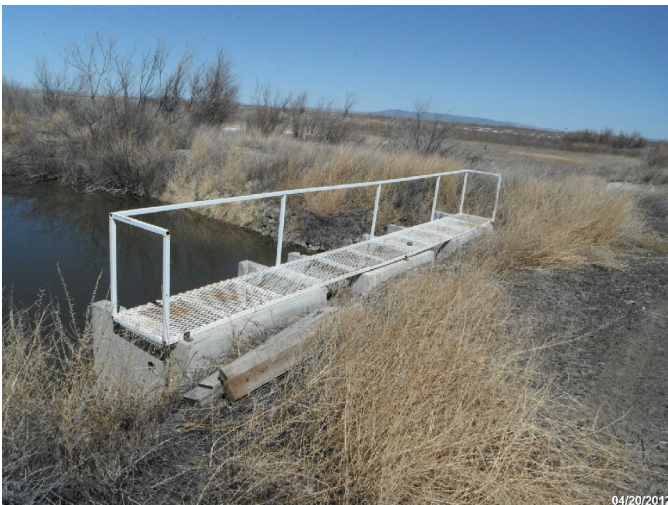
Photo: STIL_C4_1292 Route: 109-003-2.47
Plastic WCS Flashboard Riser 45ft long 48in dia. 2ft deep
Asset# NA

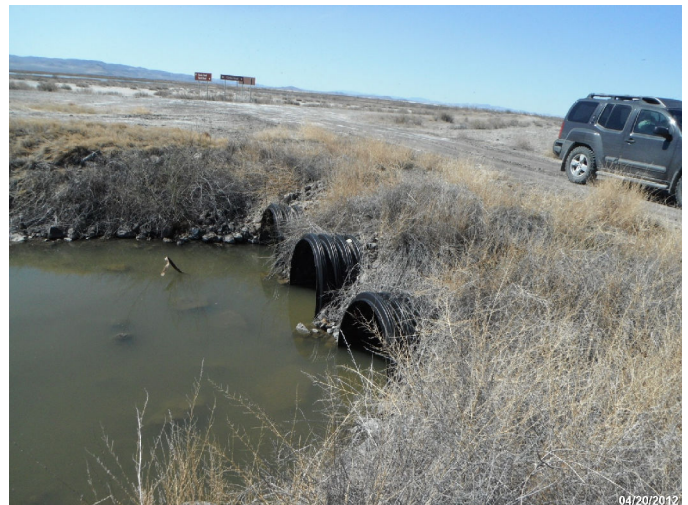
Photo: STIL_C4_1293 Route: 109-003-2.47
Plastic WCS Flashboard Riser 45ft long 48in dia. 2ft deep
Asset# NA 8-025

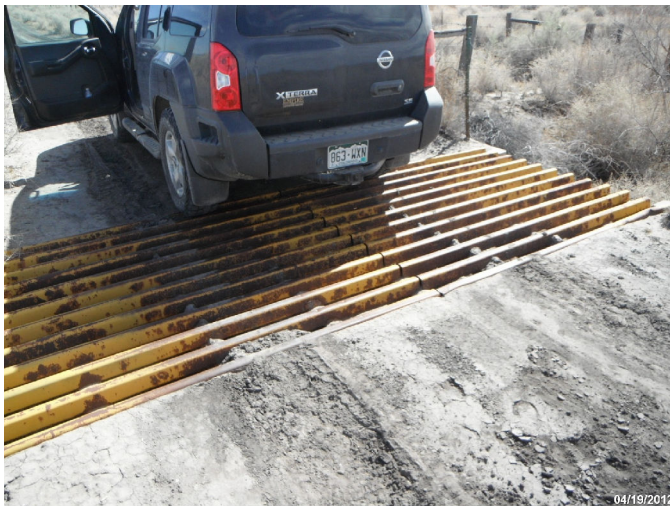
Photo: STIL_C4_1263 Route: 113-002-1.57
Metal Cattle Guard
Asset# NA

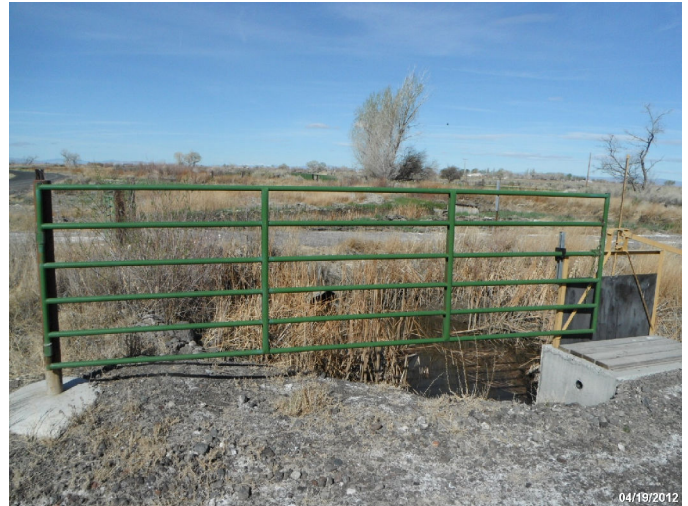
Photo: STIL_C4_1156 Route: 300-001-0.01
Metal Open Rail Gate
Asset# 10005729

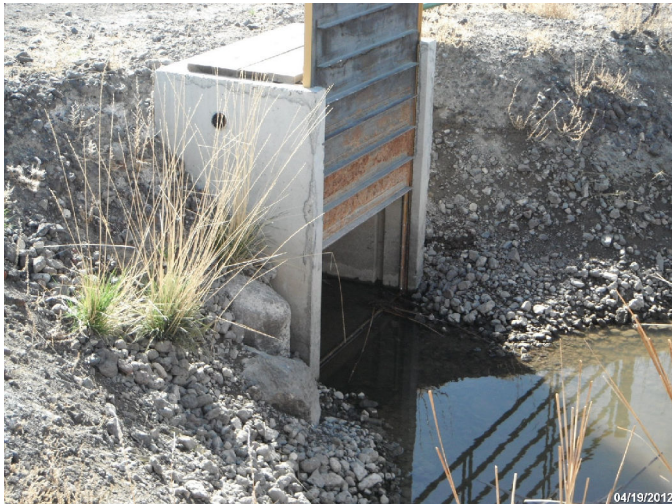
Photo: STIL_C4_1157 Route: 300-001-0.01
Plastic WCS Flap Gate/Full-Round Riser
40ft long 36in dia. 2ft deep Asset# NA

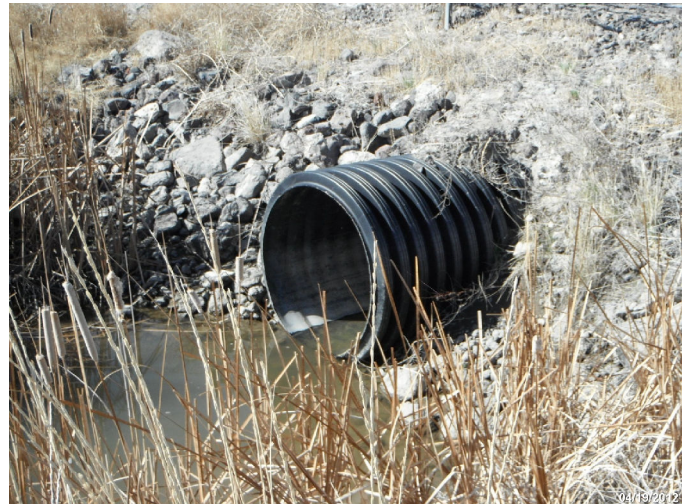
Photo: STIL_C4_1158 Route: 300-001-0.01
Plastic WCS Flap Gate/Full-Round Riser
40ft long 36in dia. 2ft deep Asset# NA

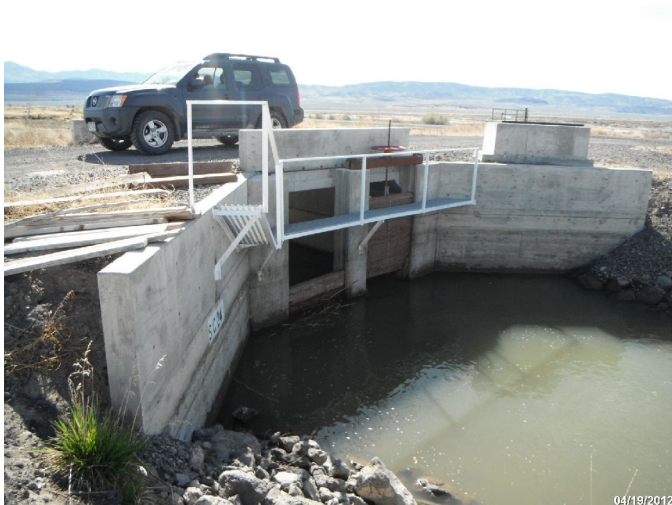
Photo: STIL_C4_1159 Route: 300-001-0.03
Concrete WCS Screw Gate 40ft long Nonein dia. 2ft deep
6 x 10 box
Asset# NA

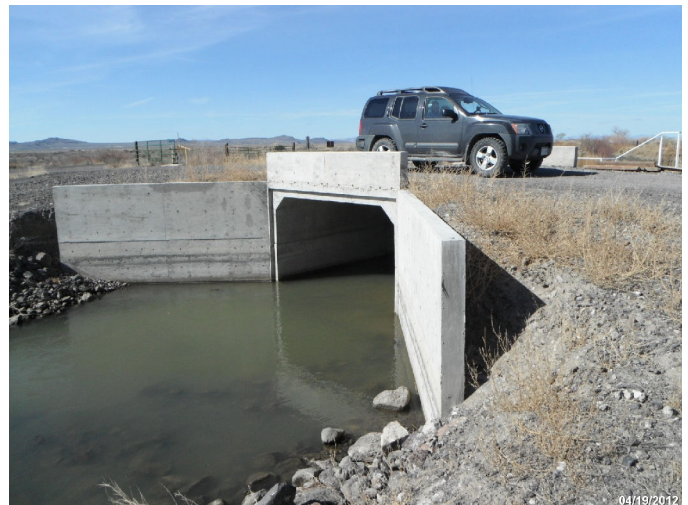
Photo: STIL_C4_1160 Route: 300-001-0.03
Concrete WCS Screw Gate 40ft long Nonein dia. 2ft deep
6 x 10 box
Asset# NA 8-033

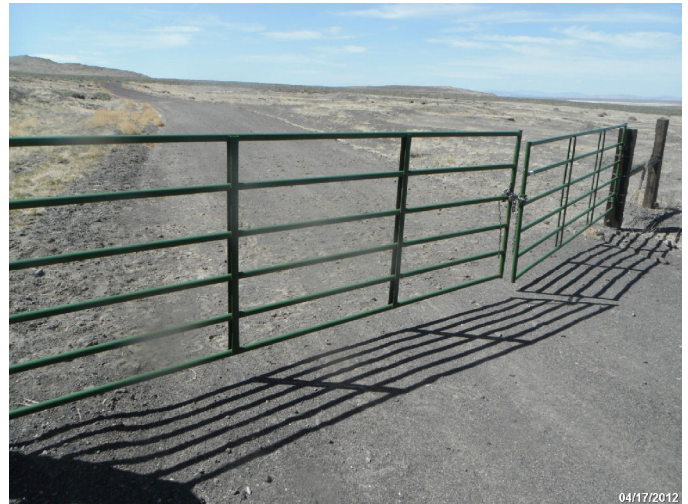
Photo: STIL_C4_1005 Route: 400-003-3.09
Metal Open Rail Gate
Asset# 10005729

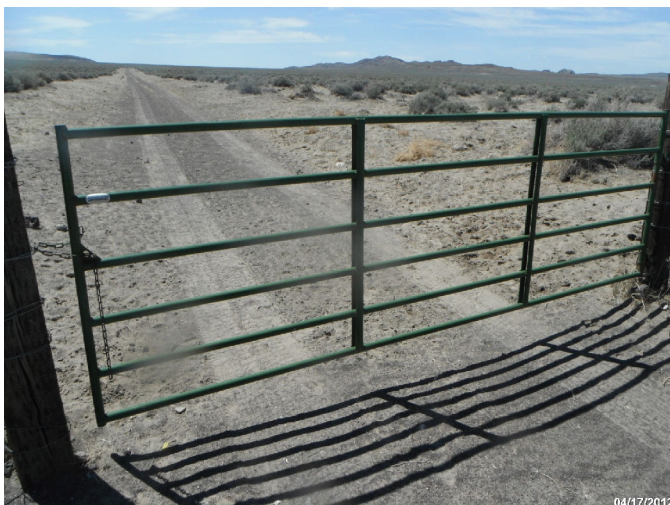
Photo: STIL_C4_1010 Route: 401-004-4.19
Metal Open Rail Gate
Asset# 10005729

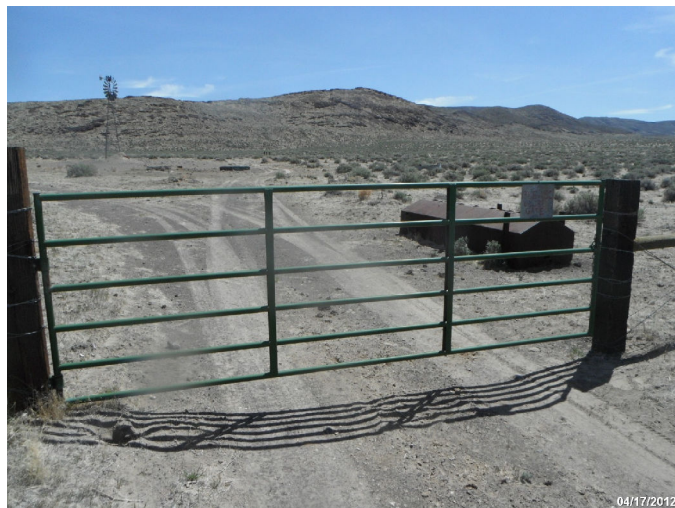
Photo: STIL_C4_1012 Route: 402-001-0.72
Metal Open Rail Gate
Asset# 10005729

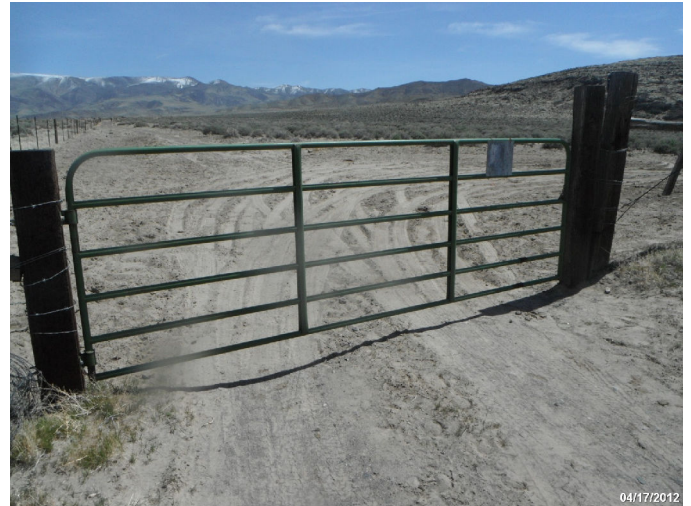
Photo: STIL_C4_1015 Route: 403-001-0.62
Metal Open Rail Gate
Asset# 10005729

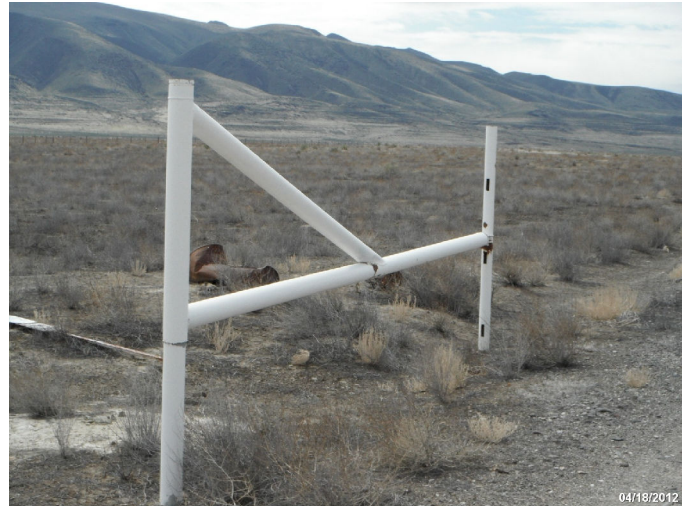
Photo: STIL_C4_1060 Route: 404-001-0.01
Metal Open Rail Gate
Asset# 10005729

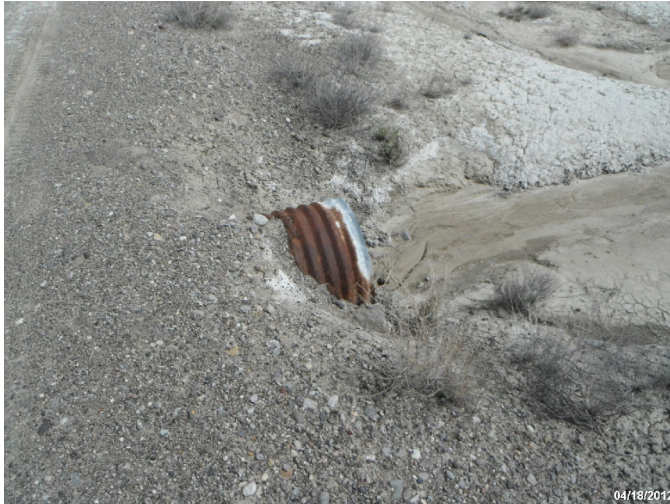
Photo: STIL_C4_1061 Route: 404-001-0.24
Metal Culvert 20ft long 24in dia. 1ft deep
Asset# NA

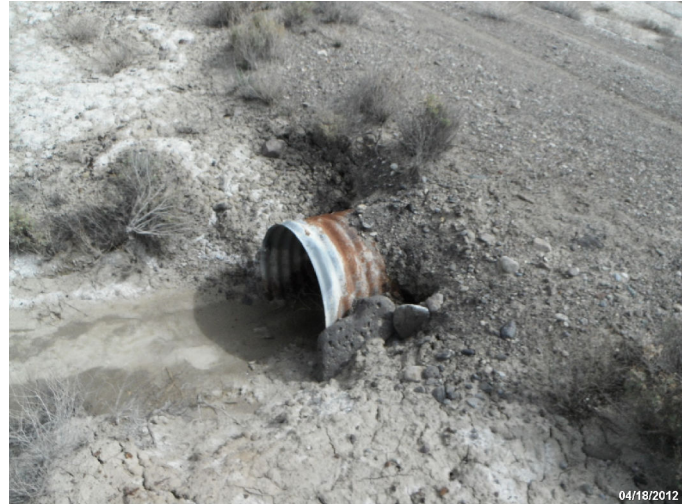
Photo: STIL_C4_1062 Route: 404-001-0.24
Metal Culvert 20ft long 24in dia. 1ft deep
Asset# NA

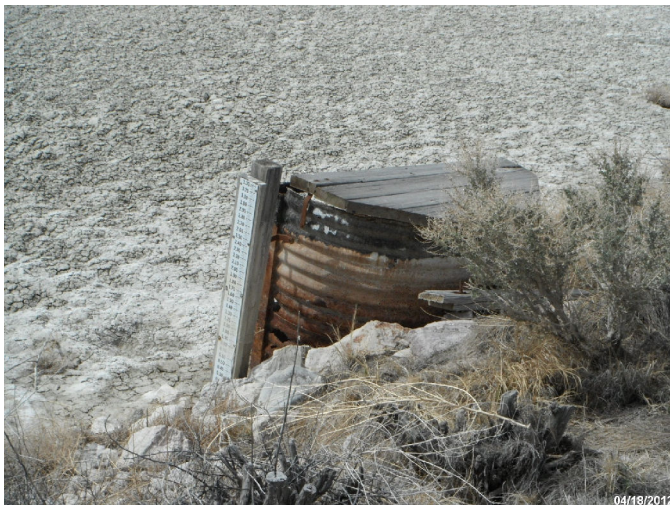
Photo: STIL_C4_1063 Route: 404-001-0.58
Metal WCS Flashboard Riser 50ft long 36in dia. 6ft deep
Asset# NA

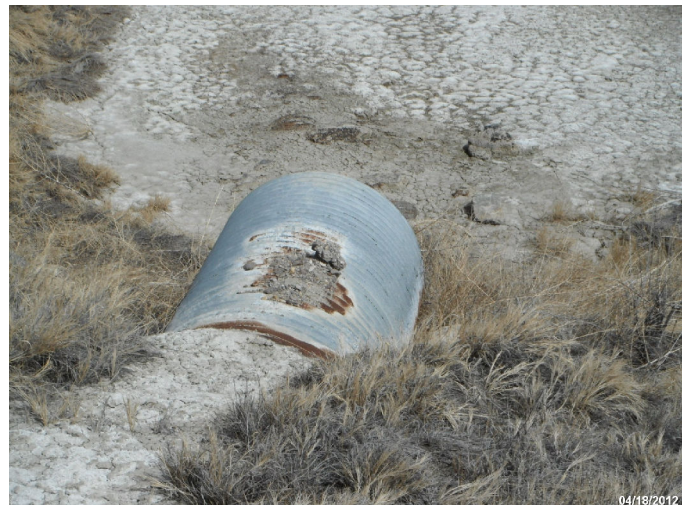
Photo: STIL_C4_1064 Route: 404-001-0.58
Metal WCS Flashboard Riser 50ft long 36in dia. 6ft deep
Asset# NA 8-038

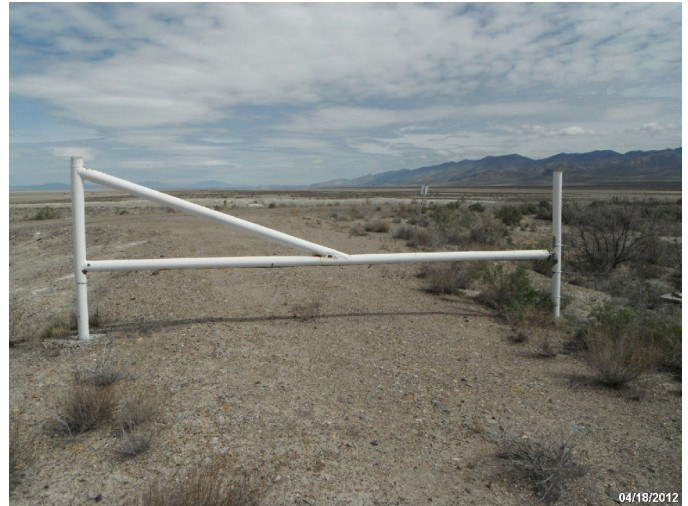
Photo: STIL_C4_1067 Route: 405-001-0.01
Metal Open Rail Gate
Asset# 10005729

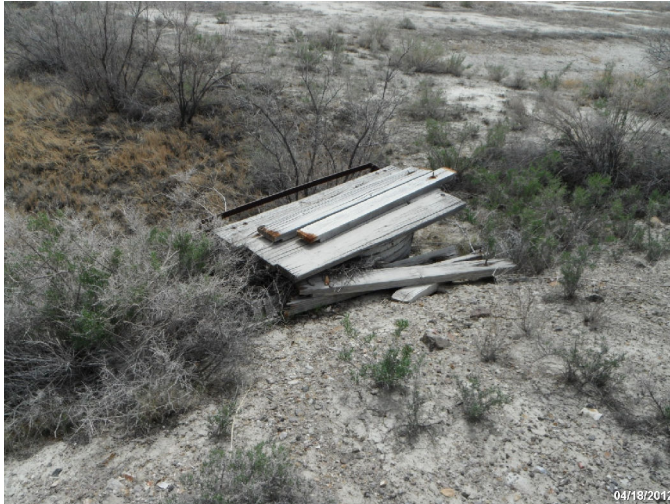
Photo: STIL_C4_1068 Route: 405-001-0.01
Metal WCS Flashboard Riser 70ft long 60in dia. 8ft deep
Asset# NA

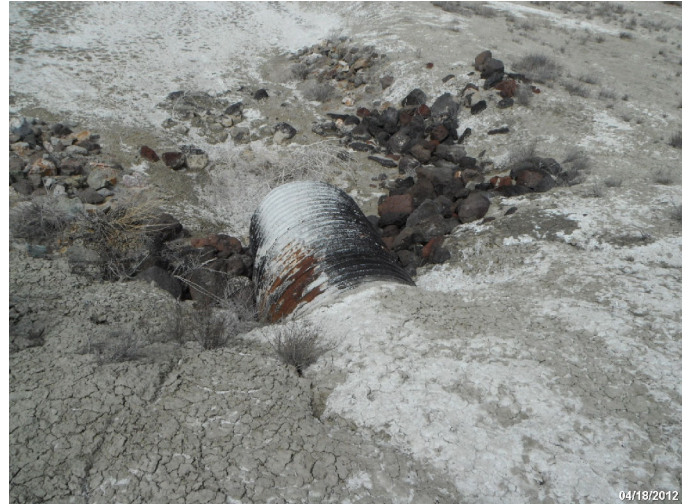
Photo: STIL_C4_1069 Route: 405-001-0.01
Metal WCS Flashboard Riser 70ft long 60in dia. 8ft deep
Asset# NA

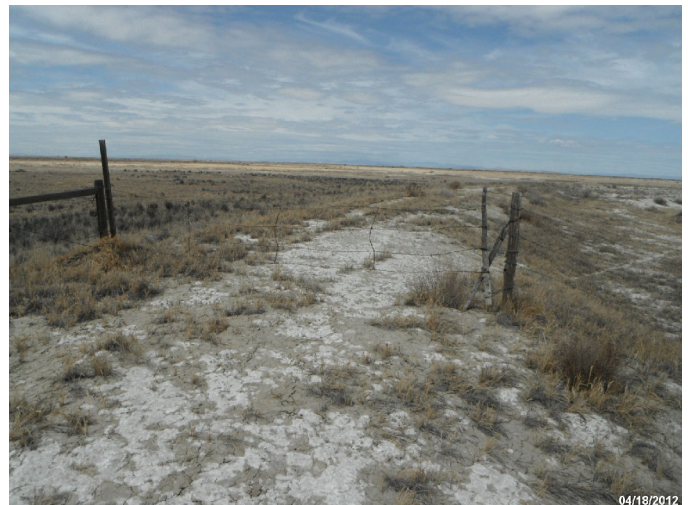
Photo: STIL_C4_1071 Route: 405-002-1.35
Metal Gate Barb Wire, Lock rusted shut
Asset# NA

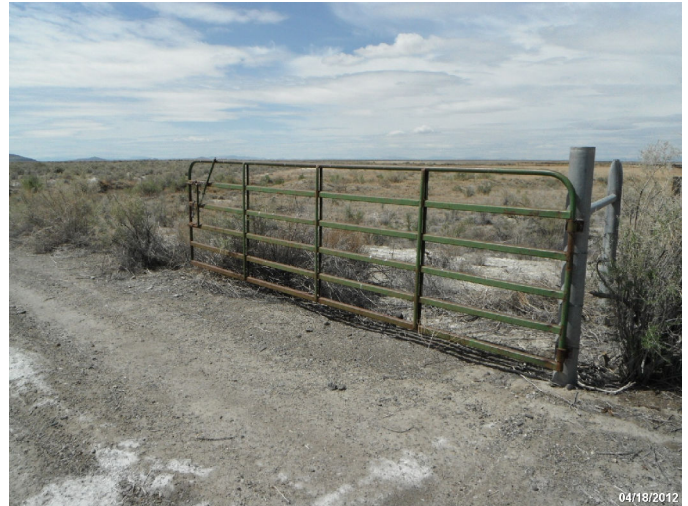
Photo: STIL_C4_1073 Route: 406-001-0.0
Metal Open Rail Gate
Asset# 10005729

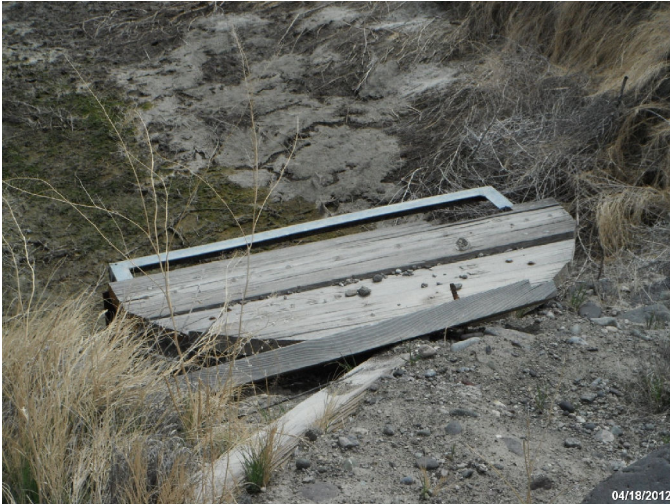
Photo: STIL_C4_1077 Route: 406-001-0.02
Metal WCS Flashboard Riser 30ft long 36in dia. 3ft deep
Asset# NA

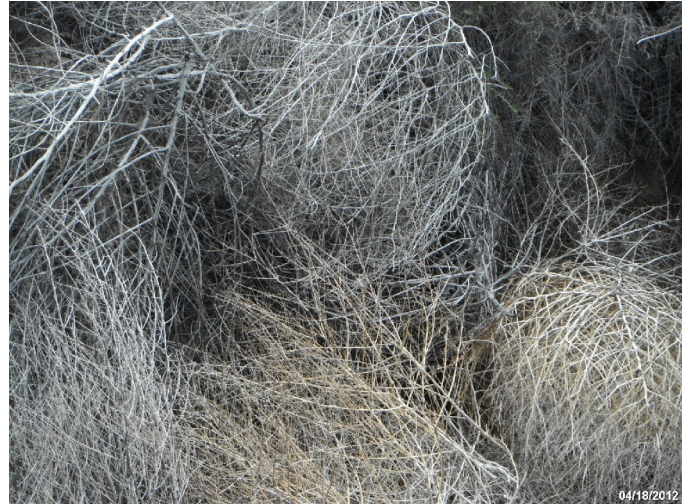
Photo: STIL_C4_1078 Route: 406-001-0.02
Metal WCS Flashboard Riser 30ft long 36in dia. 3ft deep
Asset# NA

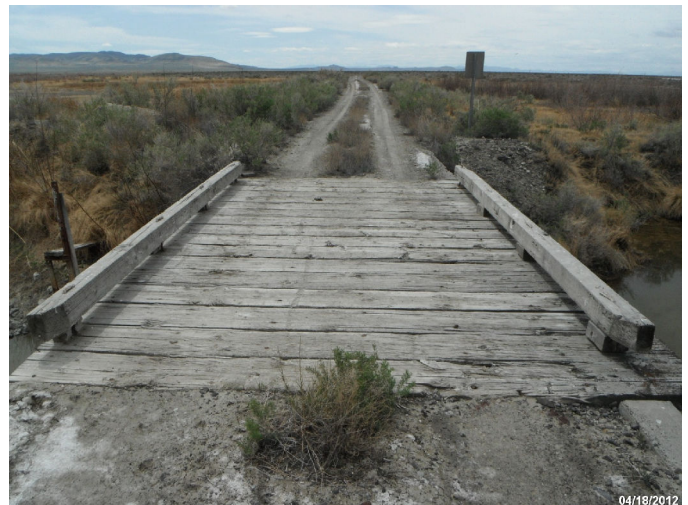
Photo: STIL_C4_1080 Route: 406-002-1.28
Wood Bridge NBIS:NA
Asset# NA

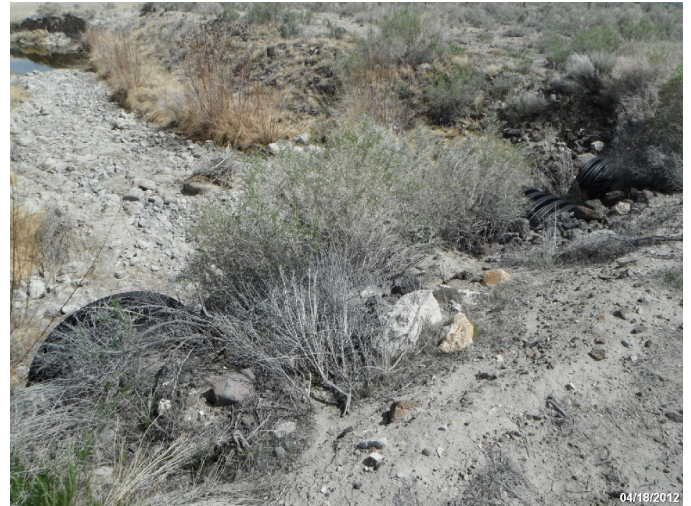
Photo: STIL_C4_1075 Route: 407-001-0.28
Plastic WCS Flashboard Riser 40ft long 48in dia. 2ft deep
Asset# NA

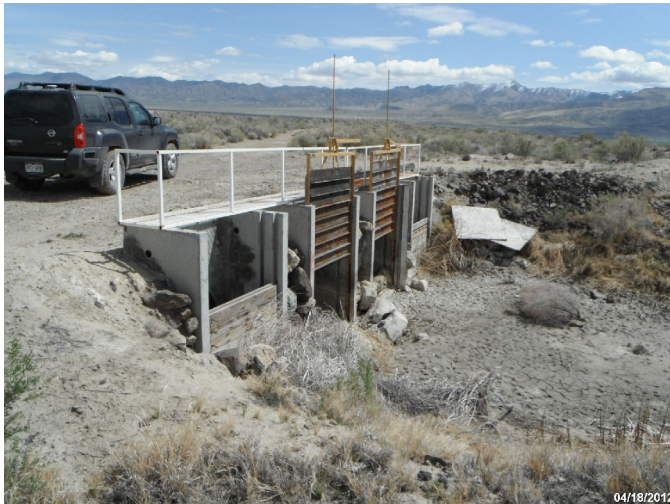
Photo: STIL_C4_1076 Route: 407-001-0.28
Plastic WCS Flashboard Riser 40ft long 48in dia. 2ft deep
Asset# NA

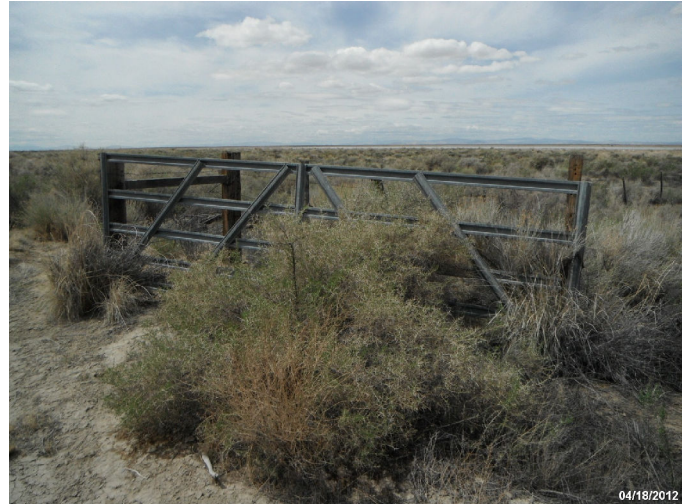
Photo: STIL_C4_1088 Route: 408-003-2.12
Metal Open Rail Gate
Asset# 10005729

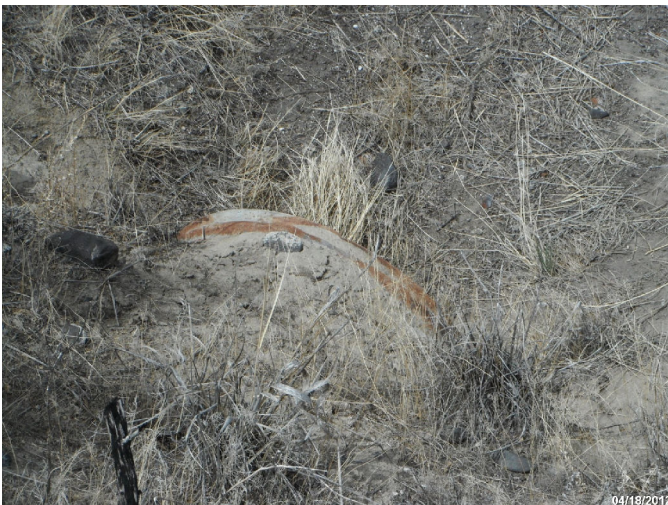
Photo: STIL_C4_1089 Route: 408-003-2.16
Metal WCS Flashboard Riser 30ft long 36in dia. 3ft deep
Asset# NA

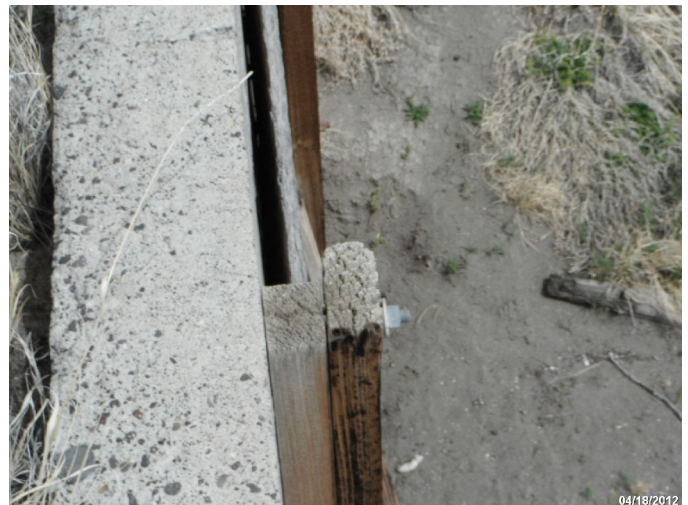
Photo: STIL_C4_1090 Route: 408-003-2.16
Metal WCS Flashboard Riser 30ft long 36in dia. 3ft deep
Asset# NA 8-044

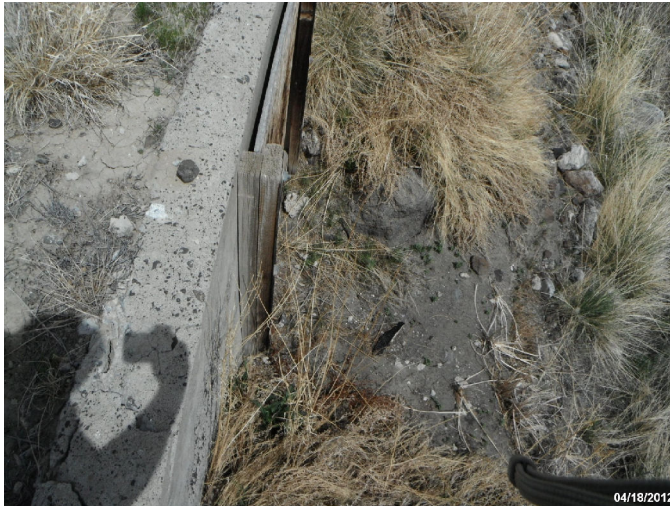
Photo: STIL_C4_1091 Route: 408-003-2.55
Metal WCS Flashboard Riser 30ft long 36in dia. 3ft deep
Asset# NA

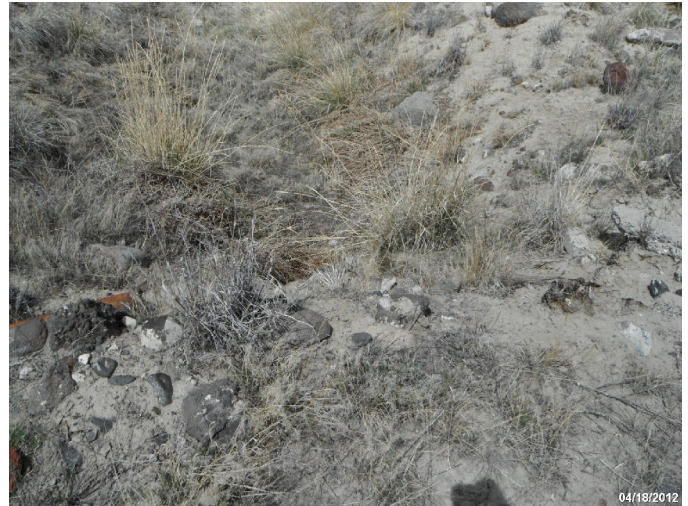
Photo: STIL_C4_1092 Route: 408-003-2.55
Metal WCS Flashboard Riser 30ft long 36in dia. 3ft deep
Asset# NA

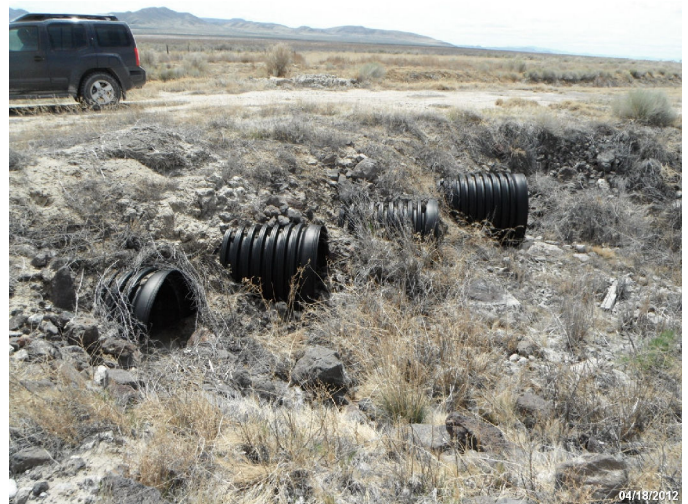
Photo: STIL_C4_1094 Route: 408-004-3.51
Plastic WCS Flashboard Riser 45ft long 48in dia. 3ft deep
Asset# NA

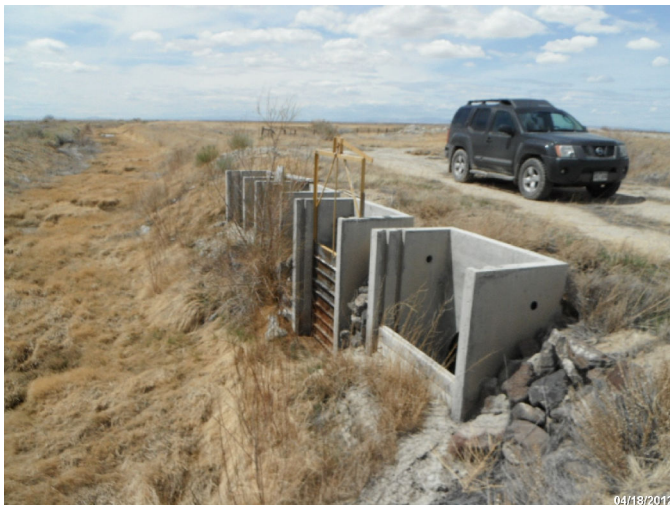
Photo: STIL_C4_1095 Route: 408-004-3.51
Plastic WCS Flashboard Riser 45ft long 48in dia. 3ft deep
Asset# NA

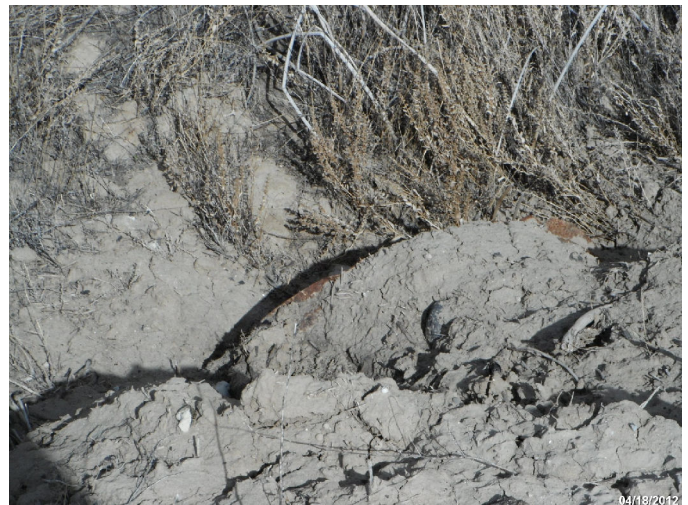
Photo: STIL_C4_1096 Route: 408-004-3.76
Metal WCS Flashboard Riser 30ft long 36in dia. 3ft deep
Asset# NA 8-045

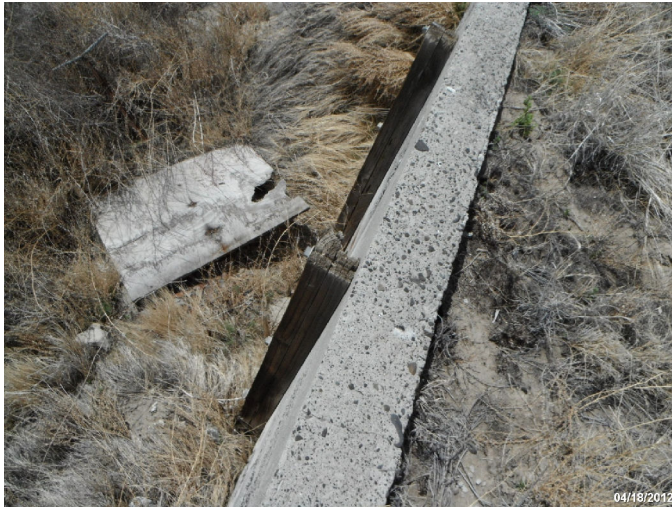
Photo: STIL_C4_1097 Route: 408-004-3.76
Metal WCS Flashboard Riser 30ft long 36in dia. 3ft deep
Asset# NA

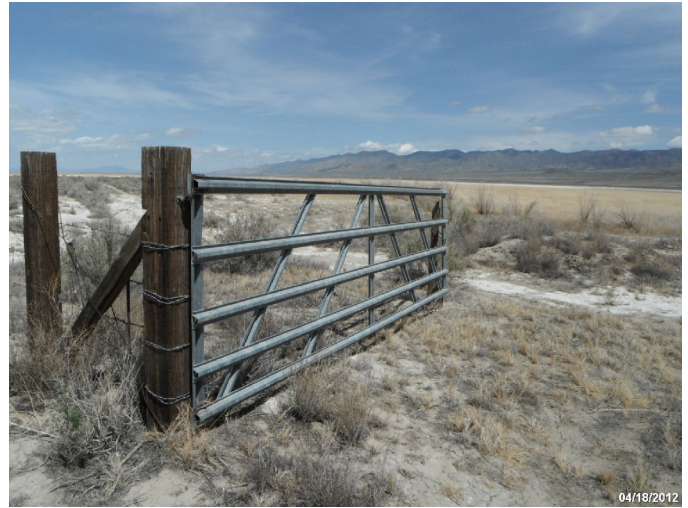
Photo: STIL_C4_1098 Route: 408-004-4.03
Metal Open Rail Gate
Asset# 10005729

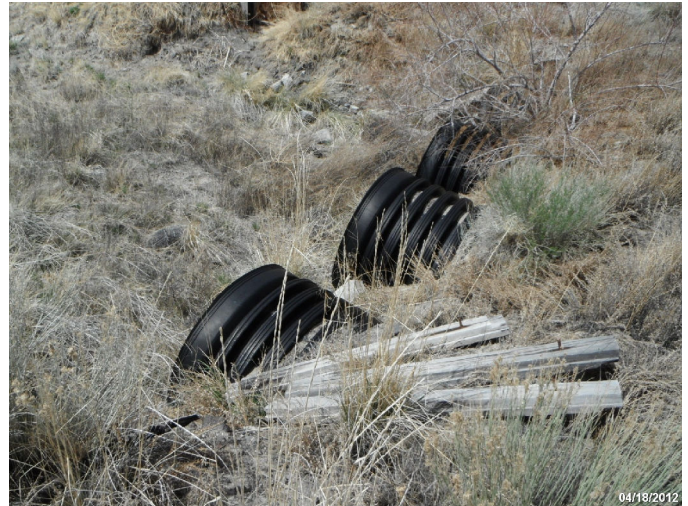
Photo: STIL_C4_1100 Route: 409-001-0.01
Plastic Culvert 30ft long 48in dia. 2ft deep
Asset# NA

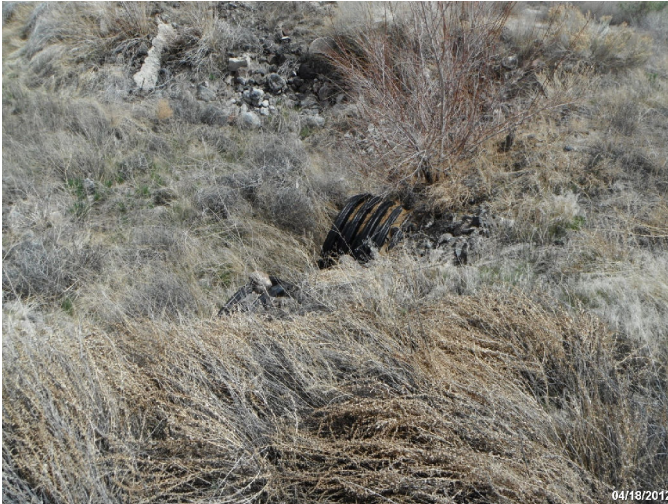
Photo: STIL_C4_1101 Route: 409-001-0.01
Plastic Culvert 30ft long 48in dia. 2ft deep
Asset# NA

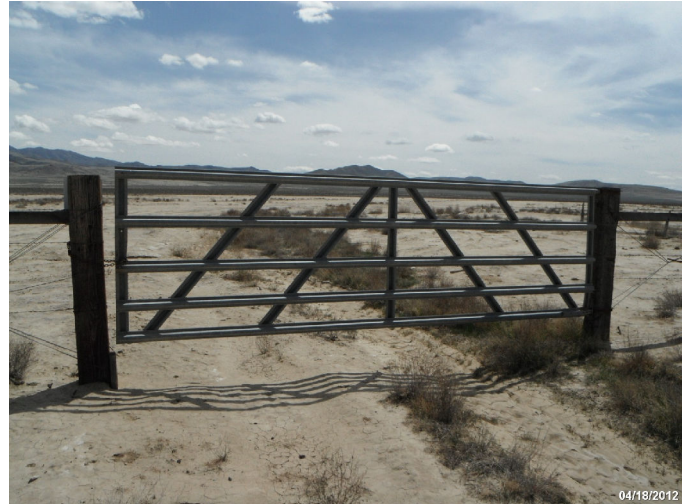
Photo: STIL_C4_1102 Route: 409-001-0.12
Metal Open Rail Gate
Asset# 10005729

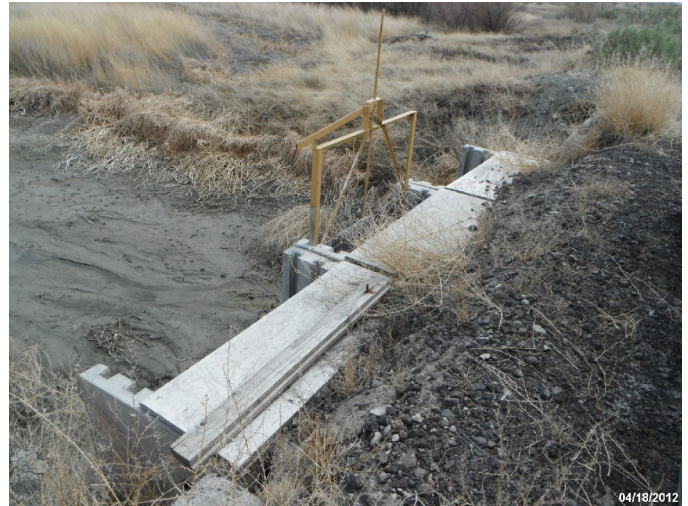
Photo: STIL_C4_1104 Route: 410-001-0.49
Plastic WCS Flap Gate/Full-Round Riser
30ft long 48in dia. 4ft deep Asset# NA

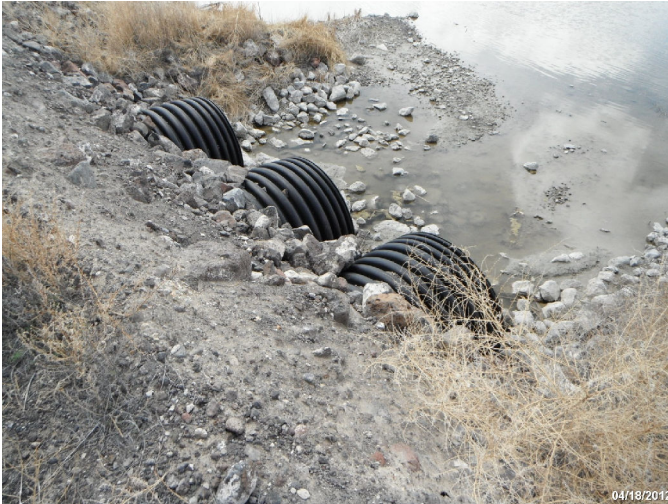
Photo: STIL_C4_1105 Route: 410-001-0.49
Plastic WCS Flap Gate/Full-Round Riser
30ft long 48in dia. 4ft deep Asset# NA

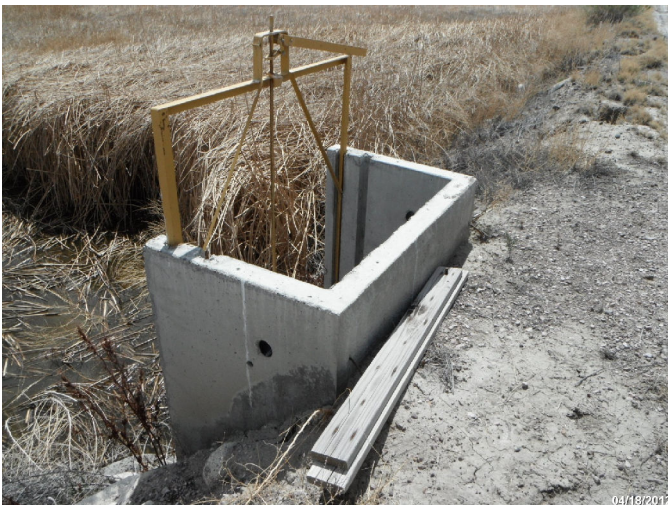
Photo: STIL_C4_1107 Route: 410-002-1.87
Plastic WCS Flap Gate/Full-Round Riser
30ft long 60in dia. 2ft deep Asset# NA

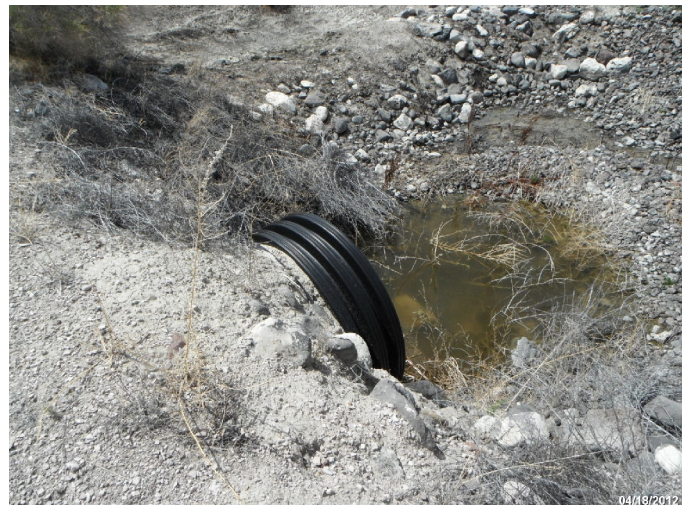
Photo: STIL_C4_1108 Route: 410-002-1.87
Plastic WCS Flap Gate/Full-Round Riser
30ft long 60in dia. 2ft deep Asset# NA

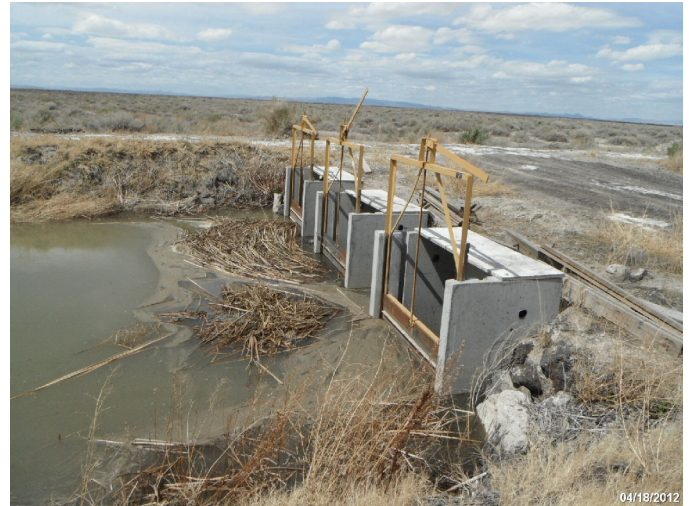
Photo: STIL_C4_1111 Route: 411-001-0.01
Plastic WCS Flap Gate/Full-Round Riser
40ft long 60in dia. 1ft deep Asset# NA

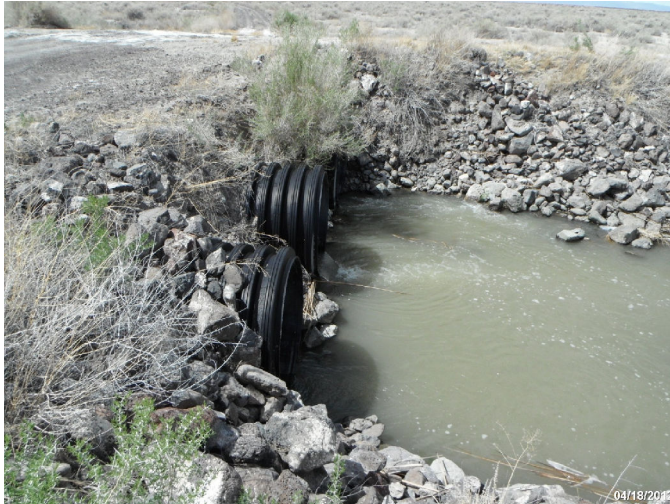
Photo: STIL_C4_1112 Route: 411-001-0.01
Plastic WCS Flap Gate/Full-Round Riser 40ft long 60in dia. 1ft deep
Asset# NA

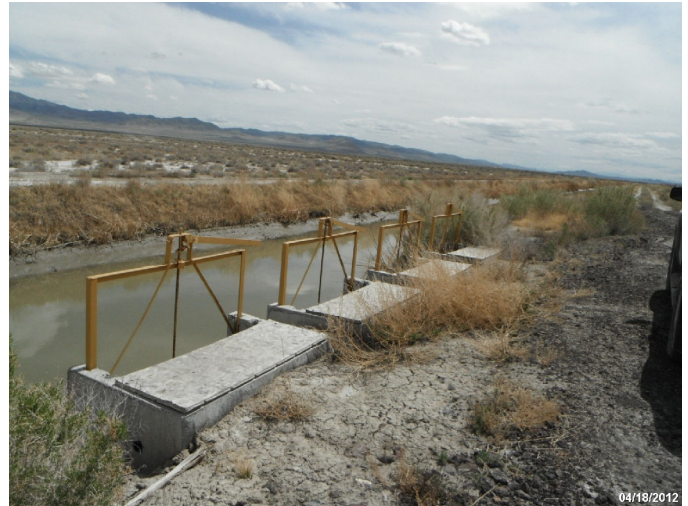
Photo: STIL_C4_1114 Route: 412-001-0.34
Plastic WCS Flap Gate/Full-Round Riser
40ft long 60in dia. 4ft deep Asset# NA

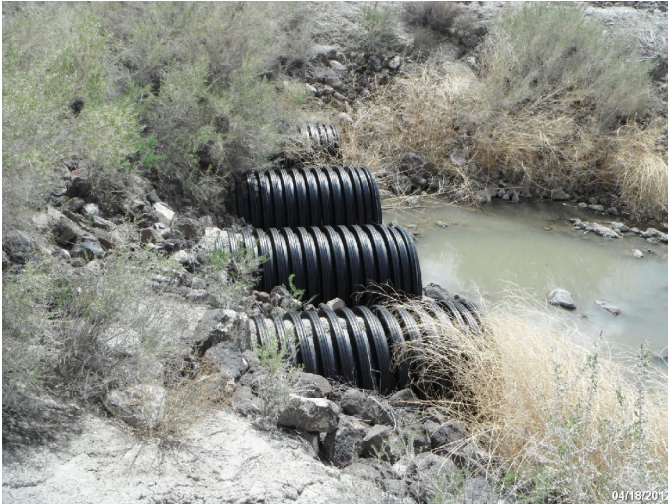
Photo: STIL_C4_1115 Route: 412-001-0.34
Plastic WCS Flap Gate/Full-Round Riser
40ft long 60in dia. 4ft deep Asset# NA

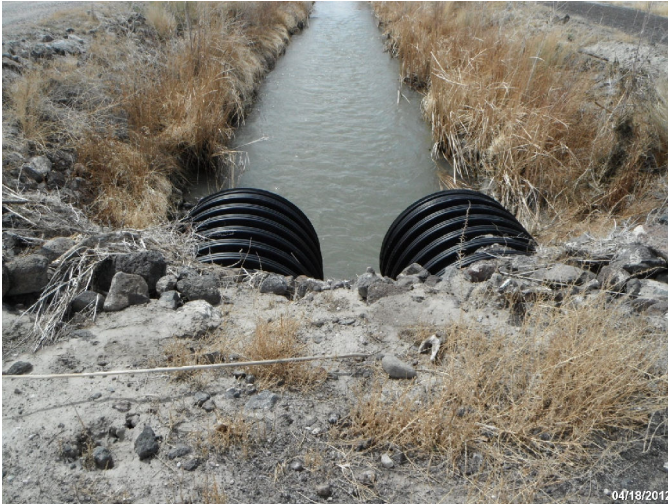
Photo: STIL_C4_1122 Route: 412-006-5.5
Plastic Culvert 120ft long 60in dia. 2ft deep
Asset# NA

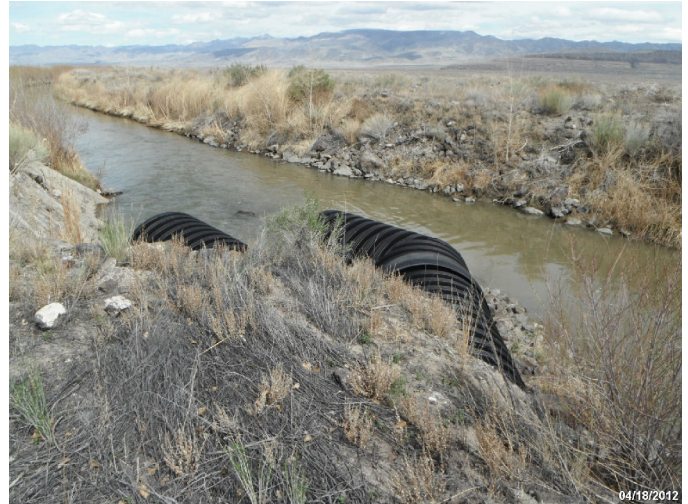
Photo: STIL_C4_1125 Route: 412-006-5.5
Plastic Culvert 120ft long 60in dia. 2ft deep
Asset# NA
