The Road Inventory of Stillwater National Wildlife Refuge Fallon, NV

Prepared By:
Federal Highway Administration
Central Federal Lands Highway Division
June 2012

Stillwater National Wildlife Refuge - 84590

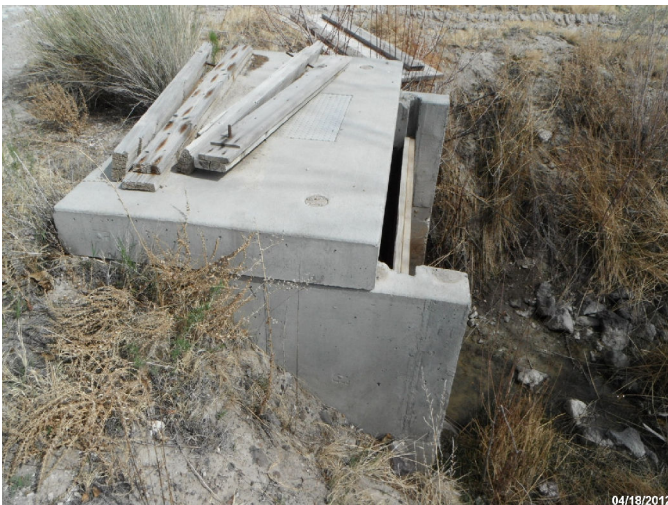
Photo: STIL_C4_1123 Route: 412-006-5.51
Concrete WCS Flashboard Riser 50ft long 48in dia. 3ft deep
Asset# NA

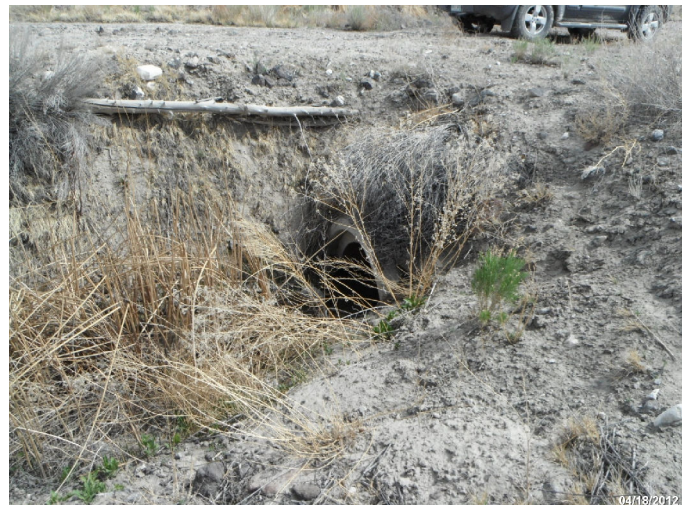
Photo: STIL_C4_1124 Route: 412-006-5.51
Concrete WCS Flashboard Riser 50ft long 48in dia. 3ft deep
Asset# NA 8-052

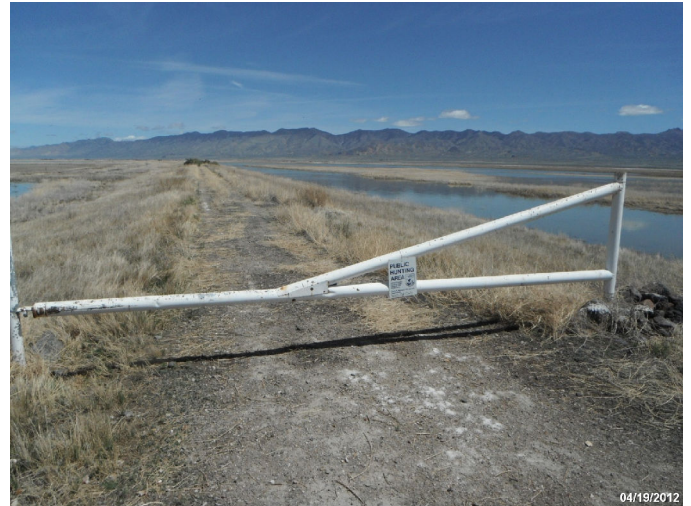
Photo: STIL_C4_1234 Route: 414-001-0.0
Metal Open Rail Gate
Asset# 10005729

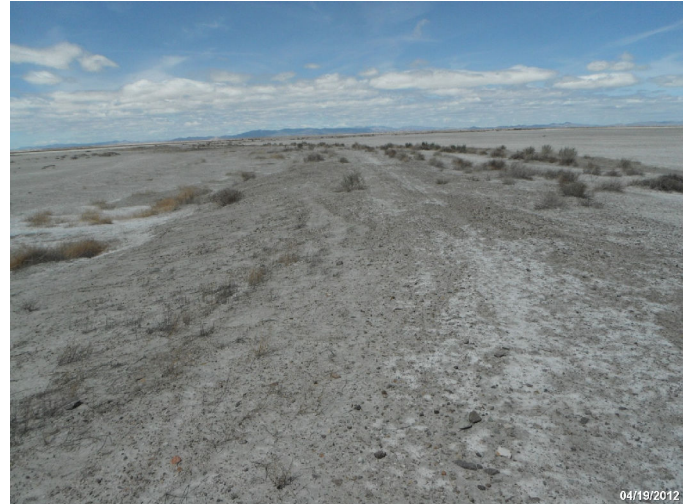
Photo: STIL_C4_1236 Route: 414-002-1.04
Problem Area Road soft and mushy

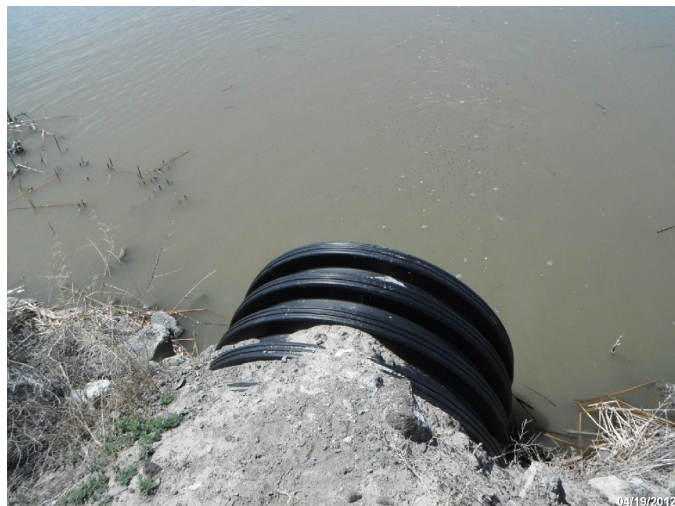
Photo: STIL_C4_1238 Route: 415-001-0.52
Plastic WCS Flashboard Riser 40ft long 48in dia. 1ft deep
Asset# NA

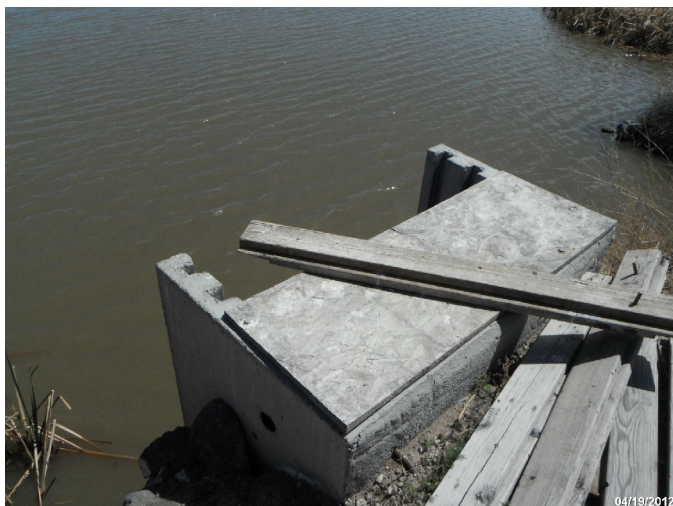
Photo: STIL_C4_1239 Route: 415-001-0.52
Plastic WCS Flashboard Riser 40ft long 48in dia. 1ft deep
Asset# NA

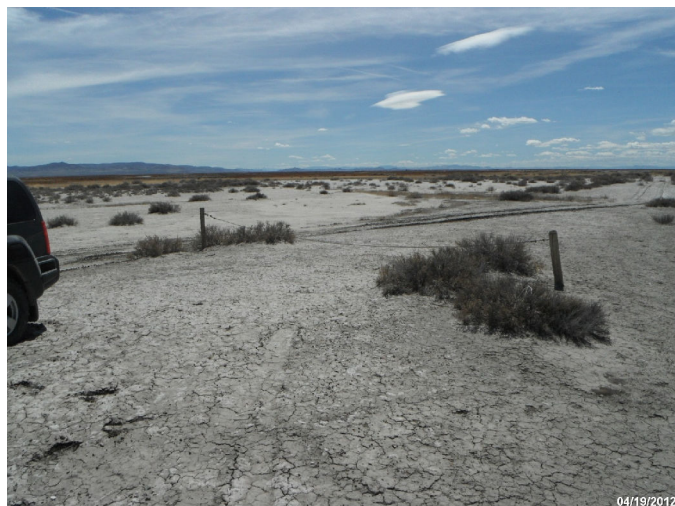
Photo: STIL_C4_1240 Route: 415-001-0.83
Metal Cable Gate
Asset# NA

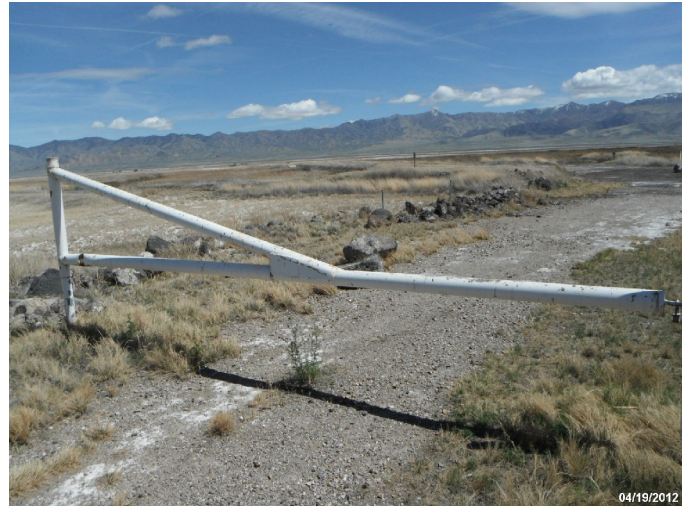
Photo: STIL_C4_1242 Route: 416-001-0.0
Metal Open Rail Gate
Asset# 10005729

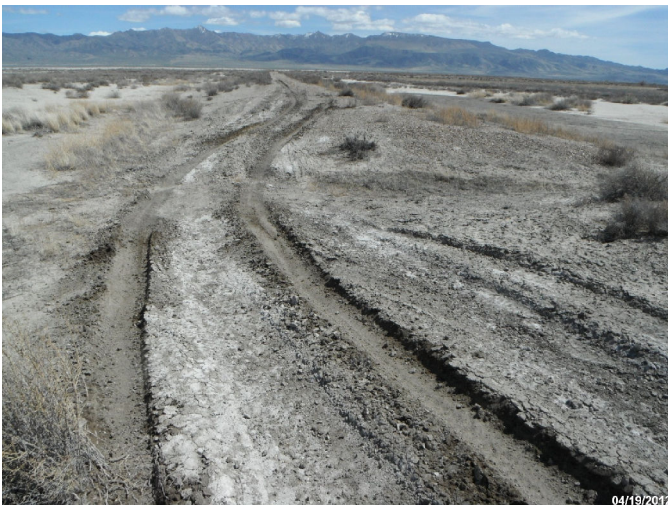
Photo: STIL_C4_1245 Route: 416-003-2.7
Problem Area Road Washed out

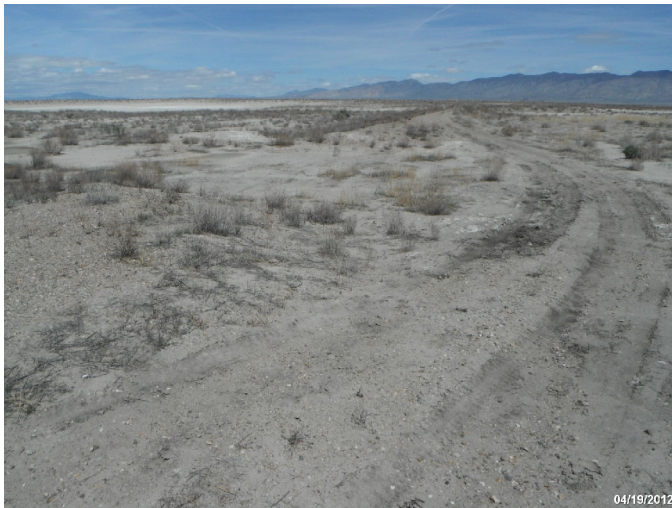
Photo: STIL_C4_1247 Route: 416-004-3.26
Problem Area Road Washed out

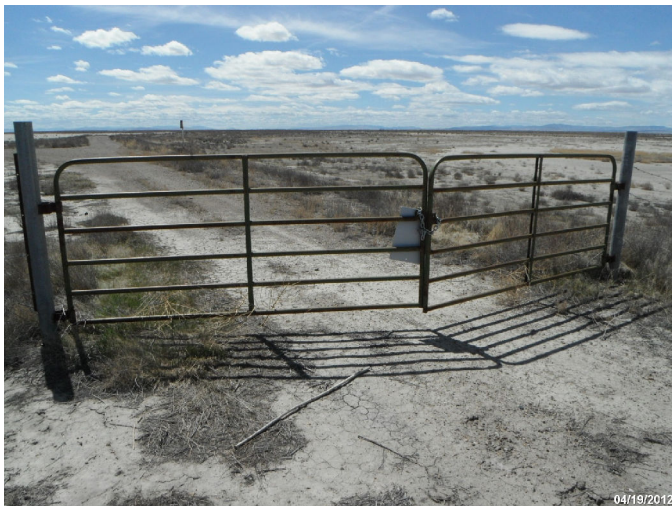
Photo: STIL_C4_1249 Route: 416-005-4.57
Metal Open Rail Gate
Asset# 10005729

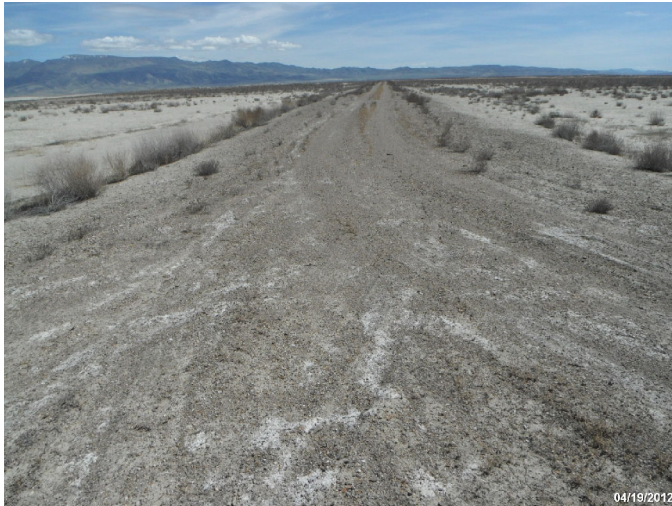
Photo: STIL_C4_1250 Route: 417-001-0.0
Begin Section

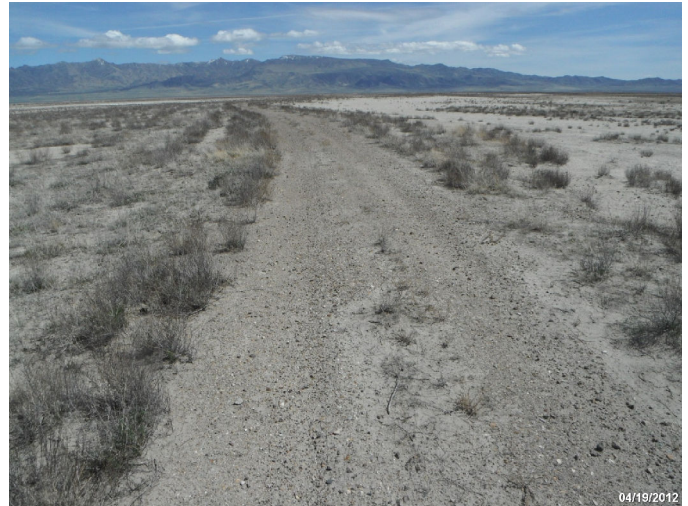
Photo: STIL_C4_1251 Route: 417-002-0.97
Begin Section

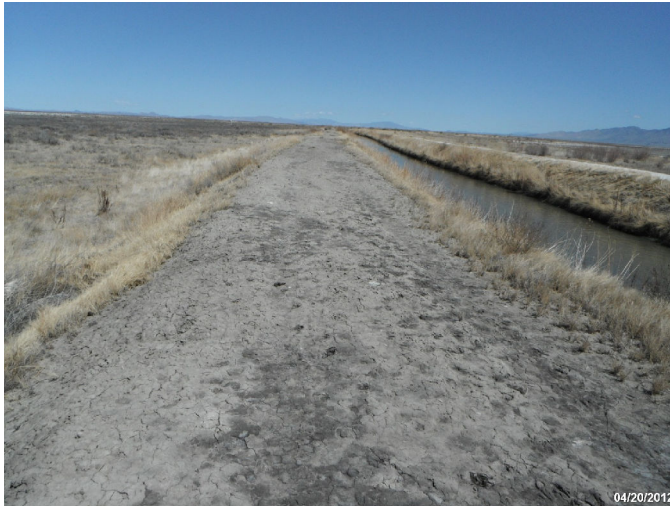
Photo: STIL_C4_1316 Route: 418-001-0.0
Begin Section

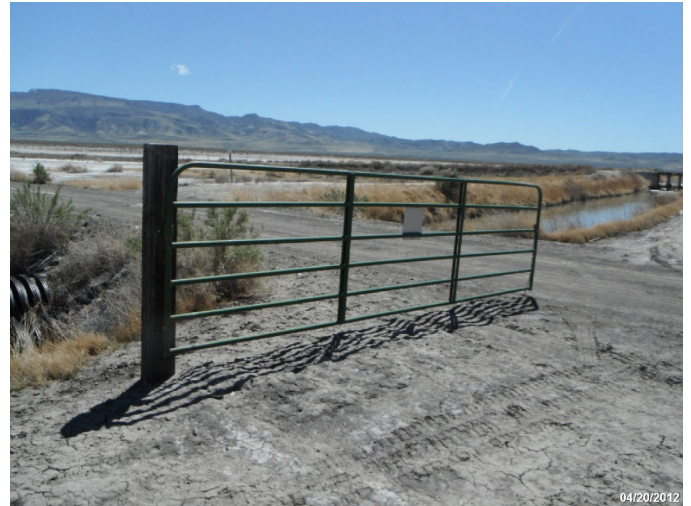
Photo: STIL_C4_1317 Route: 418-001-0.0
Metal Open Rail Gate
Asset# 10005729

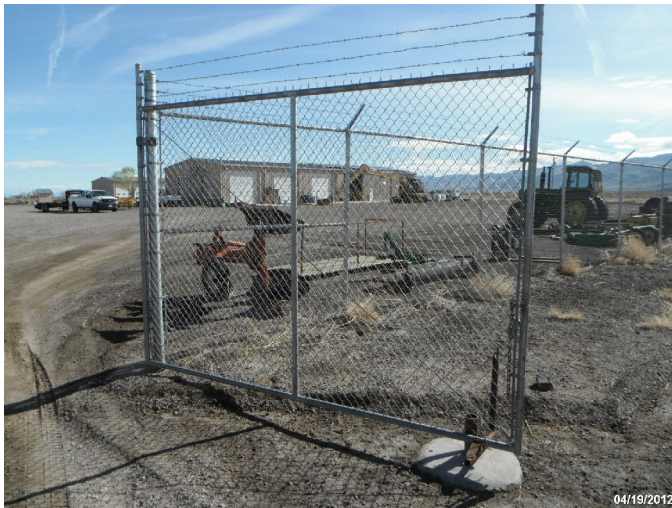
Photo: STIL_C4_1153 Route: 800
Metal Chain Link Gate
Asset# NA

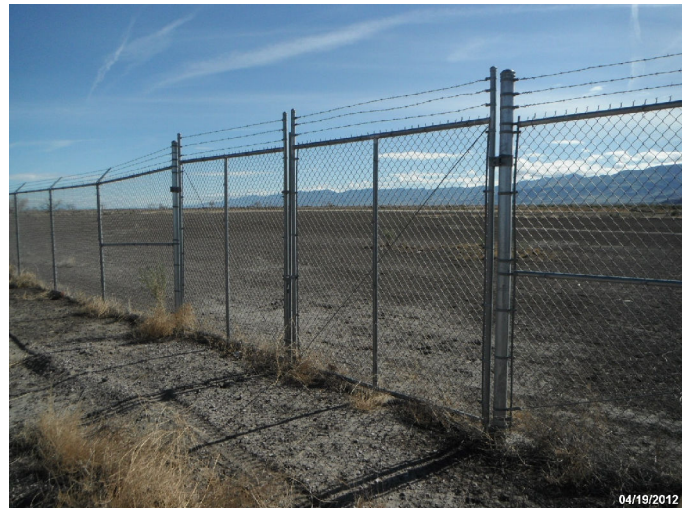
Photo: STIL_C4_1154 Route: 800
Metal Chain Link Gate
Asset# NA

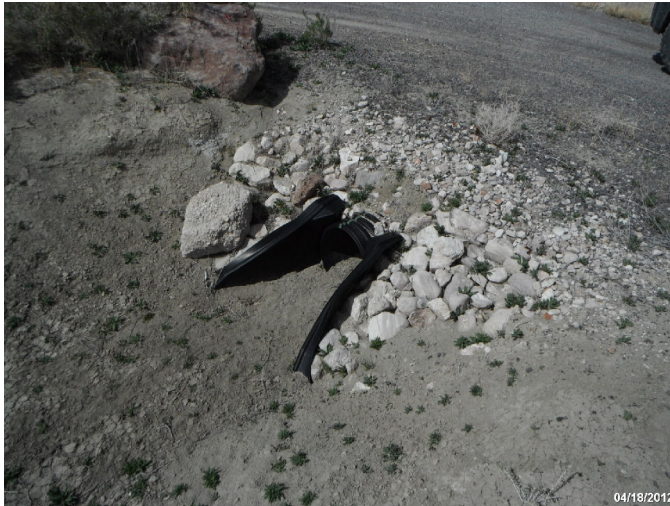
Photo: STIL_C4_1130 Route: 943
Plastic Culvert 30ft long 18in dia. 1ft deep
Asset# 10036681

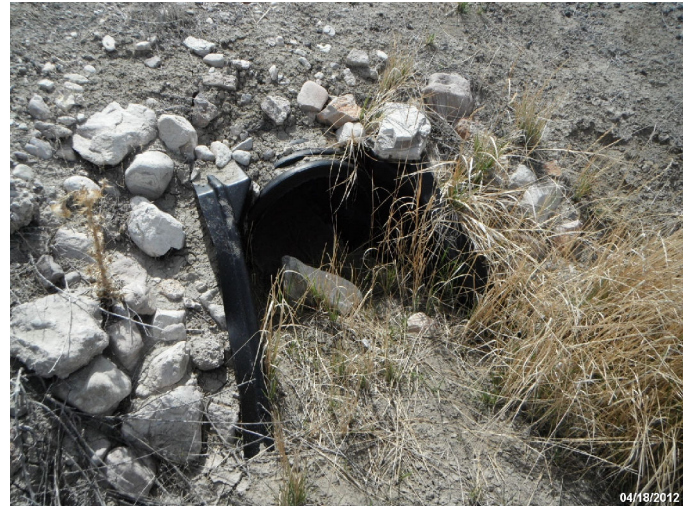
Photo: STIL_C4_1131 Route: 943
Plastic Culvert 30ft long 18in dia. 1ft deep
Asset# 10036681

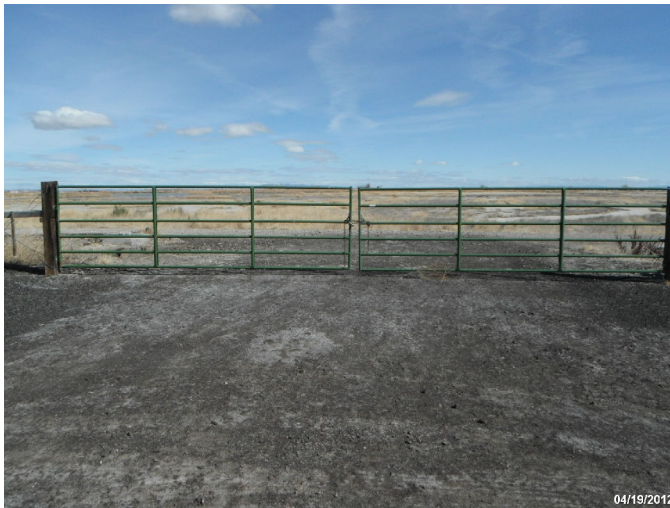
Photo: STIL_C4_1163 Route: 949
Metal Open Rail Gate
Asset# 10005729

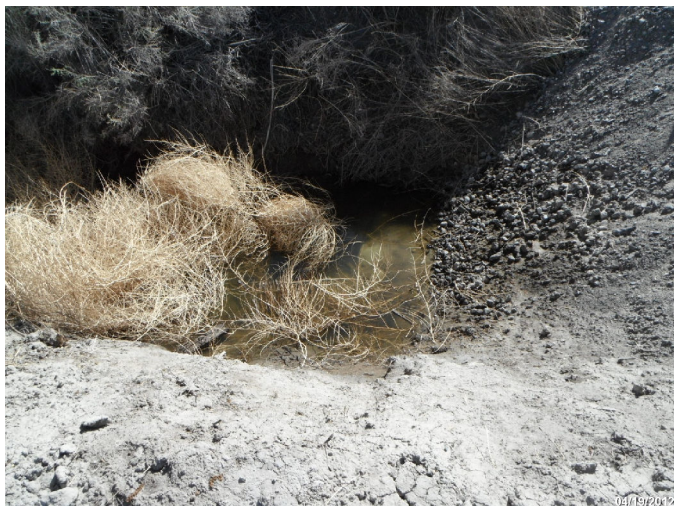
Photo: STIL_C4_1166 Route: 950
Metal Culvert 60ft long 24in dia. 9ft deep
Asset# NA

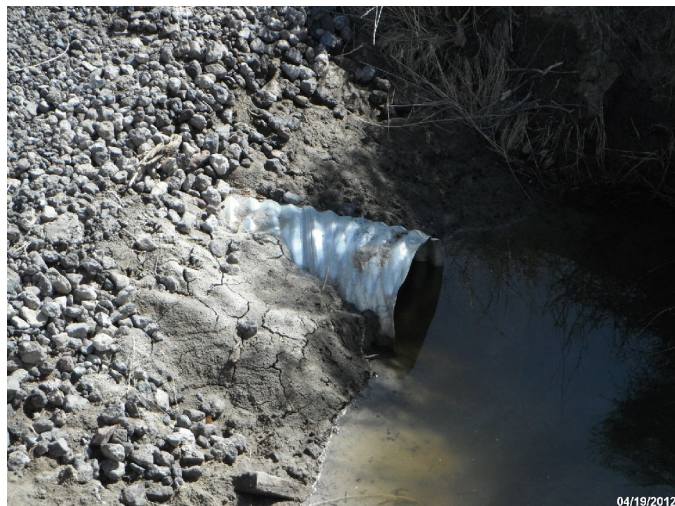
Photo: STIL_C4_1167 Route: 950
Metal Culvert 60ft long 24in dia. 9ft deep
Asset# NA

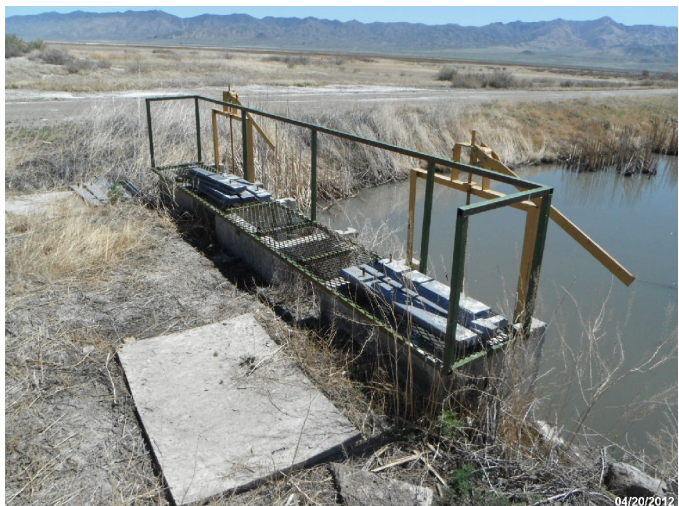
Photo: STIL_C4_1311 Route: 951
Plastic WCS Flap Gate/Full-Round Riser
40ft long 24in dia. 3ft deep Asset# NA

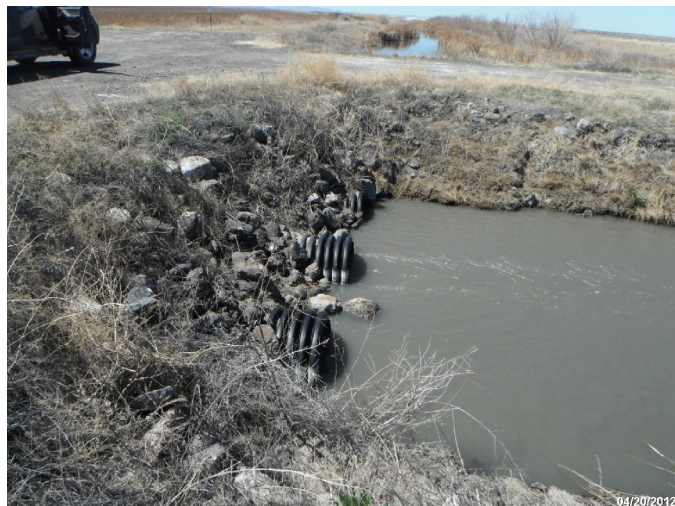
Photo: STIL_C4_1312 Route: 951
Plastic WCS Flap Gate/Full-Round Riser
40ft long 24in dia. 3ft deep Asset# NA
