LACREEK WILDLIFE REFUGE

NARRATIVE REPORT

Lacreek Migratory Waterfowl Refuge

November-December-January

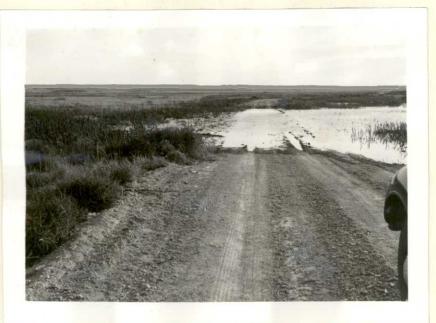
Water flowing over clay spillway in Dike 5.

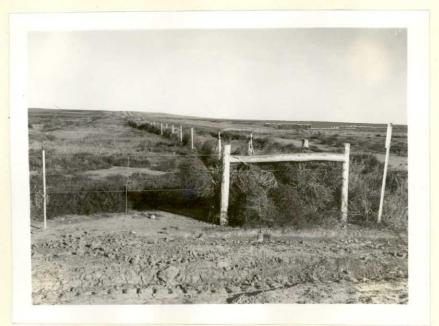
We cleared approximately 15 miles of thistle covered fence lines.

It was necessary to clean about 15 miles of fence of Russian thistle. Many miles of this distance were packed solid with the "tumblers" and it was necessary that we remove it before a snow removed the fence.

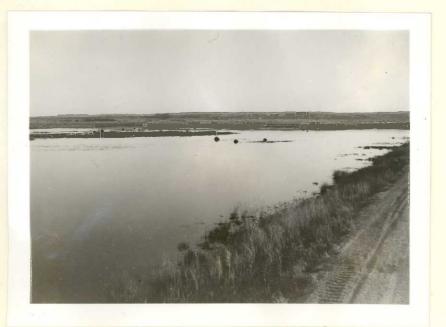
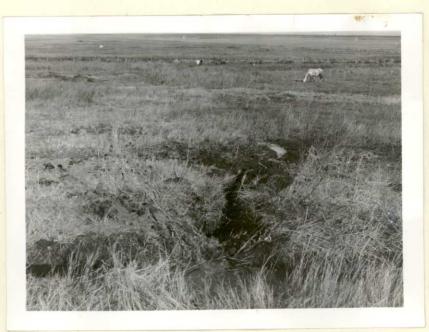
This muskrat burrow was traced down to the Refuge boundary fence and probably extended up to the knob from which the lower picture was taken.

A few muskrat burrows were located in the dikes and filled with earth and clay.

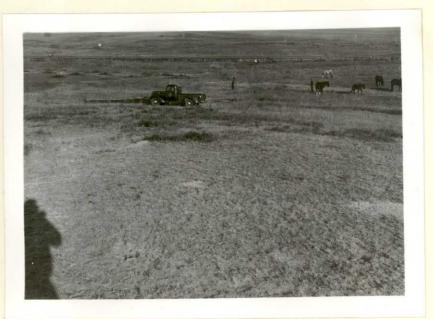
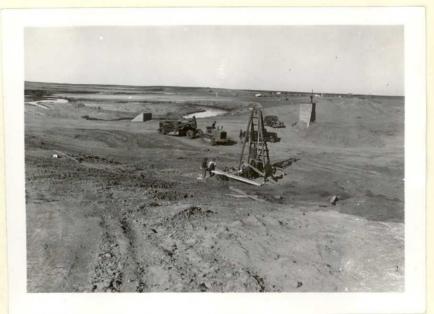
Preparing to drive the last few feet of piling across the old channel on the Little White River project and transplanting shrubs in the Recreational Area.

All dike work on Little White River has been completed with the exception of approximately 10000 cubic yards of fill around the control structure in Dike B, and the clay capping of Dikes B and C.

About 3000 trees and shrubs have been transplanted on the area and nearly tem acres of diseased or umusable brush cleared from the basin of the pool.

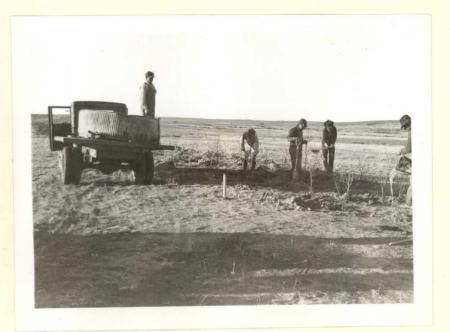
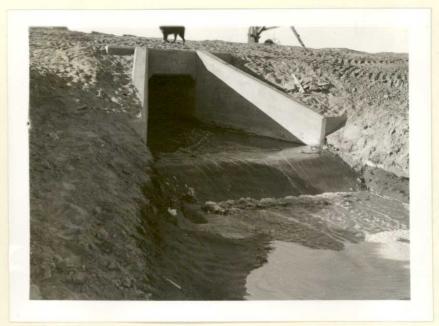
The control structure on Little White River.

Approximately 15000 cubic yards of dirt was moved during the period and about 75 cubic yards of concrete was poured, to complete the concrete work, and nearly finish the dirt work as stated above.
