The Road Inventory of Halfbreed Lake National Wildlife Refuge Lewistown, Montana

Prepared By:
Federal Highway Administration
Central Federal Lands Highway Division
August 2008

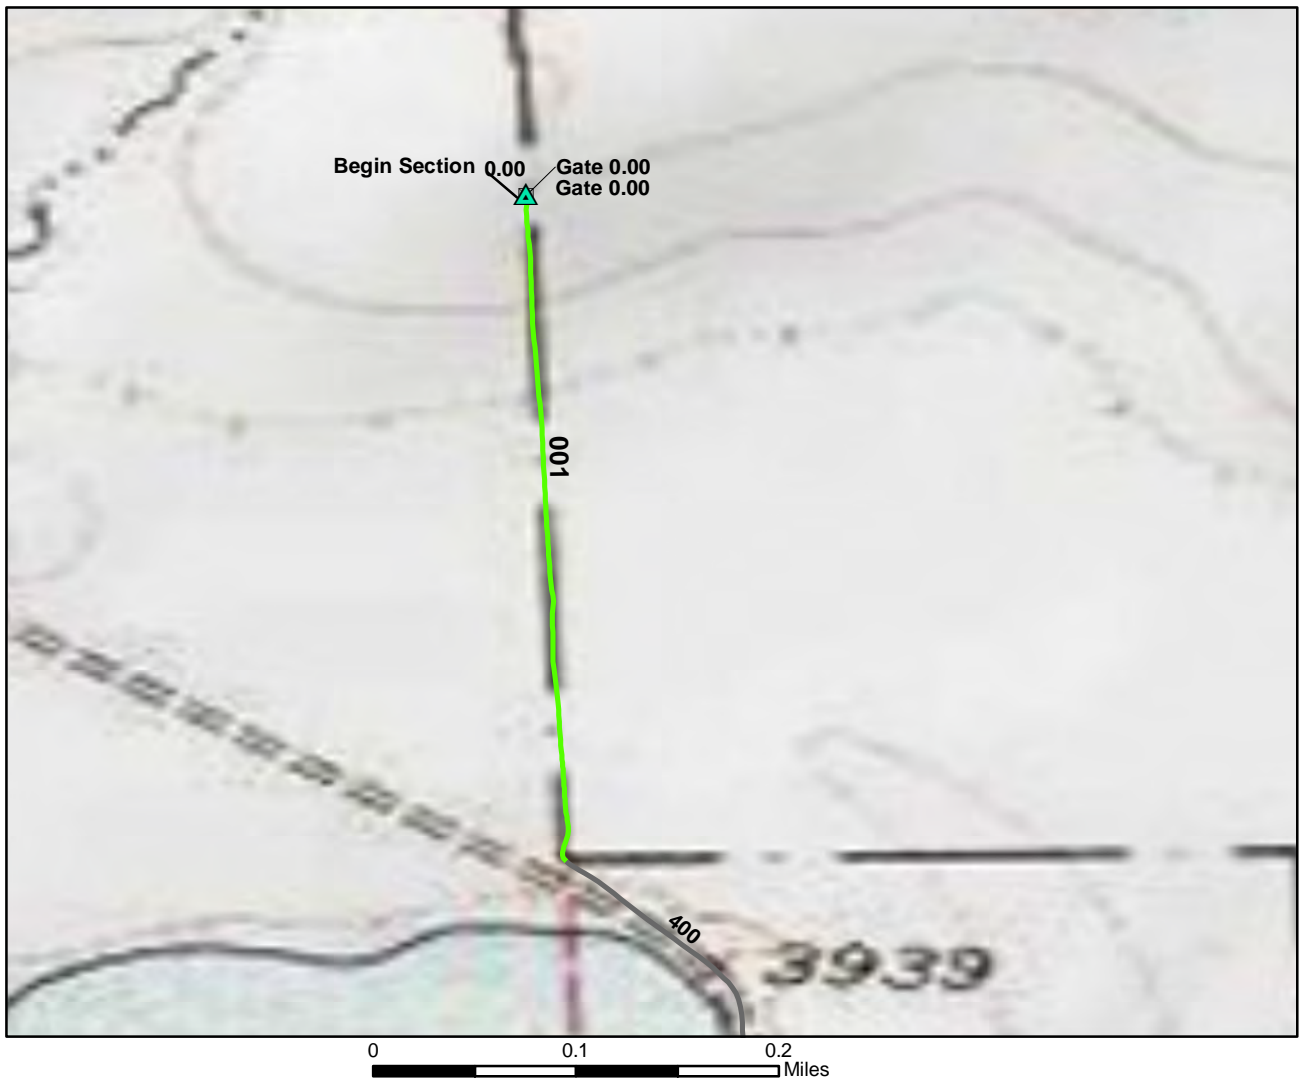
ROUTE: 100 Halfbreed Lake Public Access Road TOTAL LENGTH: 0.33 Miles

RTE DESCRIPTION: From refuge boundary, 1/4 mile south of Molt-Rapelje Road,
to Halfbreed Lake Administrative Access Road (Route 402)

Section Number	001				
Section Length (miles)	0.33				
Inspection Date	8/7/2008				
Section Information					
Surface Type	Native				
Number of Lanes	1				
Roadway Width (feet)	8				
Roadway Condition Information					
Condition	Good				
Remaining Service Life (years)	7				
Cost Estimate	\$600				
CRV	\$120200

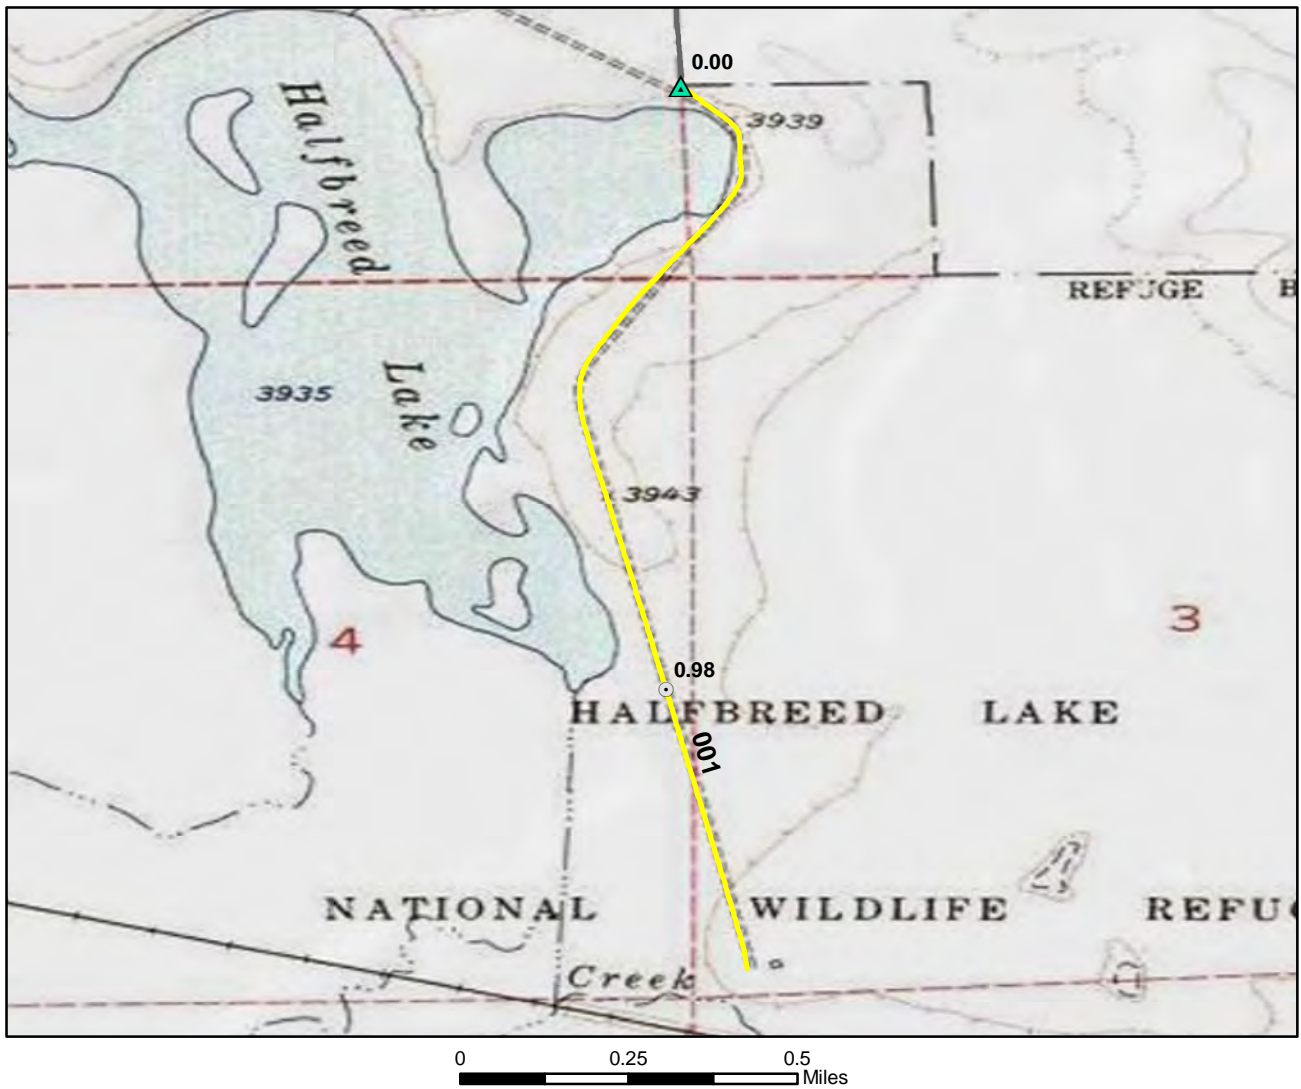
ROUTE: 400 Halfbreed Lake Administrative Access Road TOTAL LENGTH: 1.39 Miles

RTE DESCRIPTION: From Halfbreed Lake North Access Road (Route 100) to end of route at railroad grade

Section Number	001				
Section Length (miles)	1.39				
Inspection Date	8/7/2008				
Section Information					
Surface Type	Native				
Number of Lanes	1				
Roadway Width (feet)	8				
Roadway Condition Information					
Condition	Fair				
Remaining Service Life (years)	4				
Cost Estimate	\$3100				
CRV	\$507300
