The Road Inventory of Northwest Montana Flathead Waterfowl Production Area Moiese, MT

Prepared By:
Federal Highway Administration
Central Federal Lands Highway Division
August 2008

Northwest Montana Wetland Management District - Flathead County

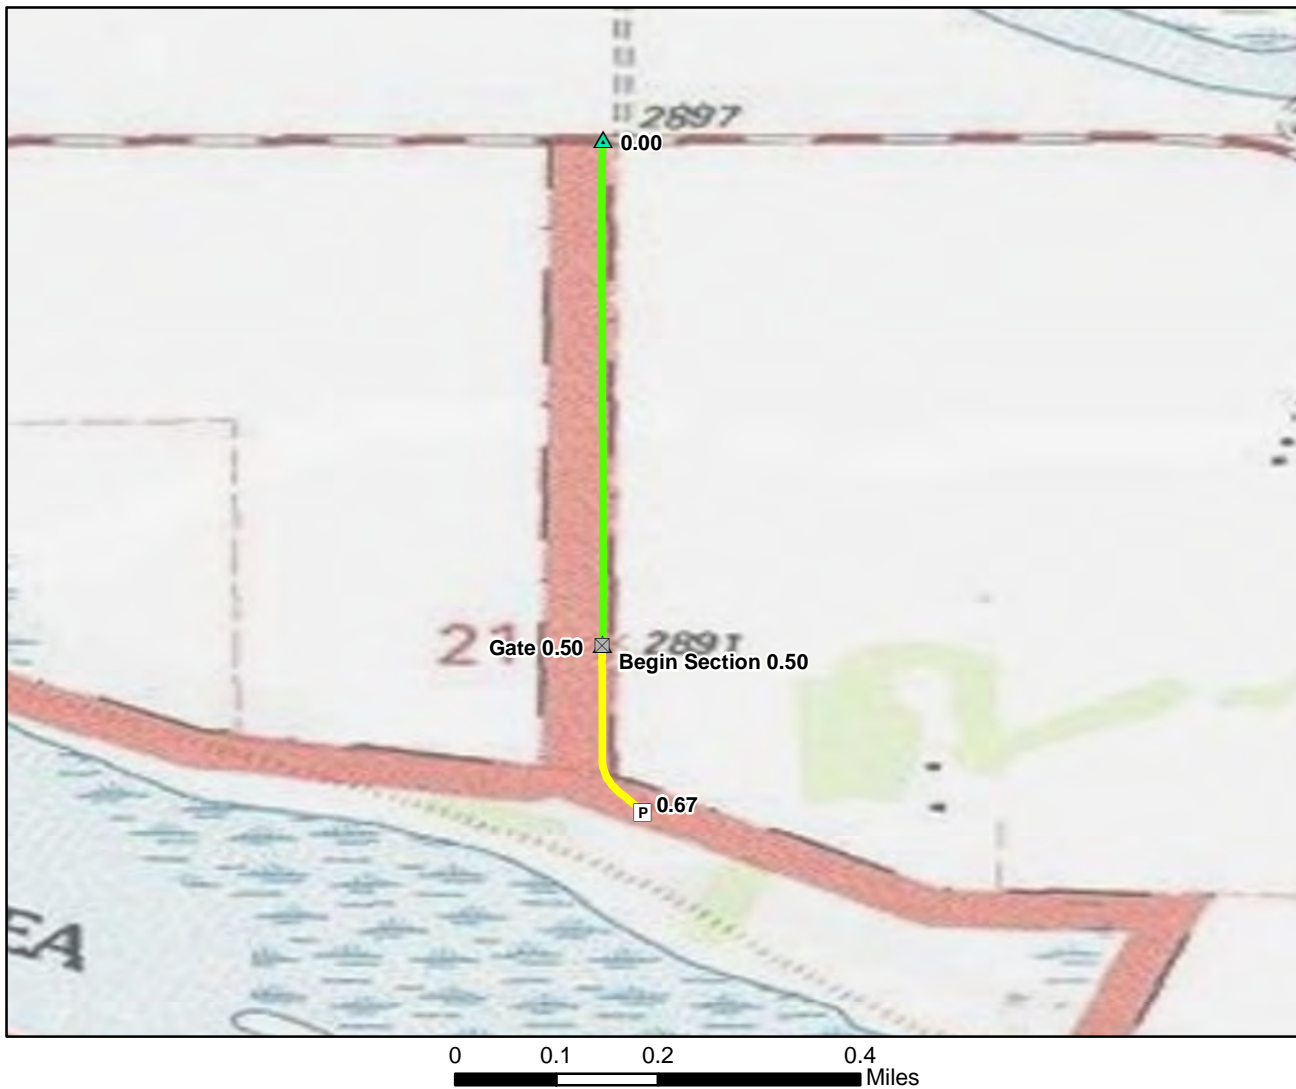
ROUTE: 105 Highway 82 Access Road TOTAL LENGTH: 0.67 Miles

Section Number	001	002			
Section Length (miles)	0.50	0.17			
Inspection Date	8/23/2008	8/23/2008			
Section Information					
Surface Type	Gravel	Gravel			
Number of Lanes	1	1			
Roadway Width (feet)	14	10			
Roadway Condition Information					
Condition	Good	Fair			
Remaining Service Life (years)	7	4			
Cost Estimate	\$800	\$600			
CRV	\$335100	\$116300

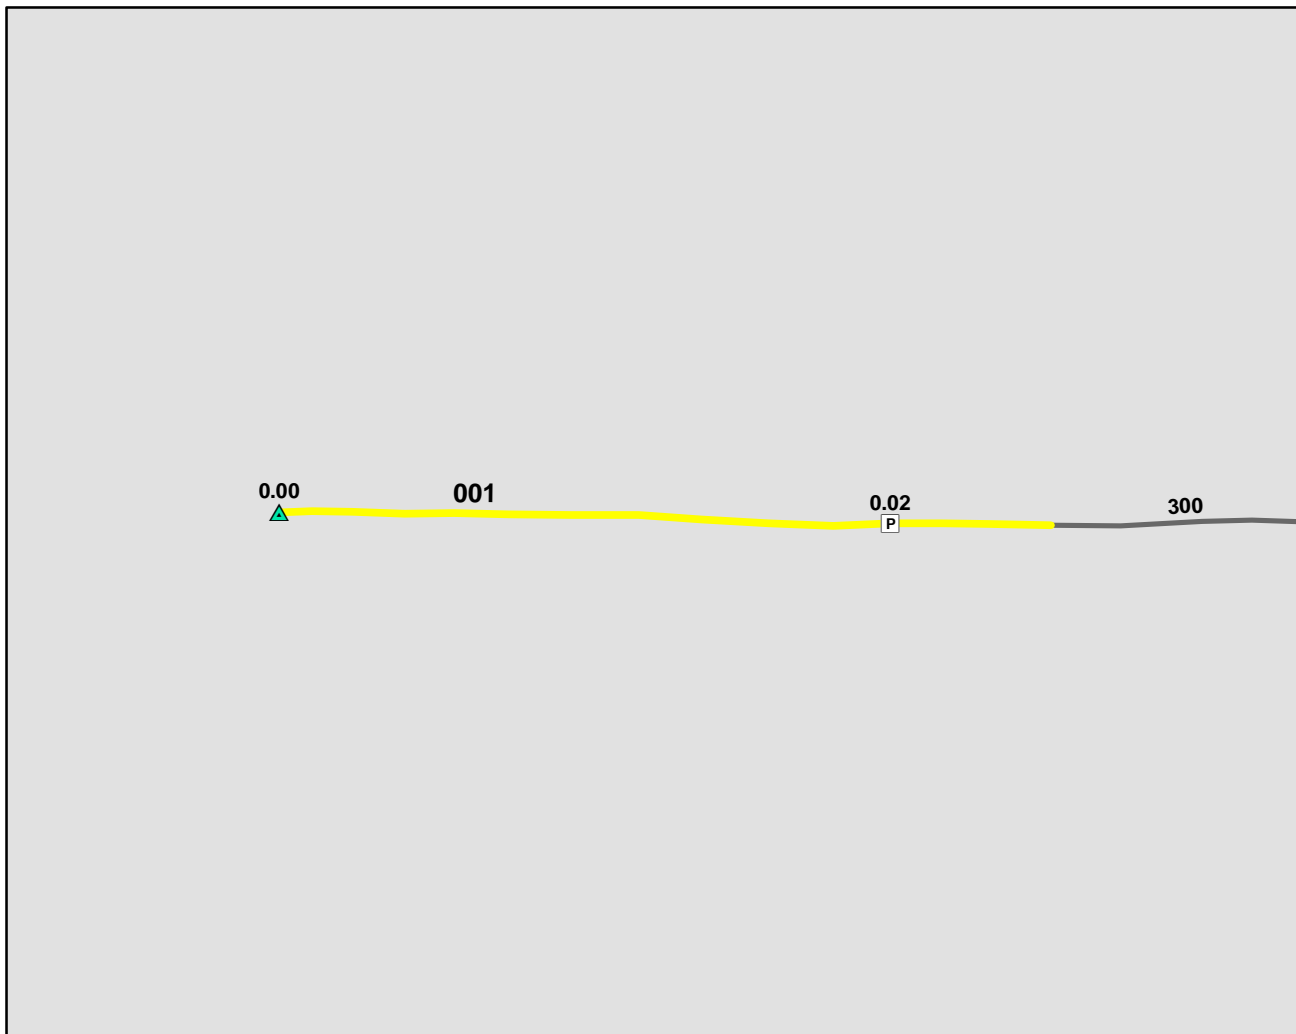
ROUTE: 108 West Blasdel Barn Parking Road TOTAL LENGTH: 0.02 Miles

Section Number	001				
Section Length (miles)	0.02				
Inspection Date	8/23/2008				
Section Information					
Surface Type	Native				
Number of Lanes	1				
Roadway Width (feet)	10				
Roadway Condition Information					
Condition	Fair				
Remaining Service Life (years)	4				
Cost Estimate	\$600				
CRV	\$7400

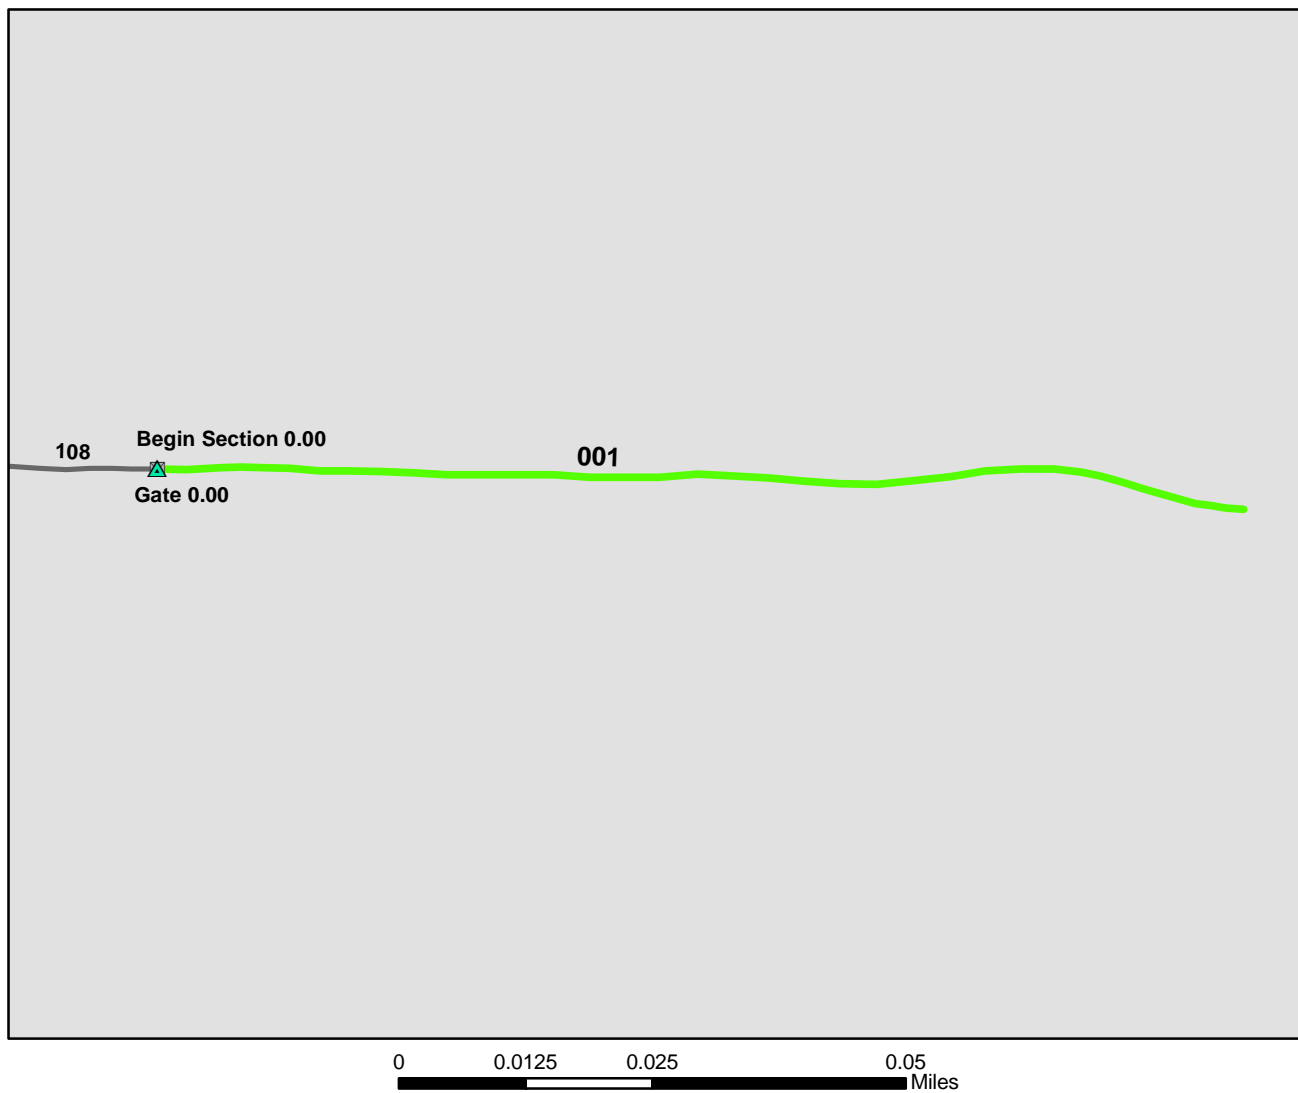
ROUTE: 300 West Blasdel Barn Service Access Road TOTAL LENGTH: 0.07 Miles

Section Number	001				
Section Length (miles)	0.07				
Inspection Date	8/23/2008				
Section Information					
Surface Type	Native				
Number of Lanes	1				
Roadway Width (feet)	10				
Roadway Condition Information					
Condition	Good				
Remaining Service Life (years)	7				
Cost Estimate	\$100				
CRV	\$25300
