The Road Inventory of Swan River National Wildlife Refuge Kalispell, MT

Prepared By: Federal Highway Administration Central Federal Lands Highway Division August 2008

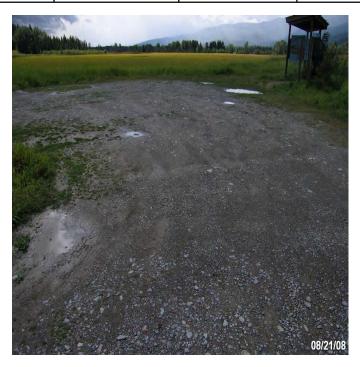
Route 901: Visitor Parking

Asset Number	Date Visited	Surface Type	Area (sq ft)	Condition	Cost to Improve
10043942	8/21/2008	Gravel	2520	Good	400
