The Road Inventory of Seal Beach National Wildlife Refuge Seal Beach, CA

Prepared By:
Federal Highway Administration
Central Federal Lands Highway Division
April 2012

Seal Beach - 81683

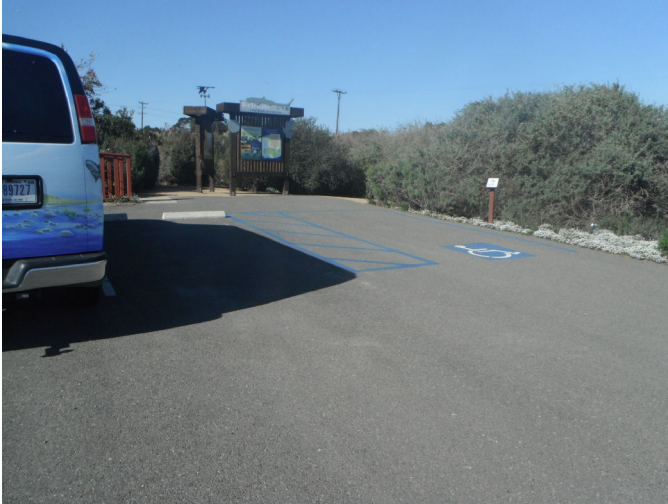
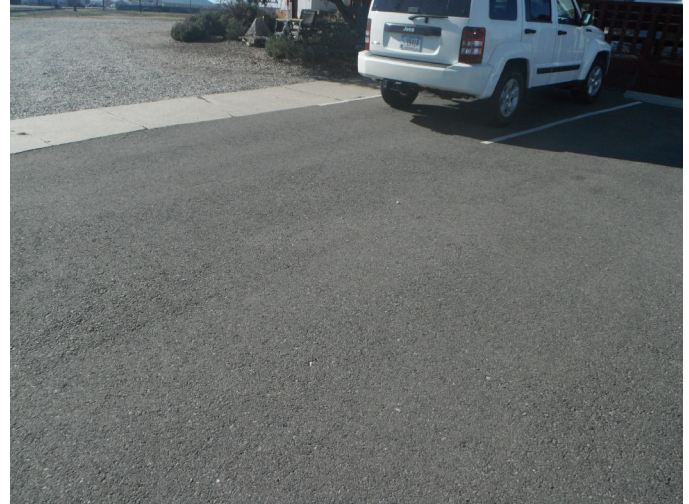
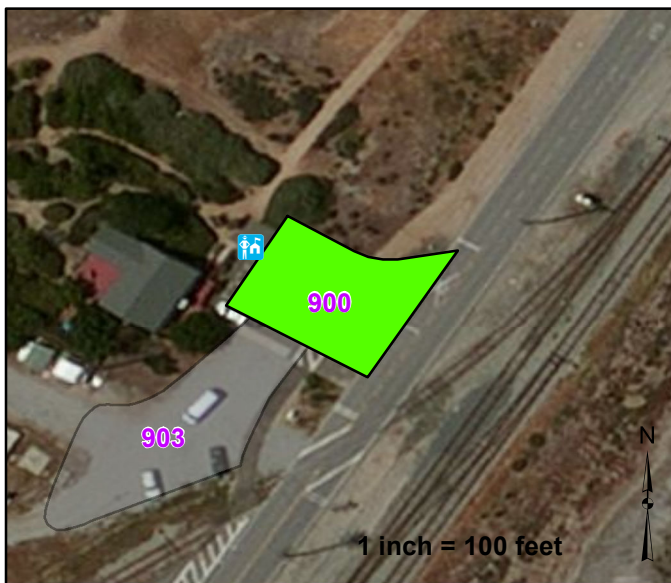
Route Number:900
Headquarters / Visitors Center Parking
From Kitts Highway

Asset Number	Area	Condition	Surface Type	Cost to Improve	Inspection Date	Current Replacement Value
10001626	4153	Good	Asphalt	\$900	12-05-2011	\$44,800

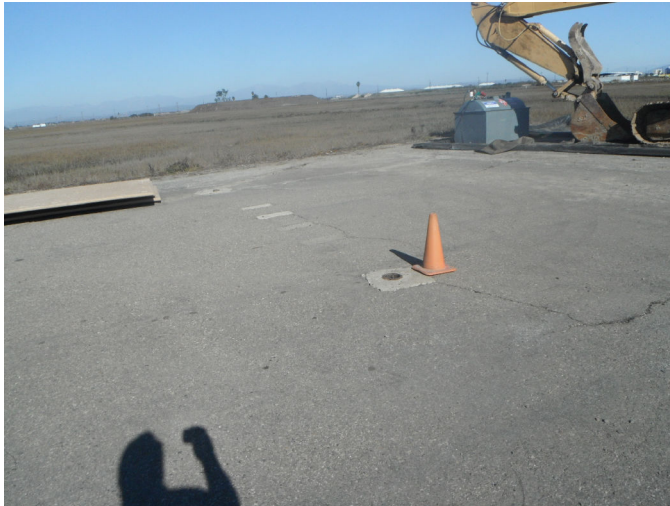
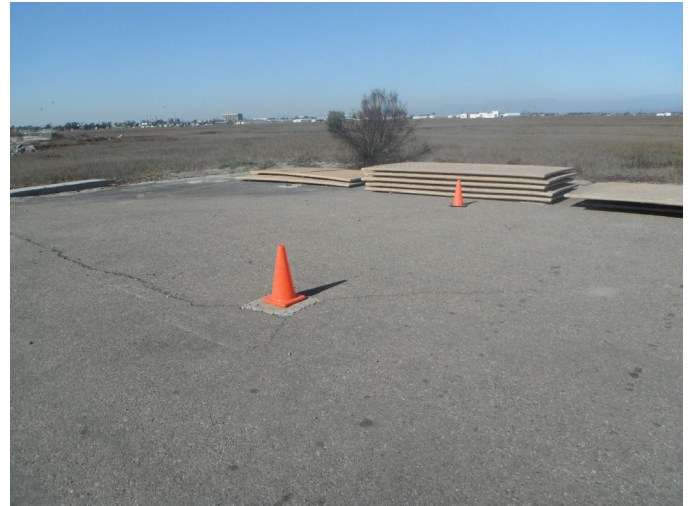
Route Number:901
NASA Island Parking Area
From NASA Road

Asset Number	Area	Condition	Surface Type	Cost to Improve	Inspection Date	Current Replacement Value
-	5141	Fair	Asphalt	\$5,200	12-05-2011	\$55,500

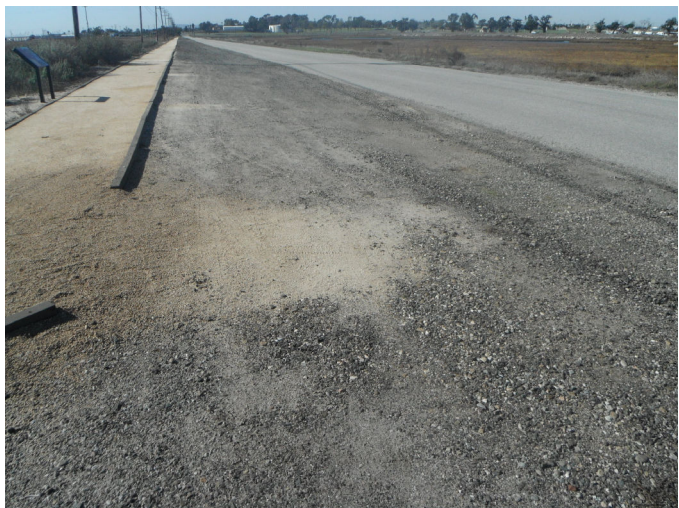
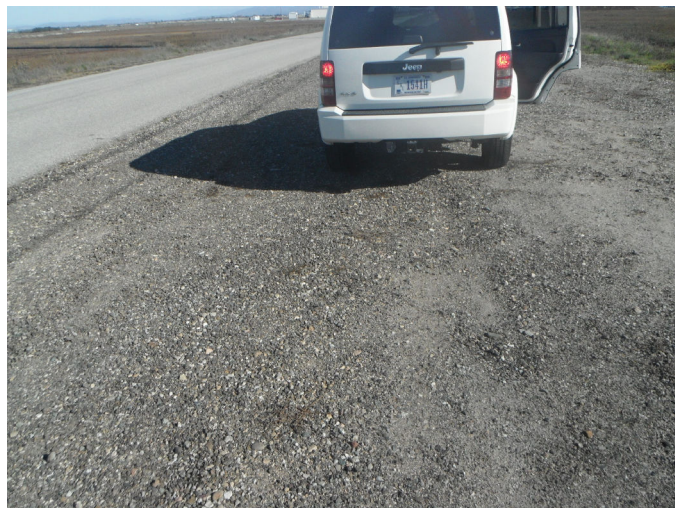
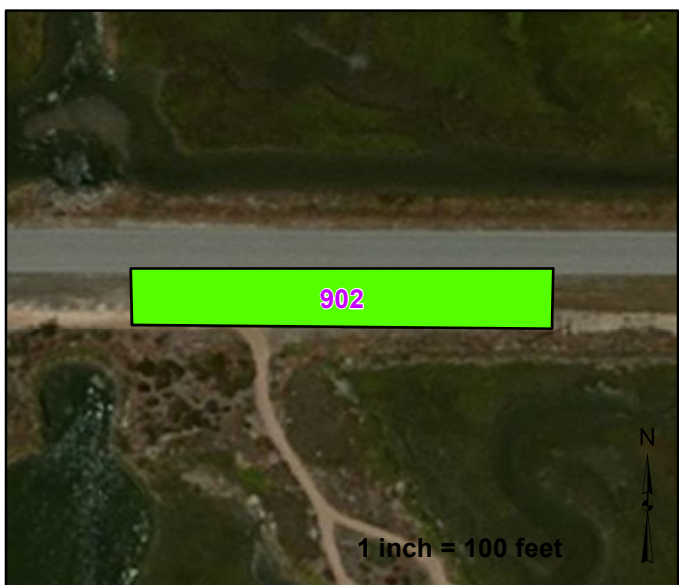
Route Number:902
Observation Deck Parking Pullout
From Bolsa Ave

Asset Number	Area	Condition	Surface Type	Cost to Improve	Inspection Date	Current Replacement Value
-	5535	Good	Gravel	\$1,000	12-05-2011	\$32,600

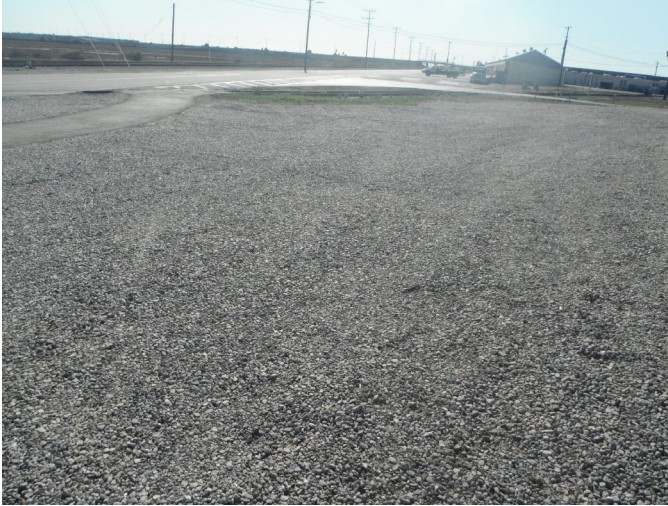
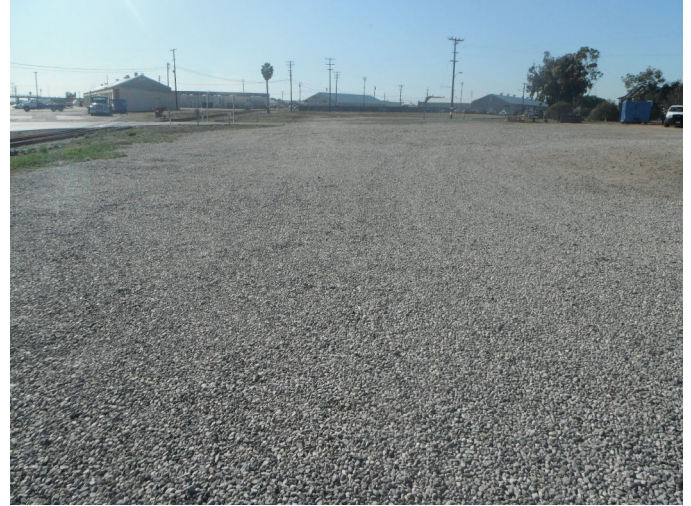
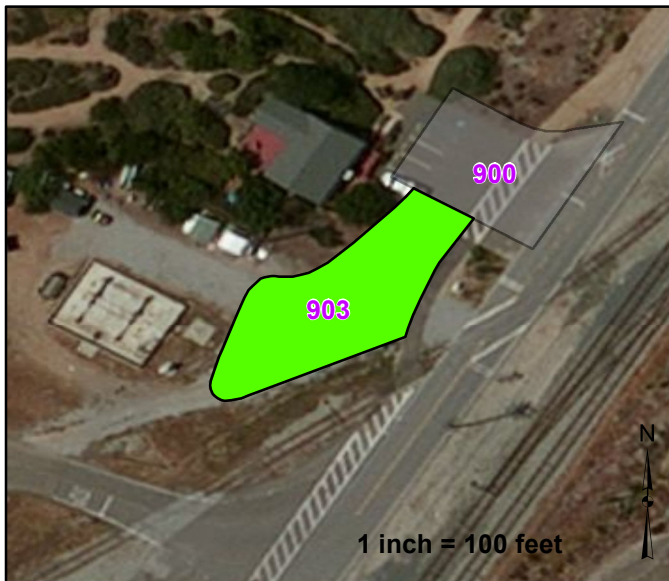
From Kitts Highway

Asset Number	Area	Condition	Surface Type	Cost to Improve	Inspection Date	Current Replacement Value
-	5555	Good	Gravel	\$1,000	12-05-2011	\$32,700

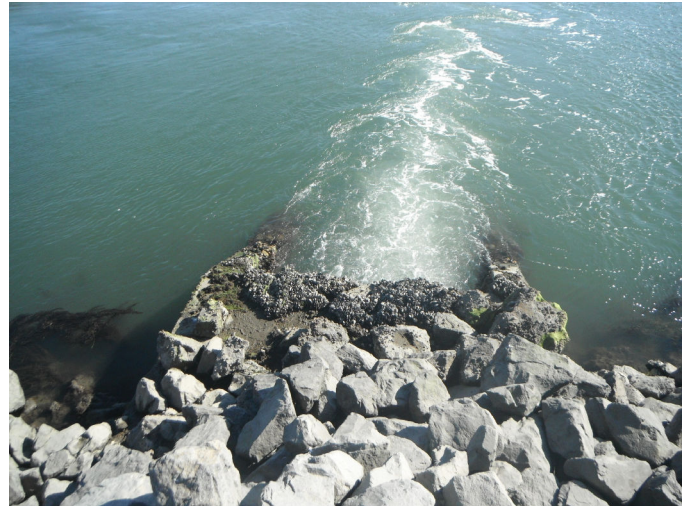
Photo: SEBE_C4_0137 Route: 403-001-0.08
Concrete Culvert Box 80ft long 5ft x 8ft 8ft deep
Asset# 10048245

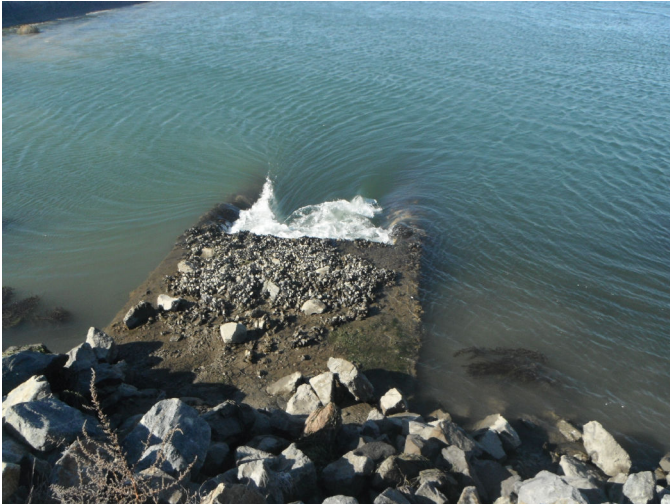
Photo: SEBE_C4_0138 Route: 403-001-0.08
Concrete Culvert Box 80ft long 5ft x 8ft 8ft deep
Asset# 10048245

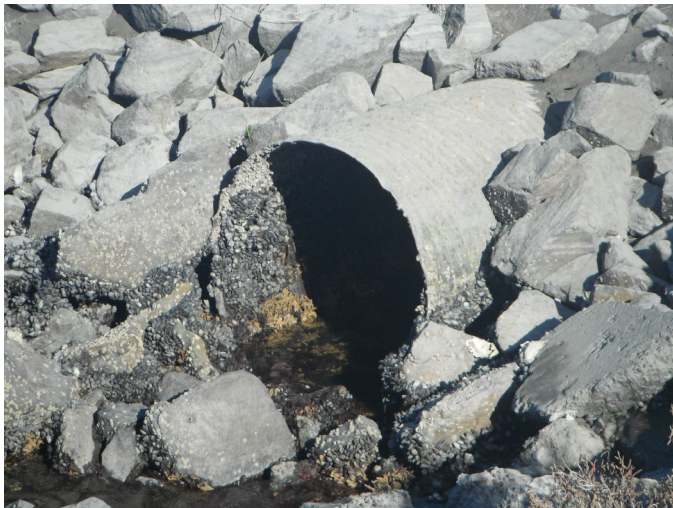
Photo: SEBE_C4_0140 Route: 406-001-0.0
Metal Culvert 61ft long 48in dia. 7ft deep
Asset# 10048167

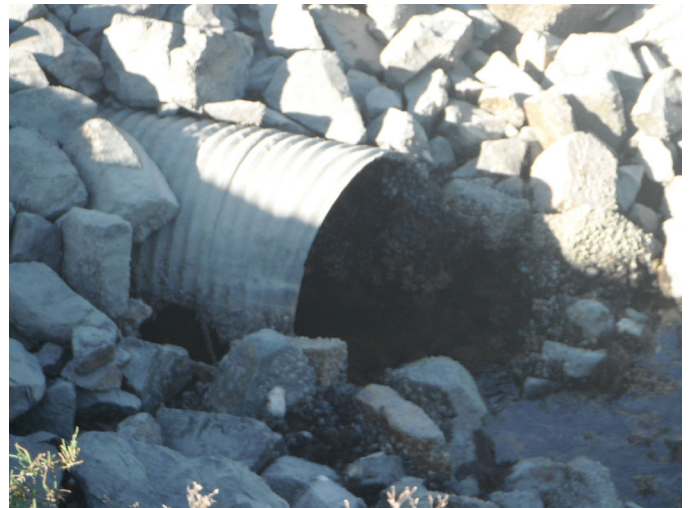
Photo: SEBE_C4_0141 Route: 406-001-0.0
Metal Culvert 61ft long 48in dia. 7ft deep
Asset# 10048167
