The Road Inventory of Cahaba River National Wildlife Refuge Fort McClellan, AL

Prepared By: Federal Highway Administration Central Federal Lands Highway Division August, 2011

Cahaba River National Wildlife Refuge - 43665

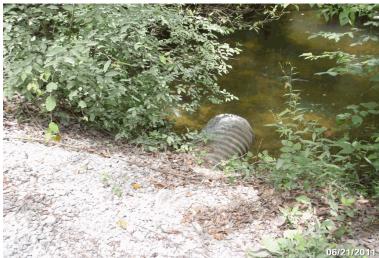
Photo # CARI_C4_0021 - MP 0.08 - Round Culvert Section 001 ROUTE NUMBER: 100 ROUTE NAME: River Road A

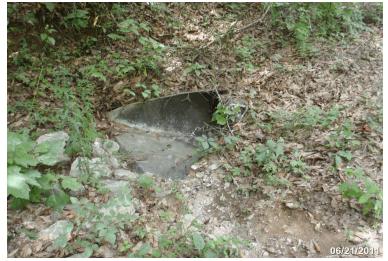
Photo # CARI_C4_0023 - MP 0.25 - Round Culvert Section 001

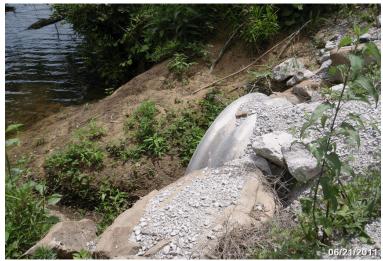
Photo # CARI_C4_0026 - MP 0.02 - Round Culvert Section 001 ROUTE NUMBER: 102 ROUTE NAME: North Road

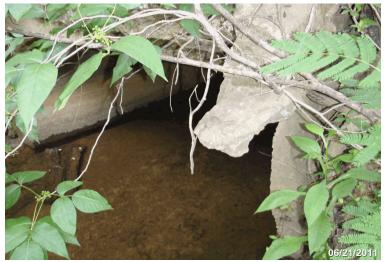
Photo # CARI_C4_0029 - MP 0.11 - Box Culvert Section 001 ROUTE NUMBER: 103 ROUTE NAME: Fullman Road

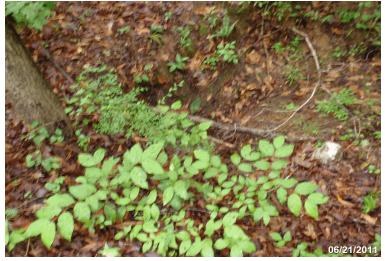
Photo # CARI_C4_0053 - MP 0.77 - Round Culvert Section 001
