The Road Inventory of Humboldt Bay National Wildlife Refuge Loleta, CA

Prepared By:
Federal Highway Administration
Central Federal Lands Highway Division
April 2012

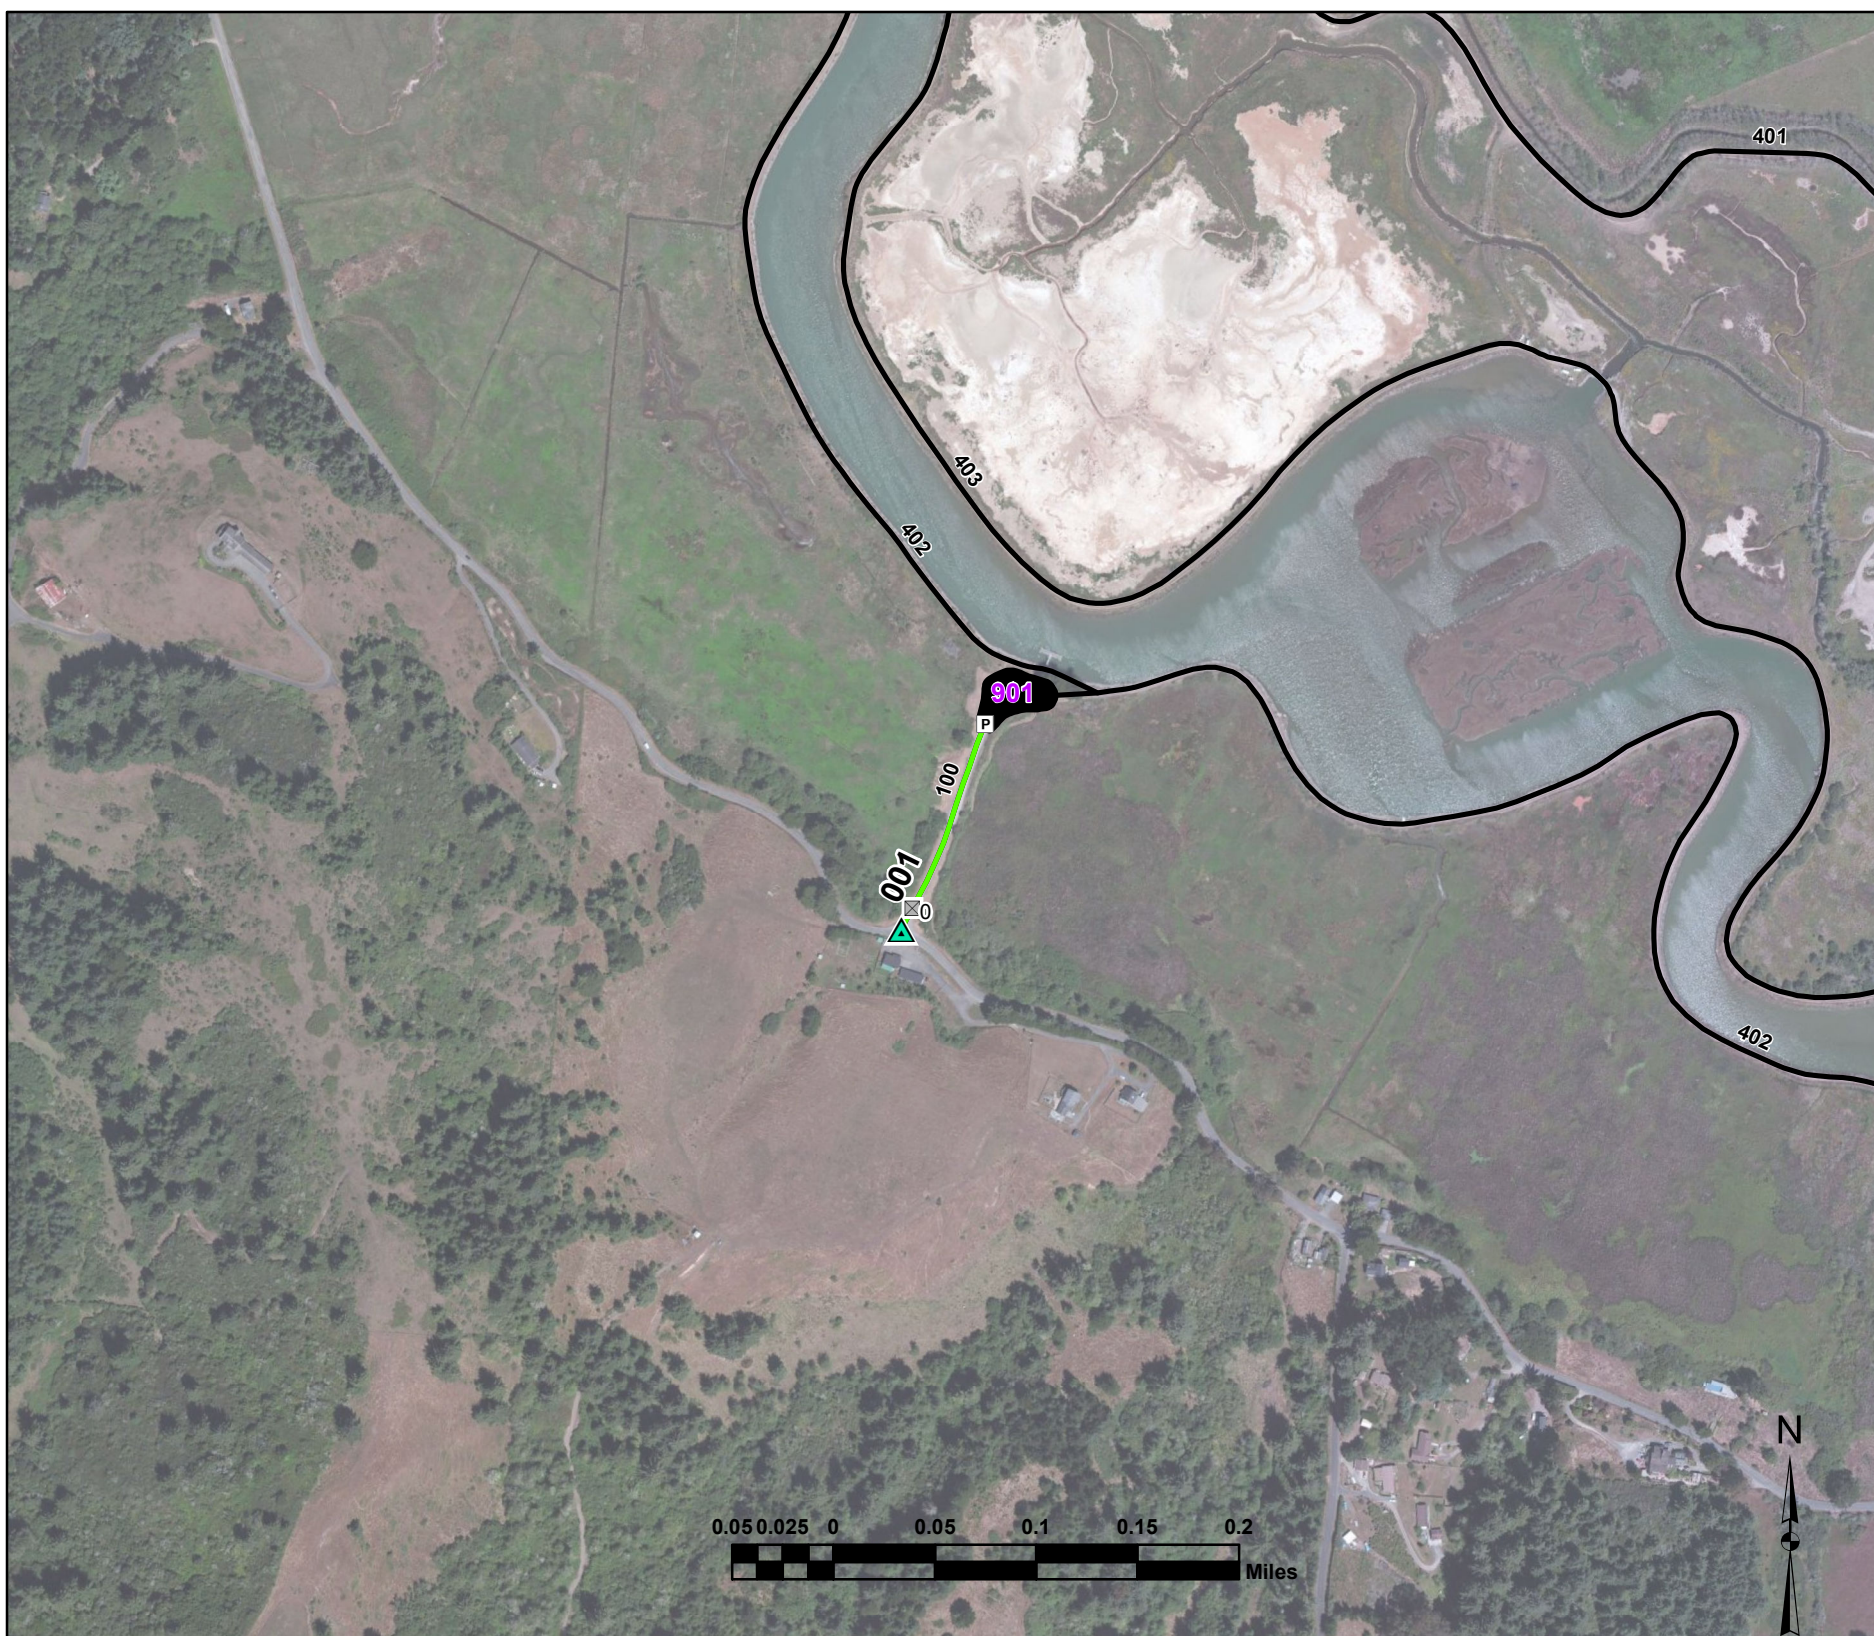
Refuge Headquarters Entrance Road

Asset Number	10000116	10000116			
Section Number	001	002			
Section Length (miles)	0.62	0.68			
Inspection Date	02-27-2012	02-27-2012			
Surface Type	Asphalt	Asphalt			
Number of Lanes	2	2			
Roadway Width (feet)	22	22			
Condition	Fair	Fair			
Remaining Service Life (years)	8	10			
Estimated Cost to Repair	\$81,200	\$89,100			
Current Replacement Value	\$899,500	\$986,500

Features	Mile Post	Features	Mile Post	Features	Mile Post	Features	Mile Post
Begin Section	001-0.0						
Turnout/Parking	001-0.05						
Gate	001-0.62						
Begin Section	002-0.62						
Culvert	002-0.63						
Gate	002-0.63						
Turnout/Parking	002-0.63						
Water Control Structure	002-1.08						
Turnout/Parking	002-1.31

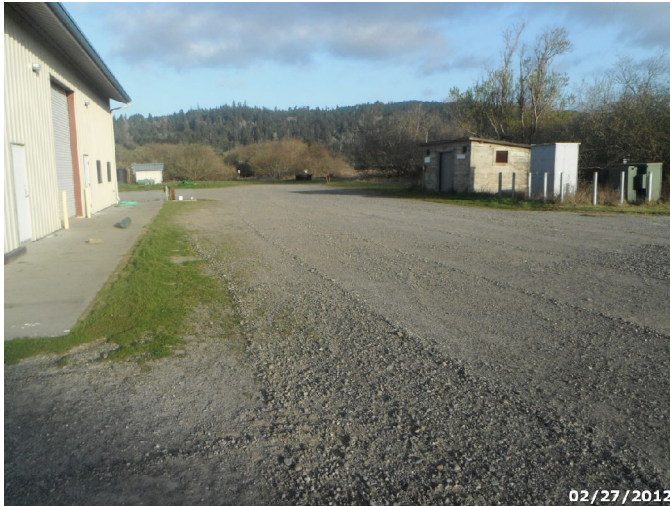
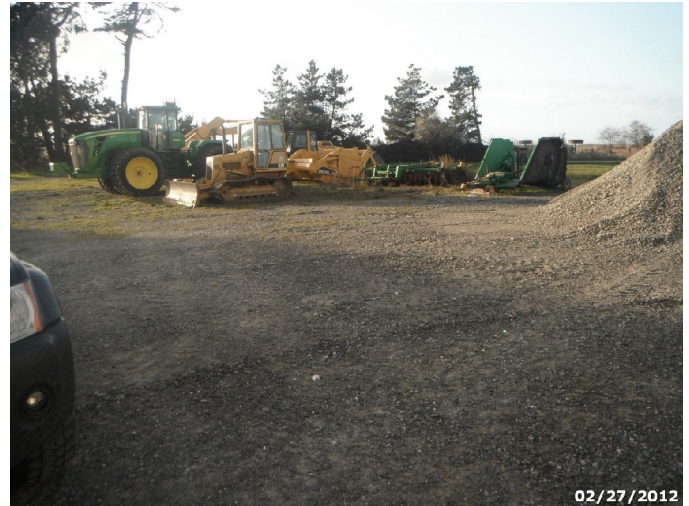
Route Number:800

Asset Number	Area	Condition	Surface Type	Cost to Improve	Inspection Date	Current Replacement Value
-	27908	Good	Gravel	\$5,100	02-27-2012	\$167,500

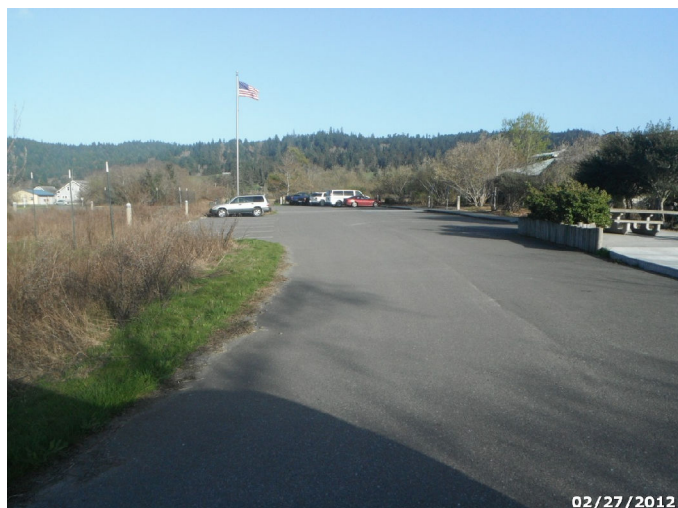
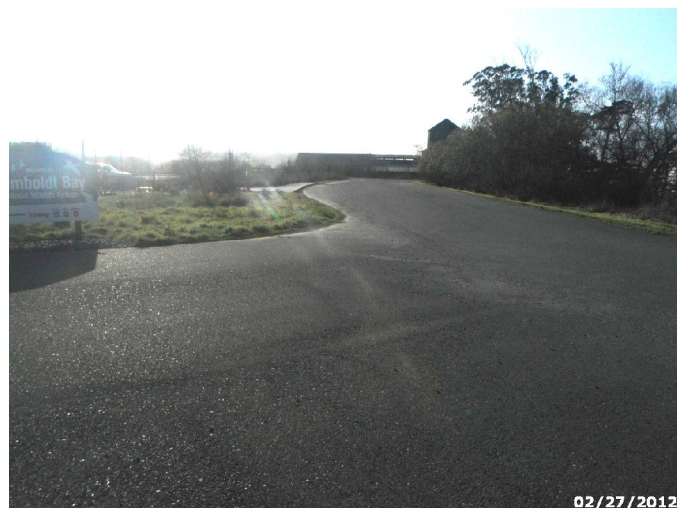
Route Number:900
Headquarters Visitor Center Parking
 From Refuge Headquarters Entrance Road (Route 010)

Asset Number	Area	Condition	Surface Type	Cost to Improve	Inspection Date	Current Replacement Value
10044445	28529	Good	Asphalt	\$6,400	02-27-2012	\$313,800

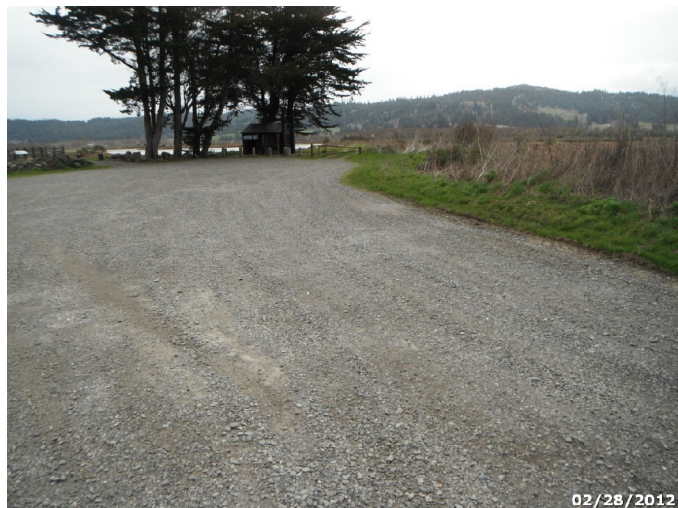
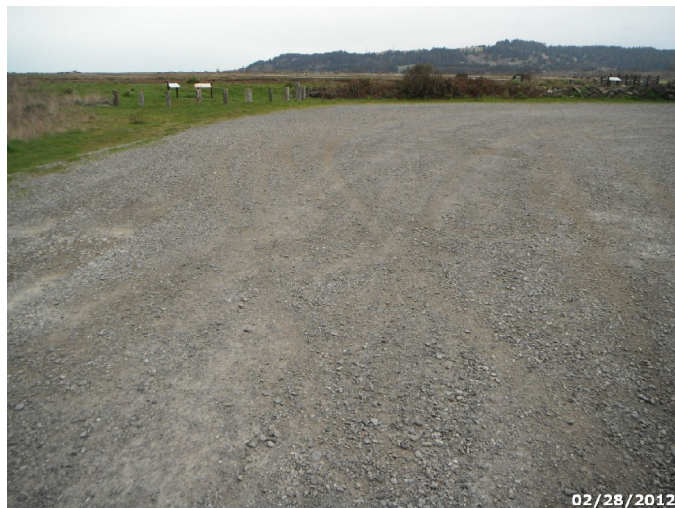
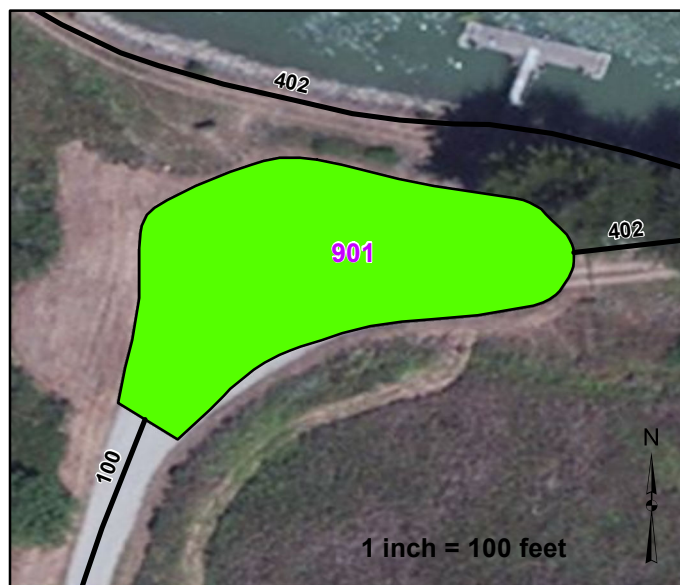
Route Number:901

Asset Number	Area	Condition	Surface Type	Cost to Improve	Inspection Date	Current Replacement Value
10044448	14782	Good	Gravel	\$2,700	02-27-2012	\$88,700

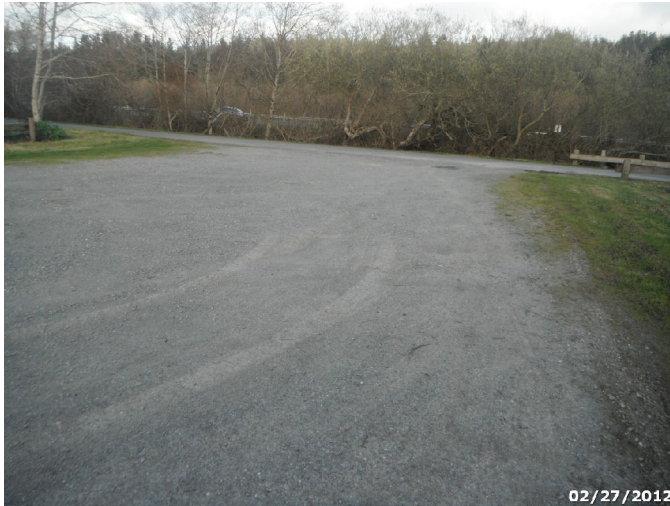
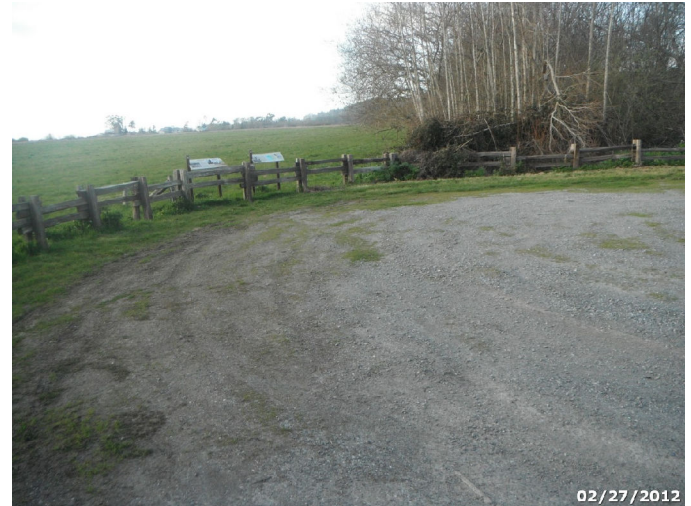
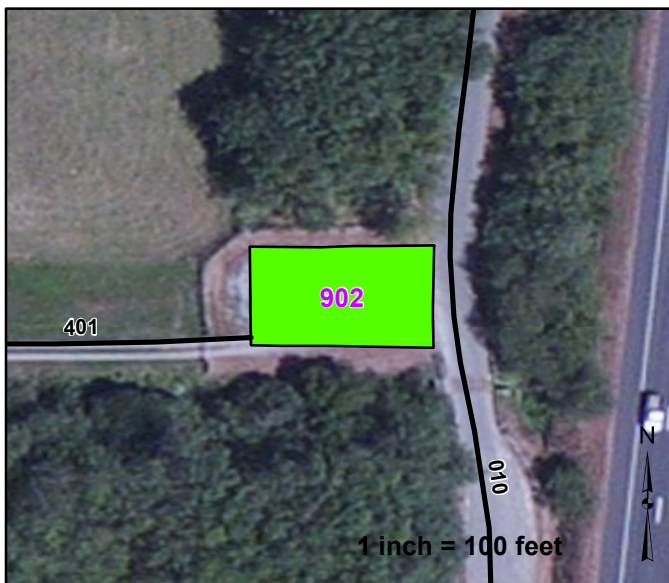
Route Number:902 Cattail Creek Parking

Asset Number	Area	Condition	Surface Type	Cost to Improve	Inspection Date	Current Replacement Value
10044531	3758	Good	Gravel	\$700	02-27-2012	\$22,600

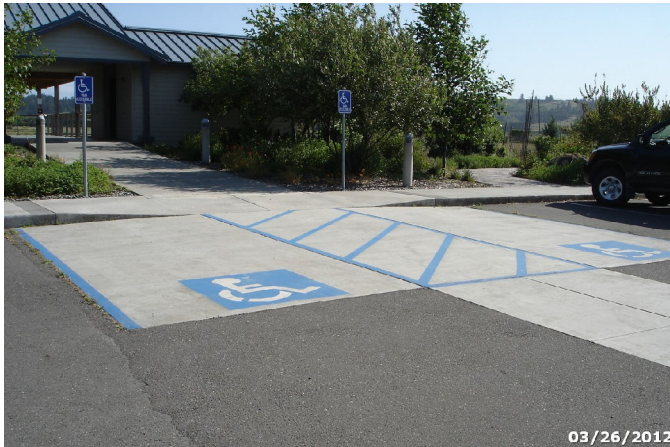
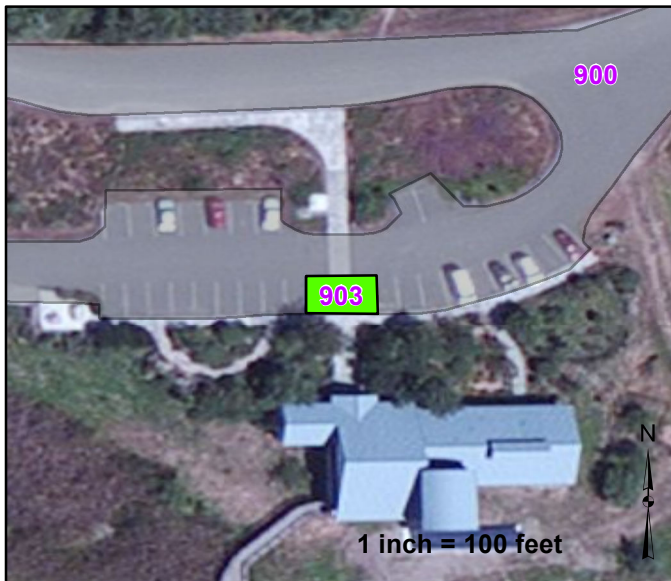
Route Number:903
Headquarters/Visitor Center Handicapped Parking
 From Refuge Headquarters Entrance Road (Route 010)

Asset Number	Area	Condition	Surface Type	Cost to Improve	Inspection Date	Current Replacement Value
10044445	554	Good	Concrete	\$100	02-27-2012	\$7,400

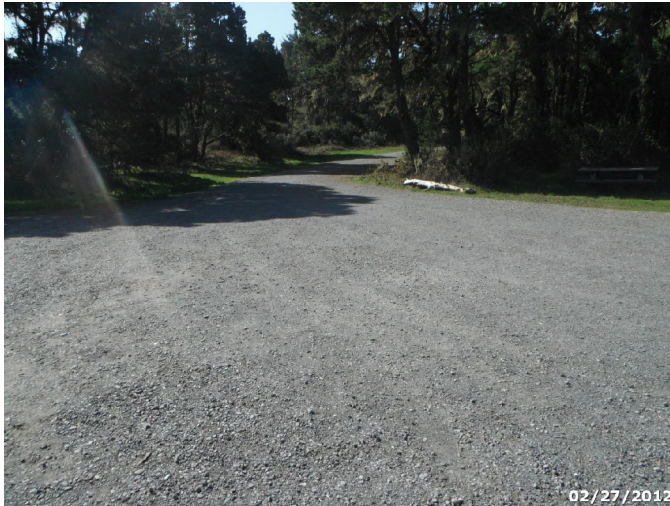
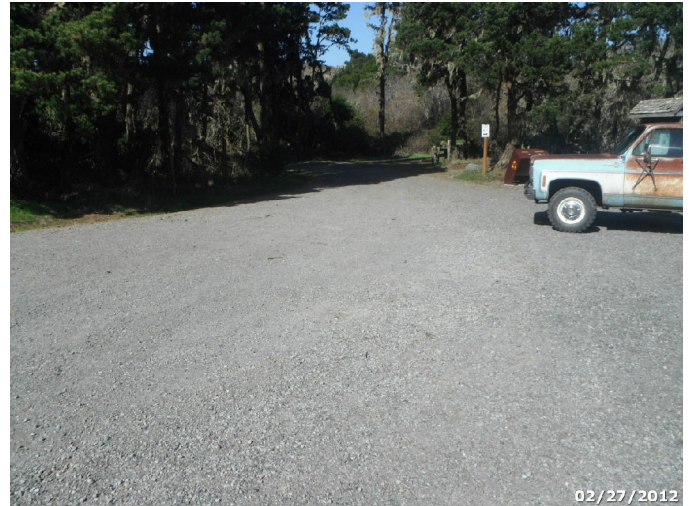
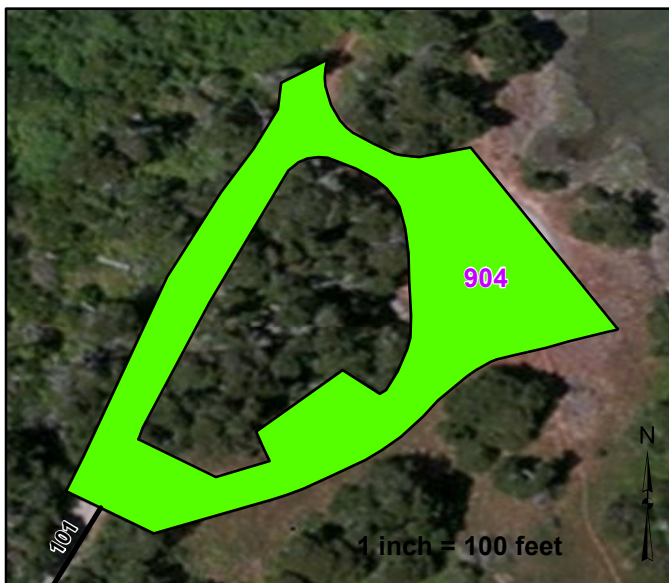
Route Number:904

Asset Number	Area	Condition	Surface Type	Cost to Improve	Inspection Date	Current Replacement Value
10056307	15966	Good	Gravel	\$2,900	02-27-2012	\$95,800

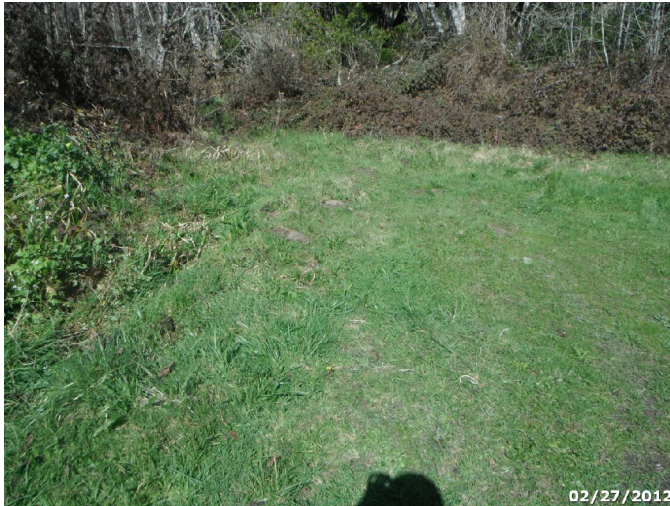
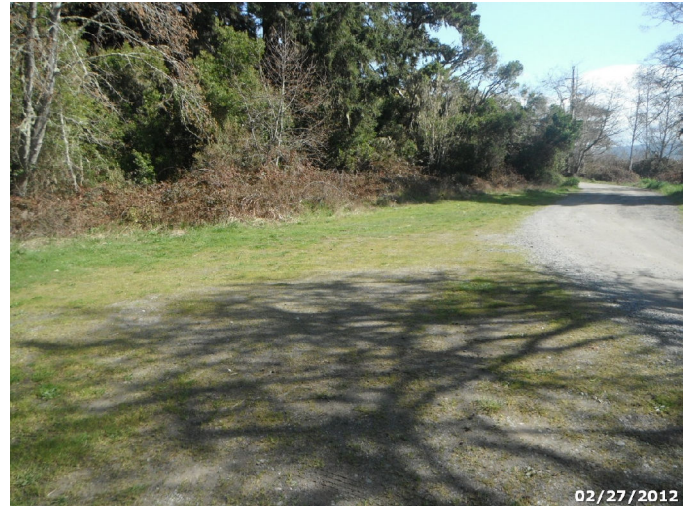
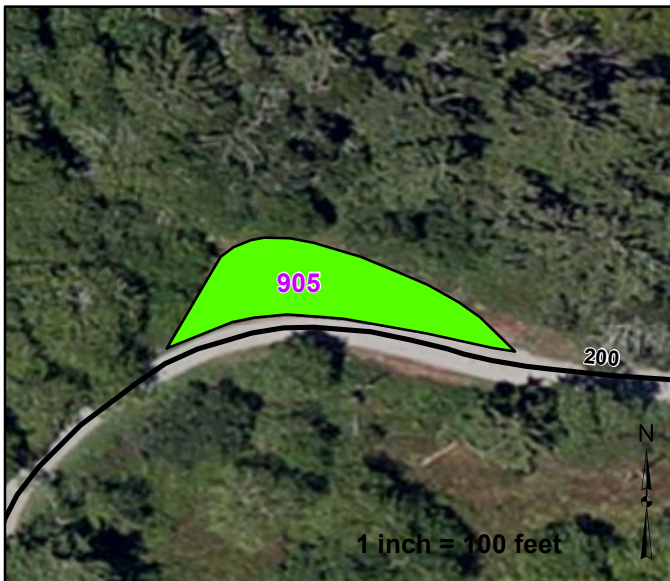
Route Number:905

Asset Number	Area	Condition	Surface Type	Cost to Improve	Inspection Date	Current Replacement Value
10000123	3820	Good	Native	\$700	02-27-2012	\$9,900

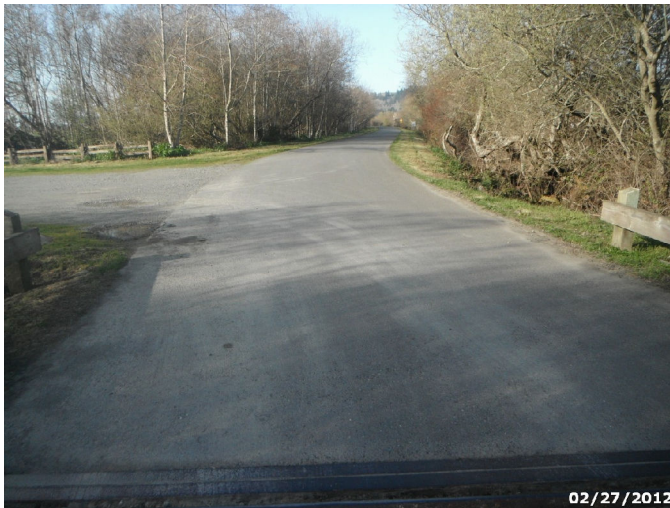
Photo: HUBA_C4_1590 Route: 010-002-0.62
Begin Section

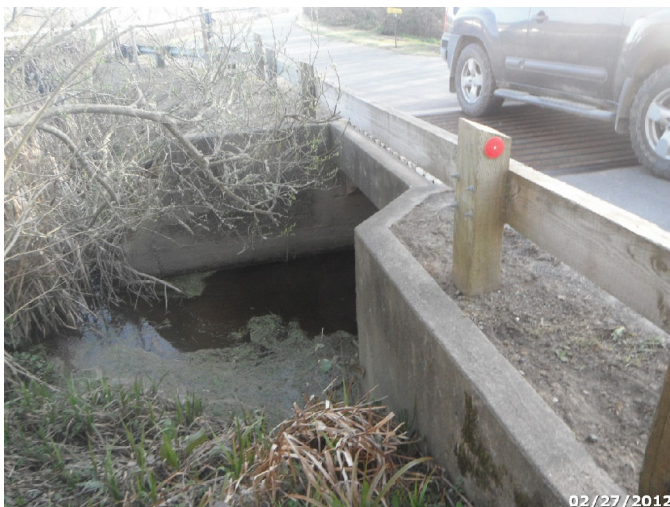
Photo: HUBA_C4_1593 Route: 010-002-0.63
Concrete Culvert Box 24ft long 6ft x 10ft 1ft deep
Asset# NA

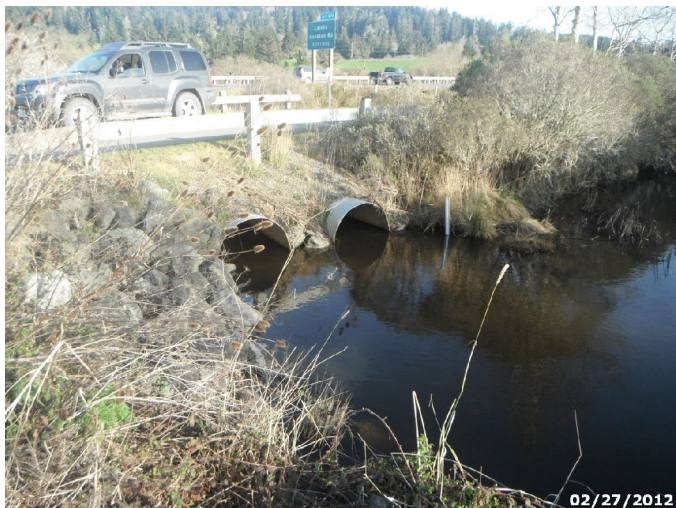
Photo: HUBA_C4_1594 Route: 010-002-1.08
Metal WCS Flashboard Riser 40ft long 48in dia. 3ft deep
Asset# NA

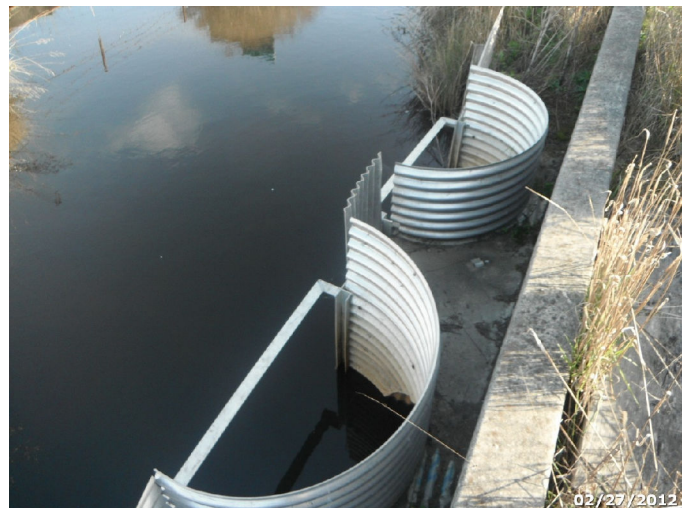
Photo: HUBA_C4_1595 Route: 010-002-1.08
Metal WCS Flashboard Riser 40ft long 48in dia. 3ft deep
Asset# NA

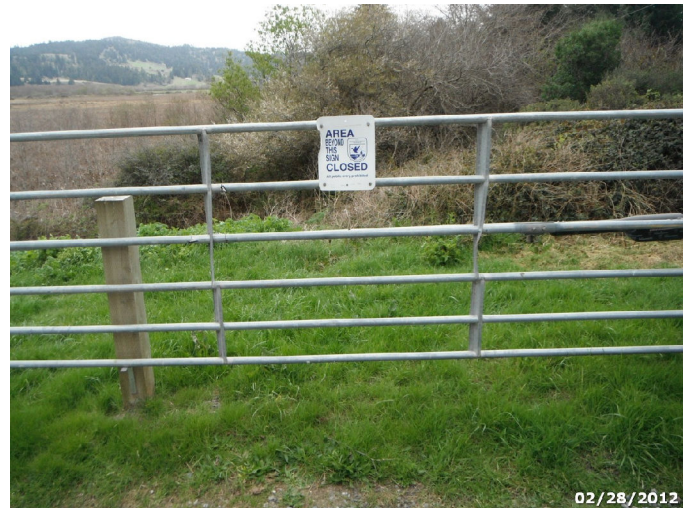
Photo: HUBA_C4_1727 Route: 100-001-0.01
Metal Open Rail Gate
Asset# 10000122

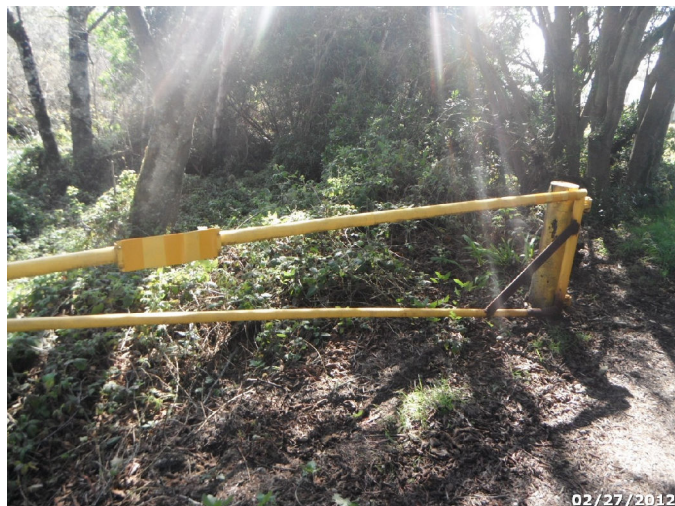
Photo: HUBA_C4_1514 Route: 101-001-0.07
Metal Open Rail Gate
Asset# 10000122

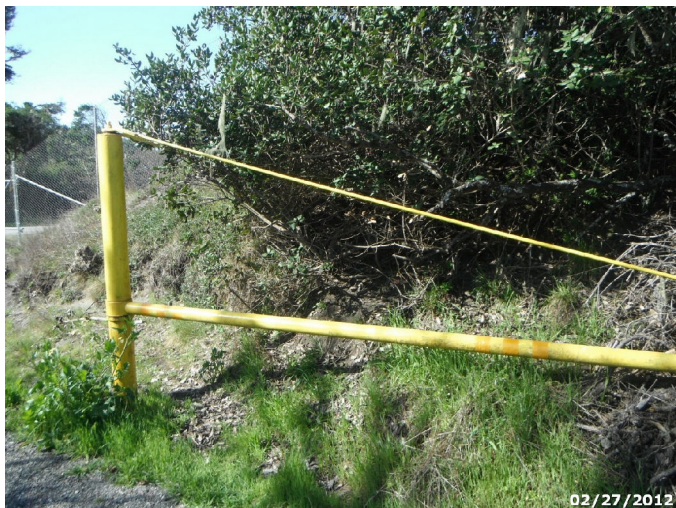
Photo: HUBA_C4_1515 Route: 101-001-0.44
Metal Open Rail Gate
Asset# 10000122

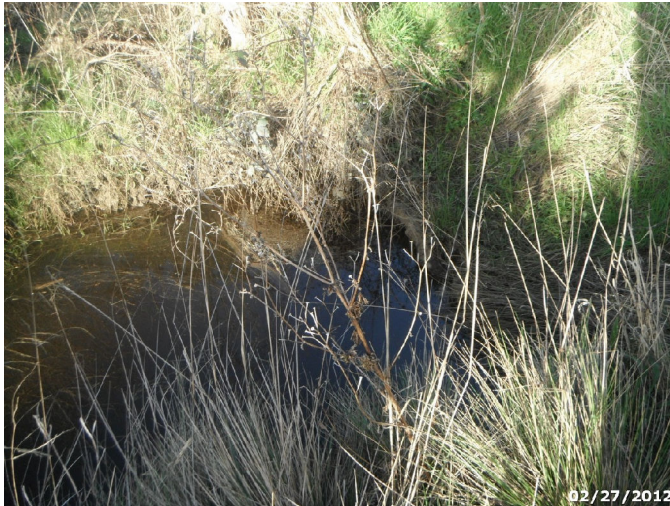
Photo: HUBA_C4_1600 Route: 102-001-0.21
Metal WCS Flashboard Riser 40ft long 24in dia. 3ft deep
Asset# NA

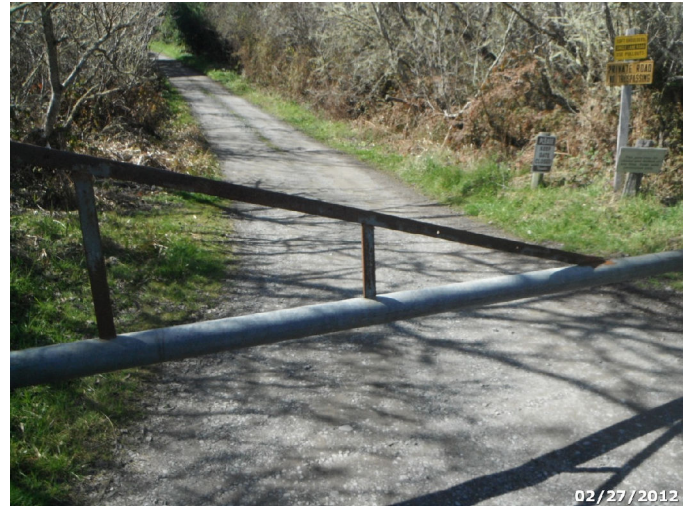
Photo: HUBA_C4_1520 Route: 200-001-0.01
Metal Open Rail Gate
Asset# 10000122

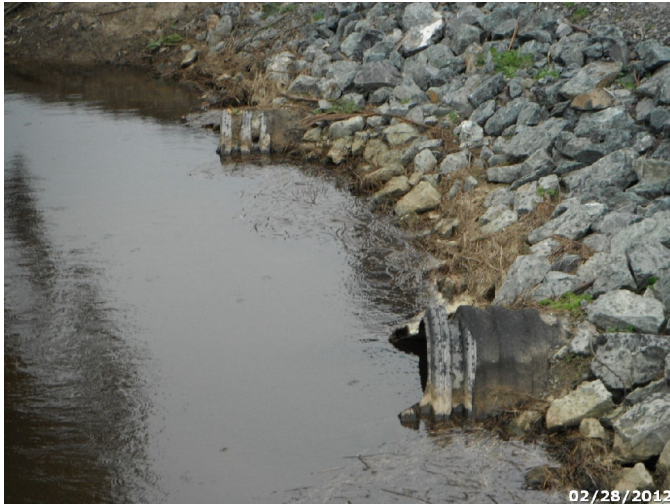
Photo: HUBA_C4_1674 Route: 400-001-0.05
Plastic Culvert 40ft long 48in dia. 2ft deep
Asset# 10000105

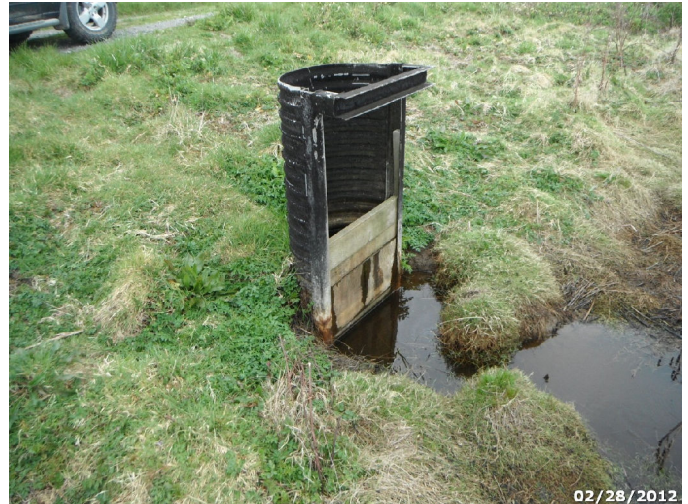
Photo: HUBA_C4_1675 Route: 400-001-0.3
Metal WCS Flashboard Riser 50ft long 24in dia. 2ft deep
Asset# NA

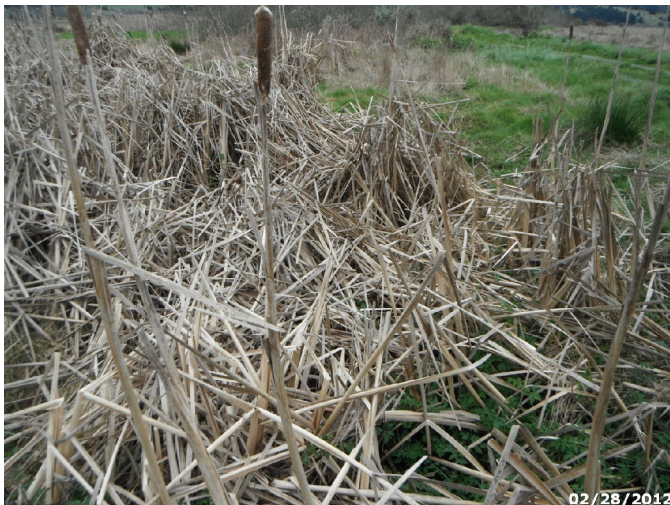
Photo: HUBA_C4_1676 Route: 400-001-0.3
Metal WCS Flashboard Riser 50ft long 24in dia. 2ft deep
Asset# NA

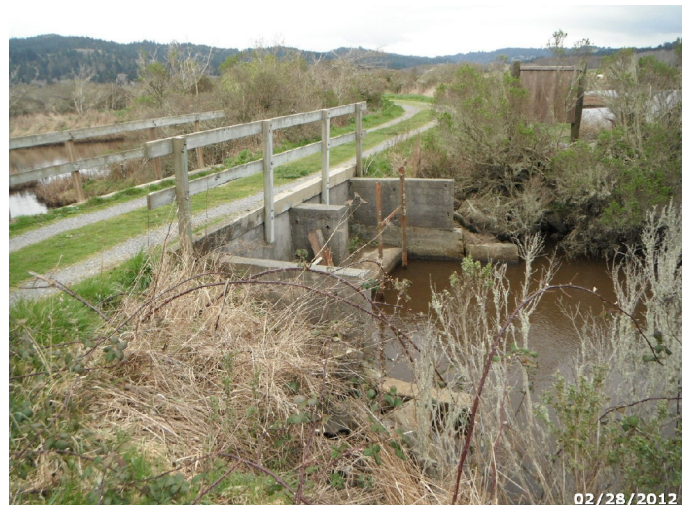
Photo: HUBA_C4_1677 Route: 400-001-0.52
Concrete WCS Flashboard Riser 15ft long 1ft deep
4x4 Box Culvert Asset# 10036311 8-007

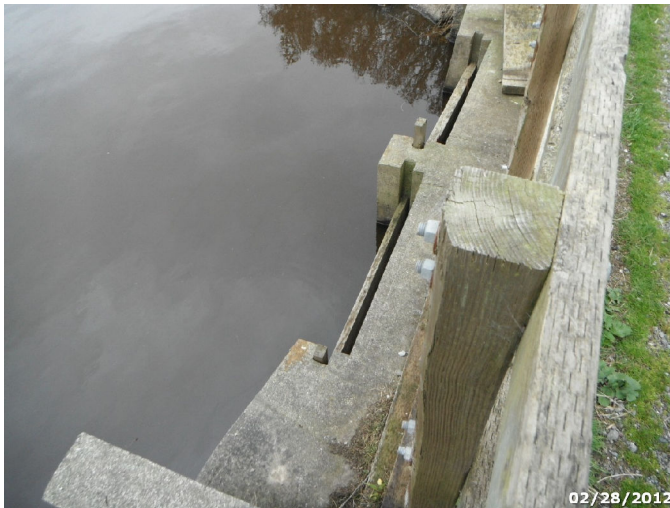
Photo: HUBA_C4_1678 Route: 400-001-0.52
Concrete WCS Flashboard Riser 15ft long 1ft deep
4x4 Box Culvert Asset# 10036311

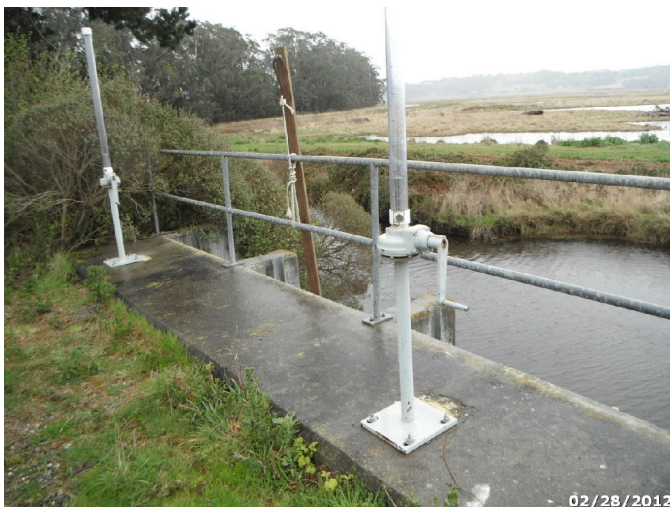
Photo: HUBA_C4_1683 Route: 400-003-2.6
Metal WCS Flashboard Riser 30ft long 1ft deep
6x10 Box Culvert Asset# NA

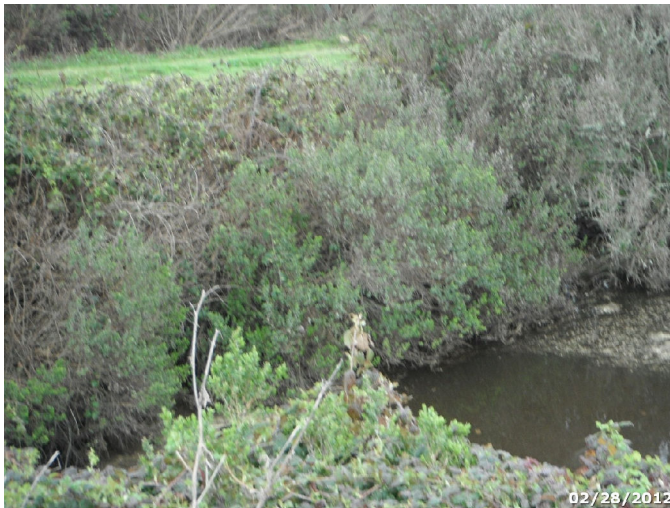
Photo: HUBA_C4_1686 Route: 400-004-2.58
Concrete Culvert 30ft long 48in dia. 4ft deep
Asset# 10000105

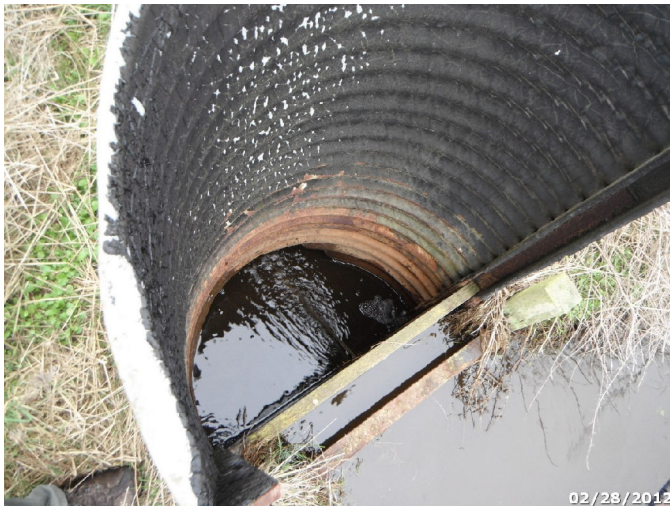
Photo: HUBA_C4_1687 Route: 400-004-3.02
Metal WCS Flashboard Riser 30ft long 24in dia. 1ft deep
Asset# NA

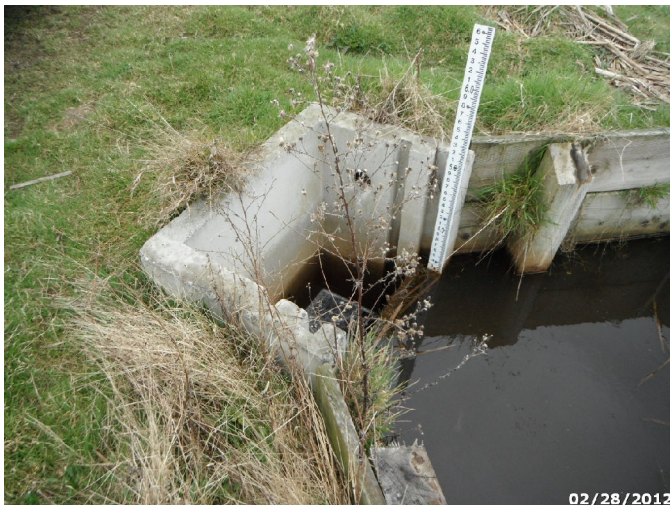
Photo: HUBA_C4_1689 Route: 400-004-3.13
Plastic WCS Flashboard Riser 40ft long 24in dia. 2ft deep
Asset# NA

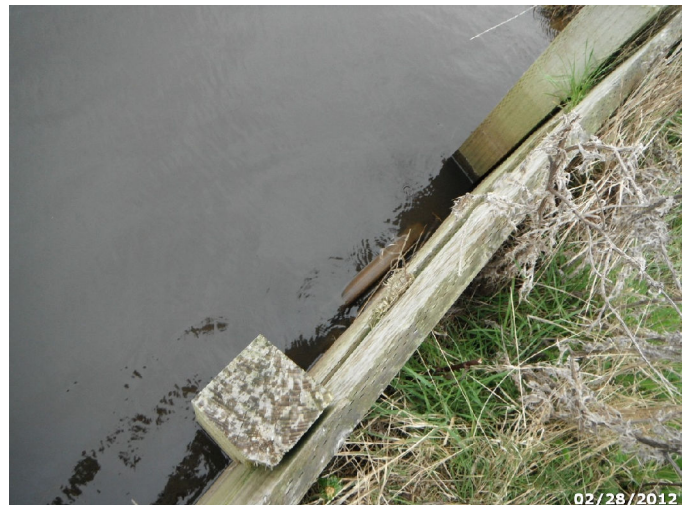
Photo: HUBA_C4_1690 Route: 400-004-3.13
Plastic WCS Flashboard Riser 40ft long 24in dia. 2ft deep
Asset# NA 8-009
