# The Road Inventory of Sonny Bono Salton Sea National Wildlife Refuge Calipatria, CA

Prepared By:  
Federal Highway Administration  
Central Federal Lands Highway Division  
April 2012

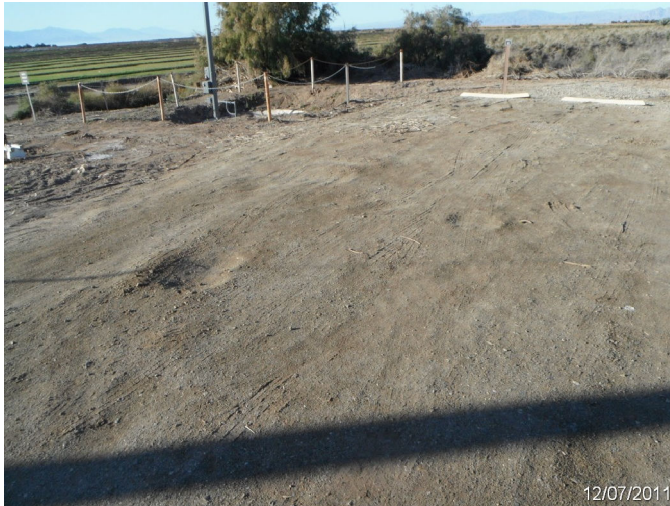
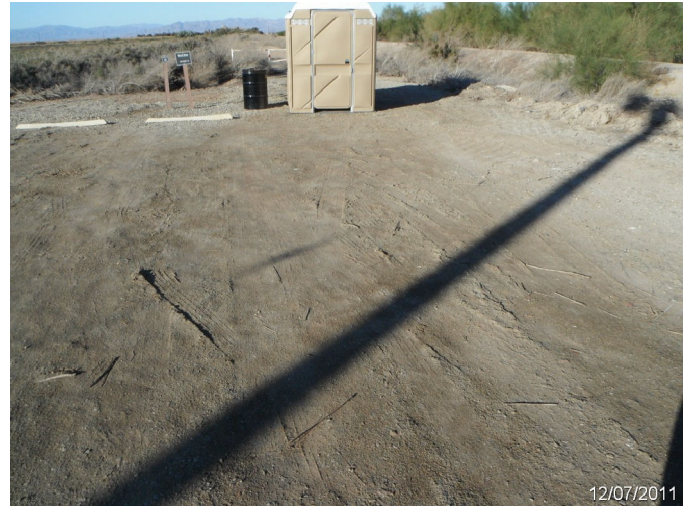
Asset Number	Area	Condition	Surface Type	Cost to Improve	Inspection Date	Current Replacement Value
-	3504	Fair	Gravel	\$1,100	05-03-2004	\$20,400

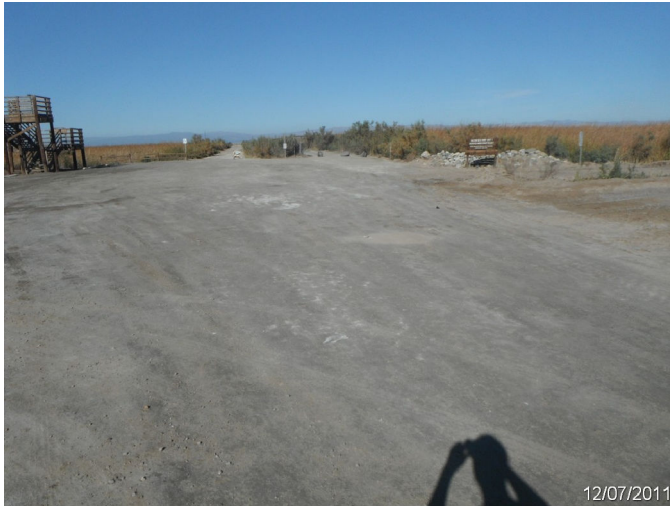
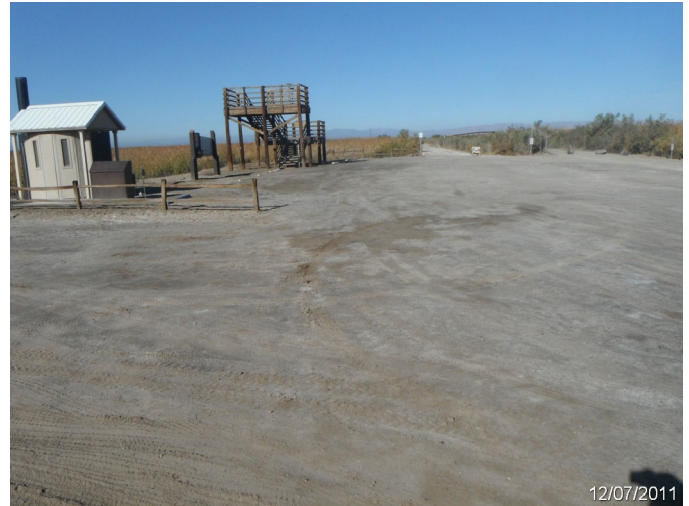
**Route Number:908**  
**Observation Tower Parking**  
 From Vendel Road (Route 103)

Asset Number	Area	Condition	Surface Type	Cost to Improve	Inspection Date	Current Replacement Value
-	9989	Good	Gravel	\$1,800	12-07-2011	\$58,300

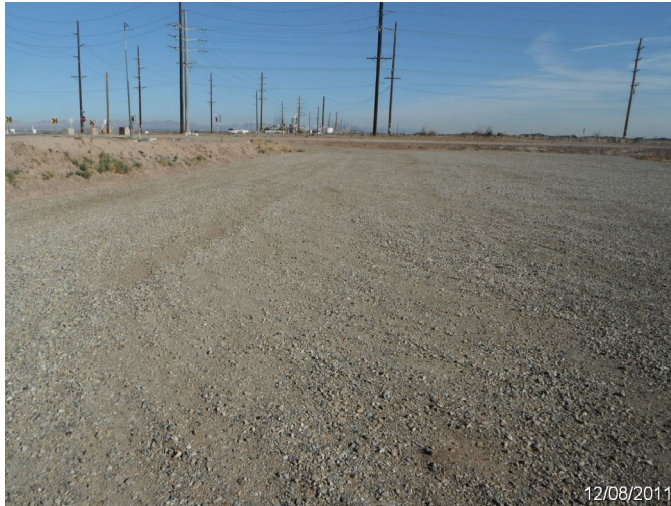
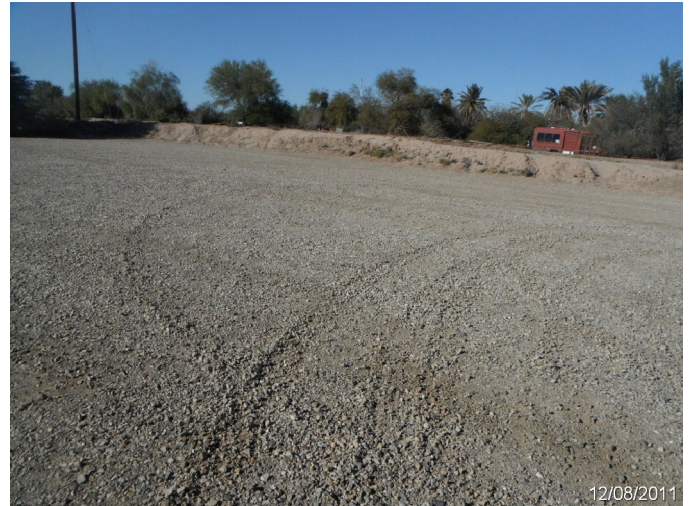
# Route Number:910

Asset Number	Area	Condition	Surface Type	Cost to Improve	Inspection Date	Current Replacement Value
-	18308	Good	Gravel	\$3,200	12-08-2011	\$106,800

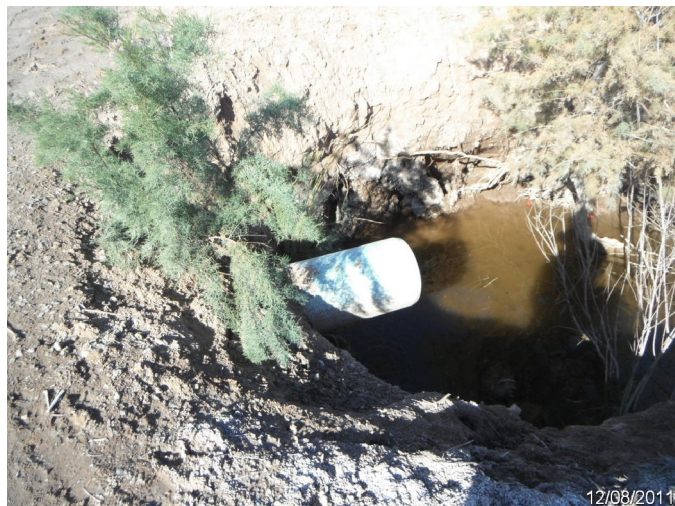
Photo: SASE\_C4\_0311 Route: 102-001-0.36  
Plastic WCS Flashboard Riser 40ft long 18in dia. 2ft deep  
Asset# NA

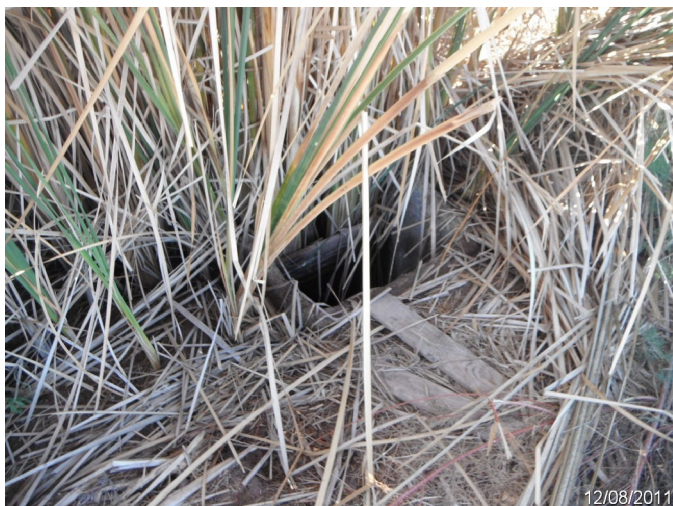
Photo: SASE\_C4\_0312 Route: 102-001-0.36  
Plastic WCS Flashboard Riser 40ft long 18in dia. 2ft deep  
Asset# NA

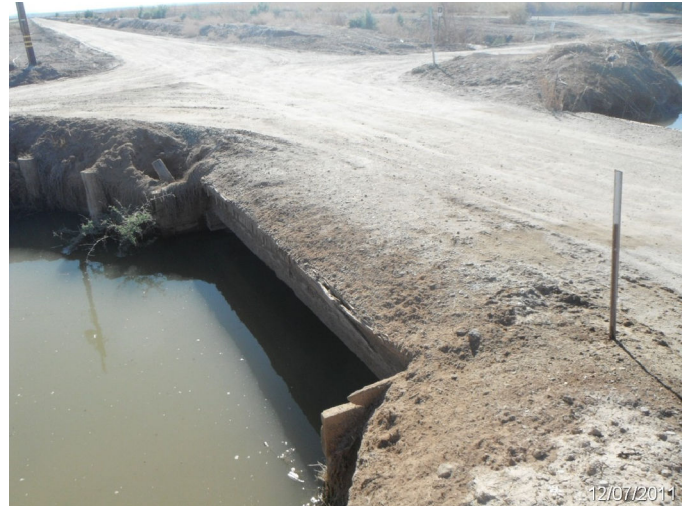
Photo: SASE\_C4\_0036 Route: 103-001-1.14  
Wood Bridge NBIS:NA  
Asset# NA

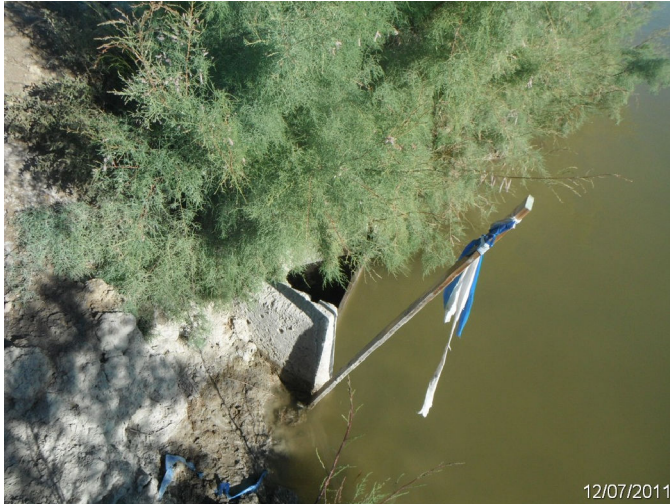
Photo: SASE\_C4\_0041 Route: 400-002-0.99  
Plastic WCS Flashboard Riser 25ft long 12in dia. 3ft deep  
Asset# 10000670

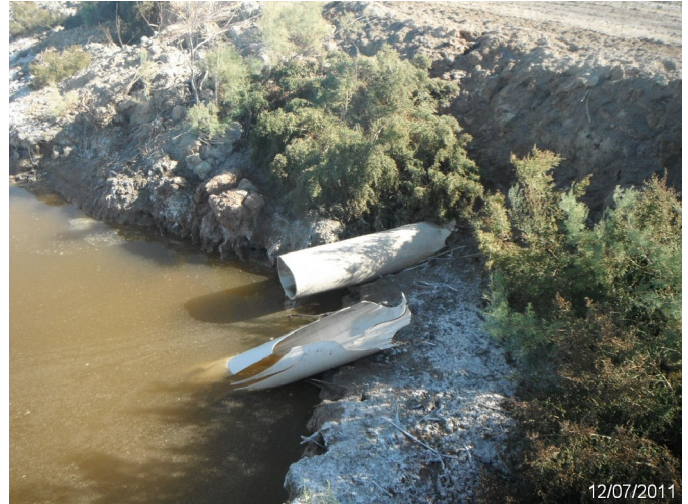
Photo: SASE\_C4\_0042 Route: 400-002-0.99  
Plastic WCS Flashboard Riser 25ft long 12in dia. 3ft deep  
Asset# 10000670

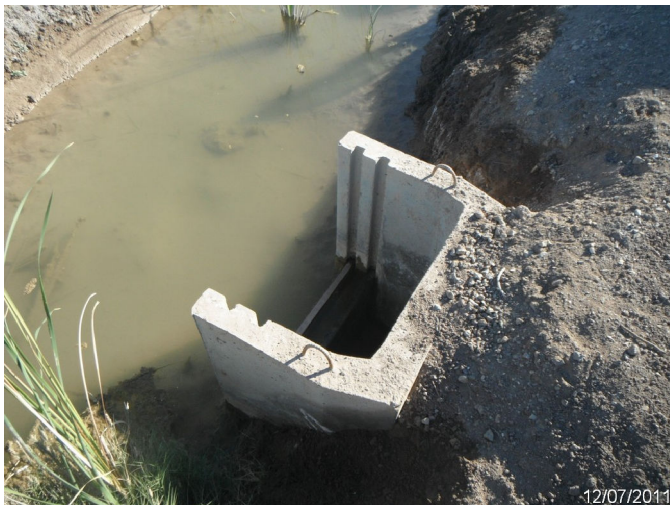
Photo: SASE\_C4\_0043 Route: 400-002-1.57  
Metal WCS Flashboard Riser 20ft long 18in dia. 3ft deep  
Asset# 10000670

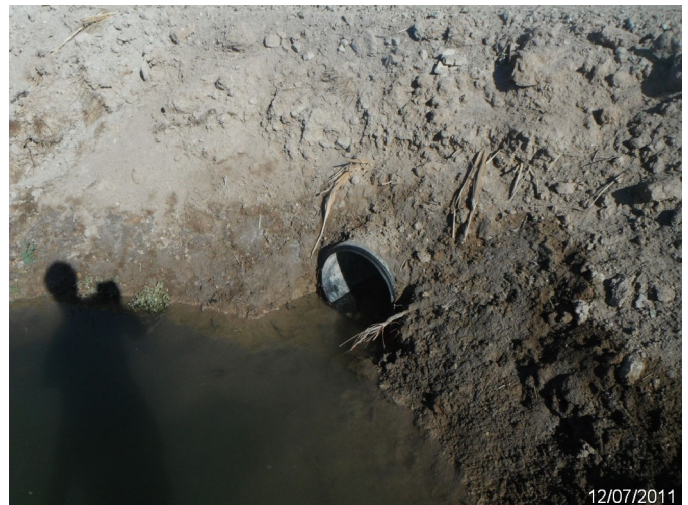
Photo: SASE\_C4\_0044 Route: 400-002-1.57  
Metal WCS Flashboard Riser 20ft long 18in dia. 3ft deep  
Asset# 10000670 8-004

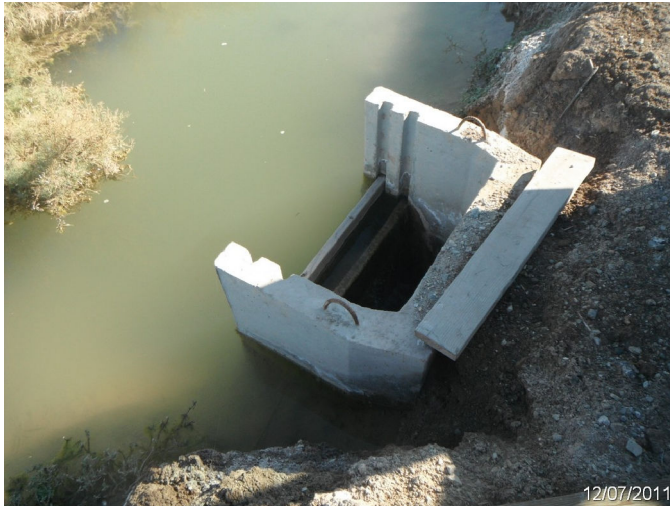
Photo: SASE\_C4\_0045 Route: 400-002-1.62  
Plastic WCS Flashboard Riser 20ft long 18in dia. 3ft deep  
Asset# 10000670

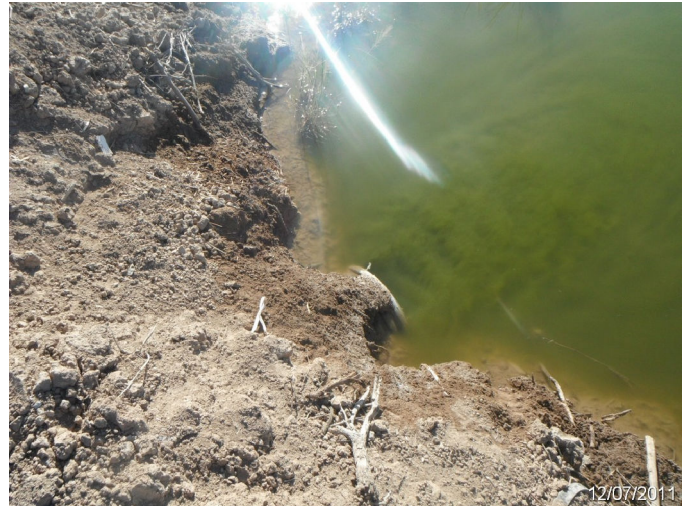
Photo: SASE\_C4\_0046 Route: 400-002-1.62  
Plastic WCS Flashboard Riser 20ft long 18in dia. 3ft deep  
Asset# 10000670

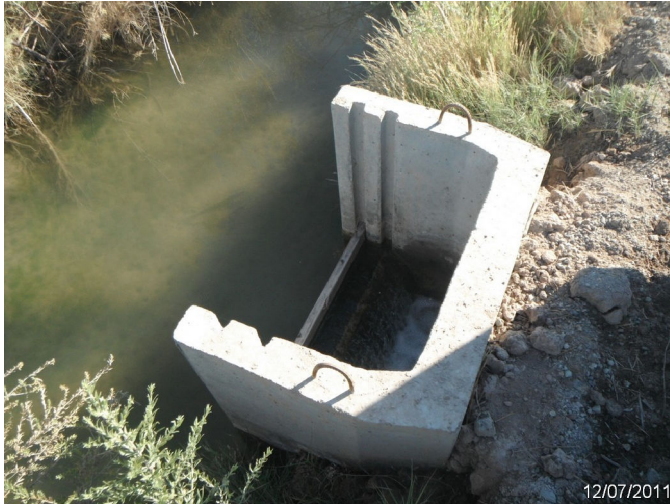
Photo: SASE\_C4\_0047 Route: 400-002-1.69  
Plastic WCS Flashboard Riser 20ft long 18in dia. 2ft deep  
Asset# 10000670

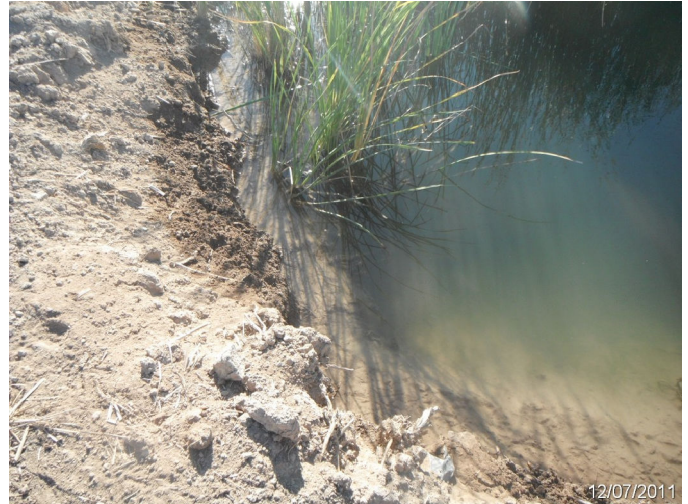
Photo: SASE\_C4\_0048 Route: 400-002-1.69  
Plastic WCS Flashboard Riser 20ft long 18in dia. 2ft deep  
Asset# 10000670

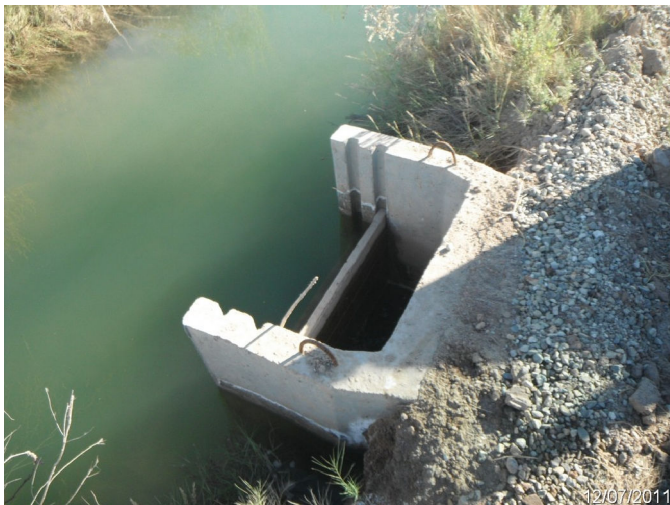
Photo: SASE\_C4\_0049 Route: 400-002-1.81  
Plastic WCS Flashboard Riser 20ft long 18in dia. 2ft deep  
Asset# 10000670

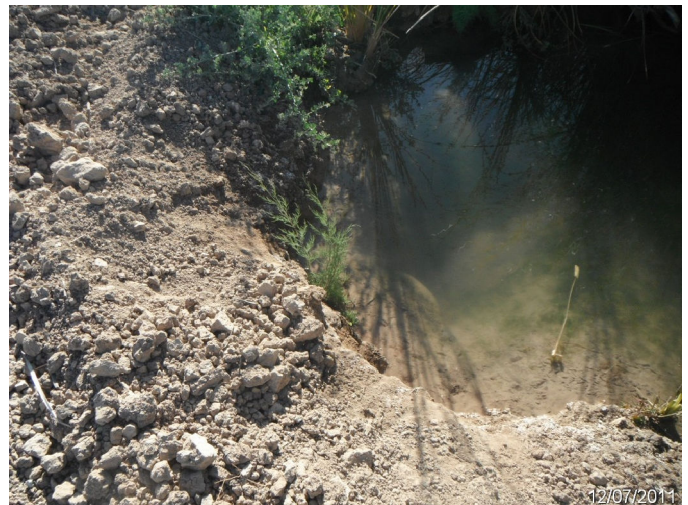
Photo: SASE\_C4\_0050 Route: 400-002-1.81  
Plastic WCS Flashboard Riser 20ft long 18in dia. 2ft deep  
Asset# 10000670  
8-005

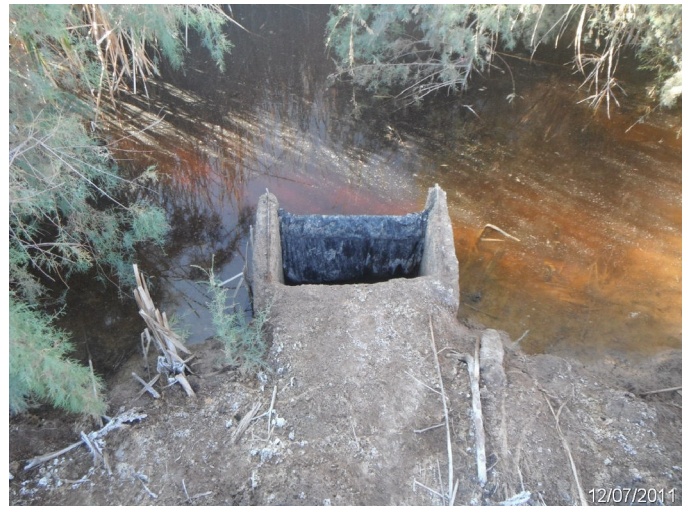
Photo: SASE\_C4\_0052 Route: 401-001-0.63  
Plastic WCS Flashboard Riser 30ft long 18in dia. 1ft deep  
Asset# 10000671

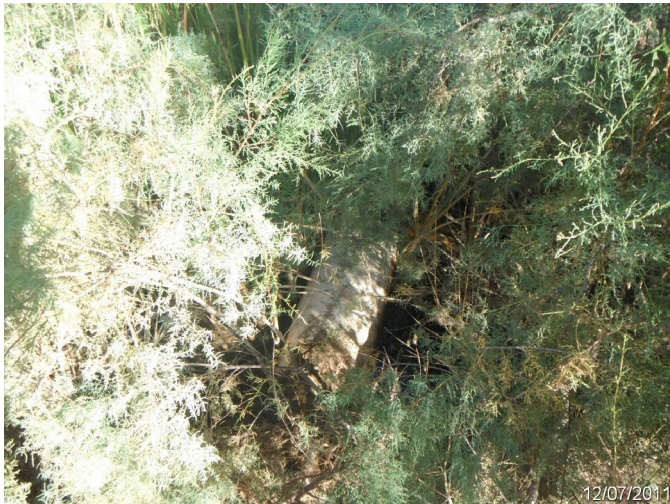
Photo: SASE\_C4\_0053 Route: 401-001-0.63  
Plastic WCS Flashboard Riser 30ft long 18in dia. 1ft deep  
Asset# 10000671

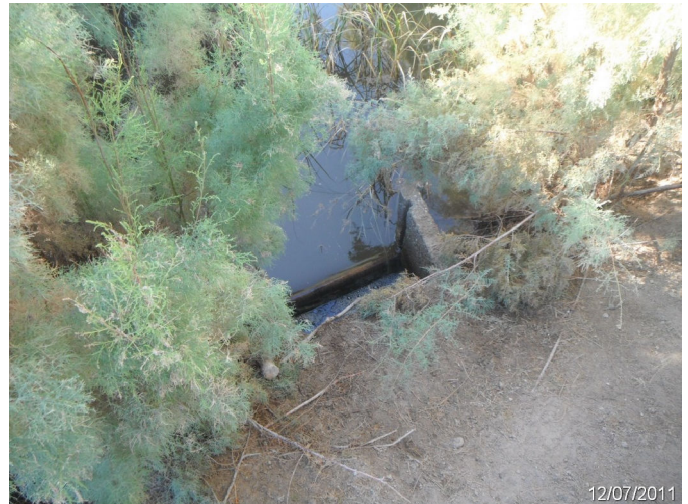
Photo: SASE\_C4\_0054 Route: 401-001-0.73  
Plastic WCS Flashboard Riser 30ft long 12in dia. 1ft deep  
Asset# 10000671

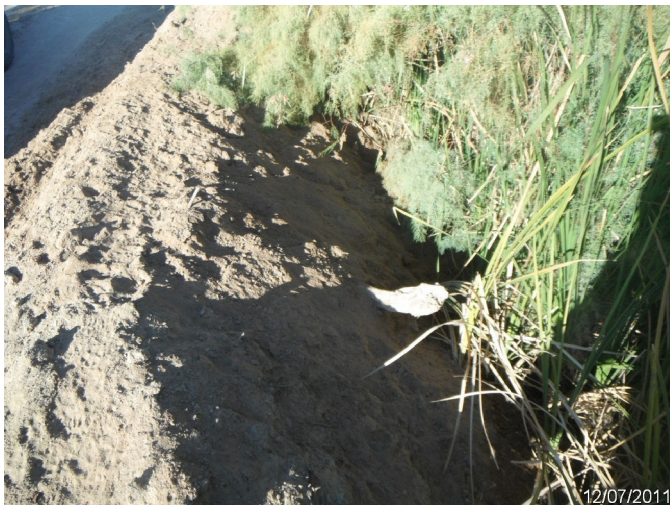
Photo: SASE\_C4\_0055 Route: 401-001-0.73  
Plastic WCS Flashboard Riser 30ft long 12in dia. 1ft deep  
Asset# 10000671

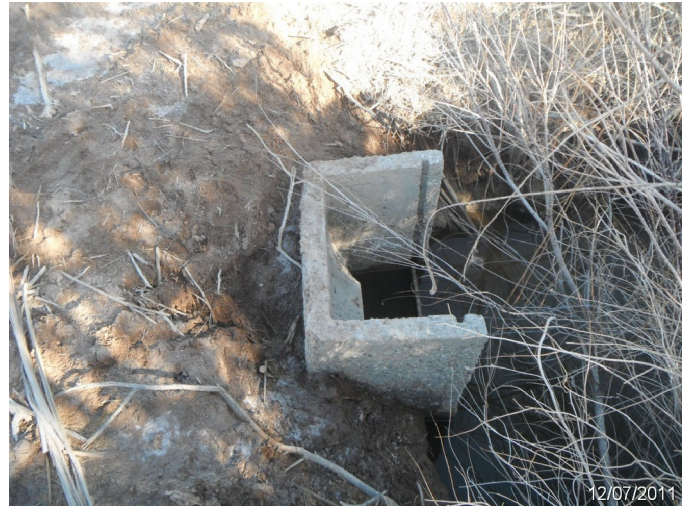
Photo: SASE\_C4\_0059 Route: 402-001-0.5  
Plastic WCS Flashboard Riser 35ft long 18in dia. 2ft deep  
Asset# 10000660

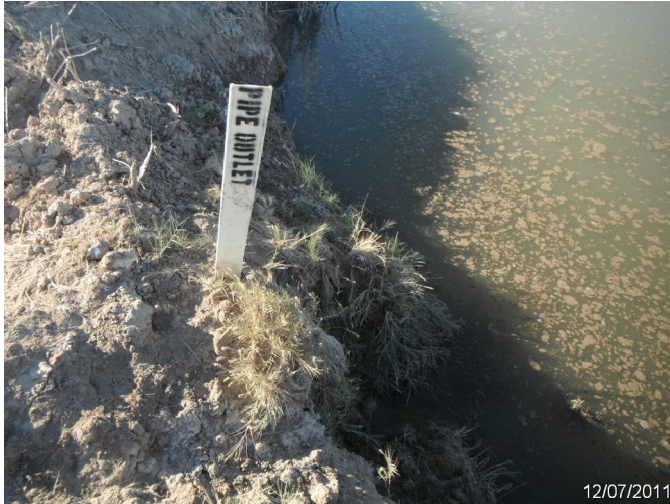
Photo: SASE\_C4\_0060 Route: 402-001-0.5  
Plastic WCS Flashboard Riser 35ft long 18in dia. 2ft deep  
Asset# 10000660

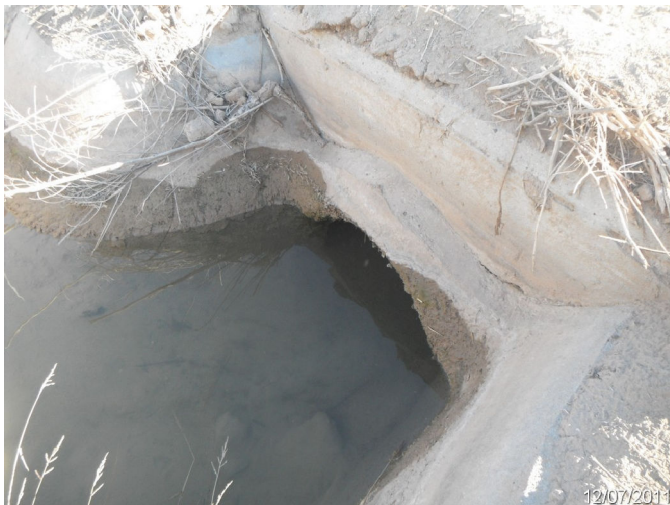
Photo: SASE\_C4\_0062 Route: 402-002-1.06  
Concrete Culvert 15ft long 36in dia. 1ft deep  
Asset# 10000660

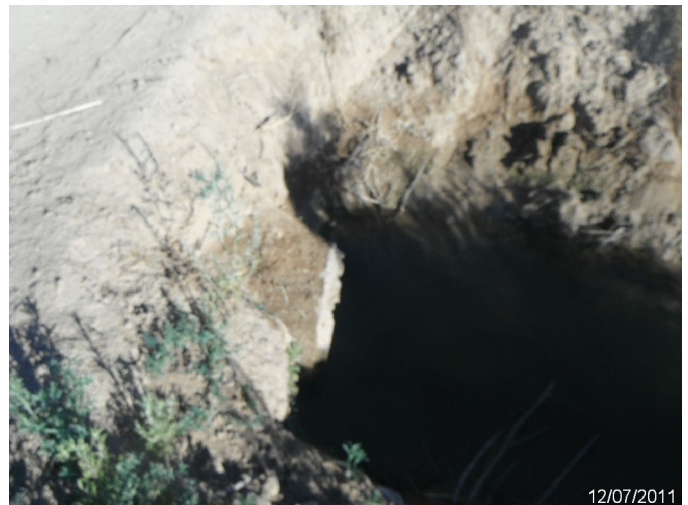
Photo: SASE\_C4\_0063 Route: 402-002-1.06  
Concrete Culvert 15ft long 36in dia. 1ft deep  
Asset# 10000660

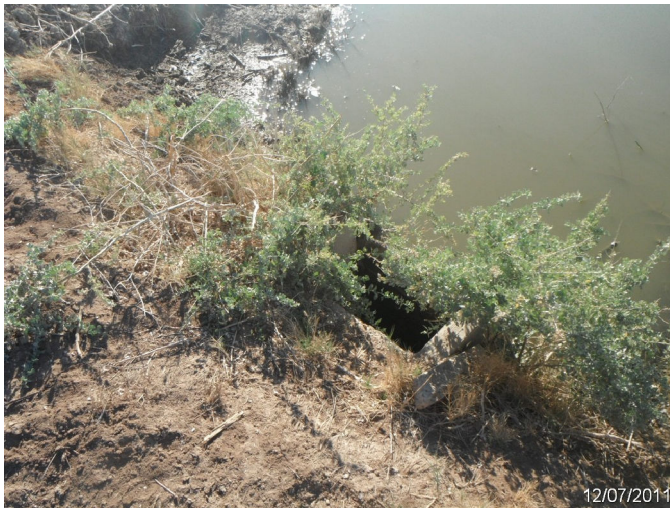
Photo: SASE\_C4\_0064 Route: 402-002-1.51  
Concrete WCS Flashboard Riser 40ft long 12in dia. 1ft deep  
Asset# 10000660

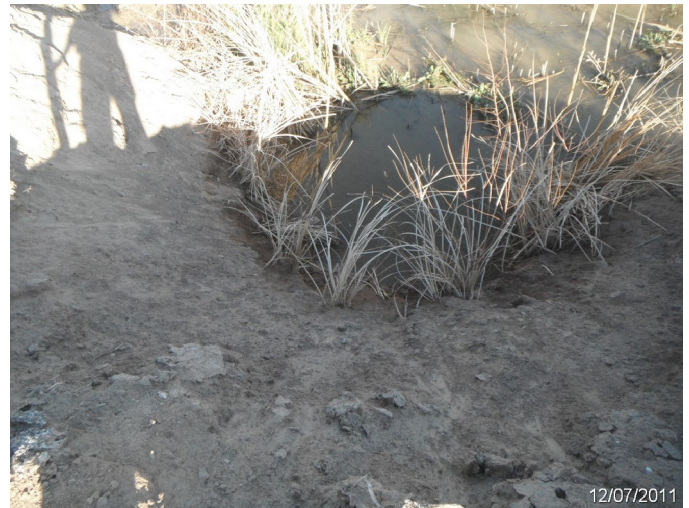
Photo: SASE\_C4\_0065 Route: 402-002-1.51  
Concrete WCS Flashboard Riser 40ft long 12in dia. 1ft deep  
Asset# 10000660

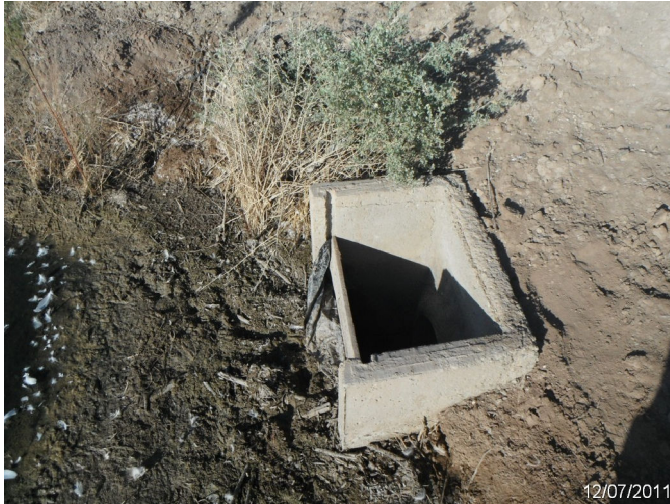
Photo: SASE\_C4\_0066 Route: 402-002-1.62  
Plastic WCS Flashboard Riser 40ft long 18in dia. 2ft deep  
Asset# 10000660

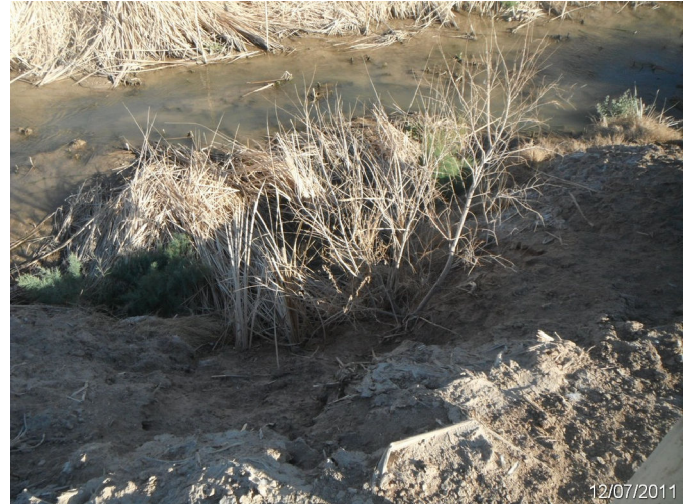
Photo: SASE\_C4\_0067 Route: 402-002-1.62  
Plastic WCS Flashboard Riser 40ft long 18in dia. 2ft deep  
Asset# 10000660

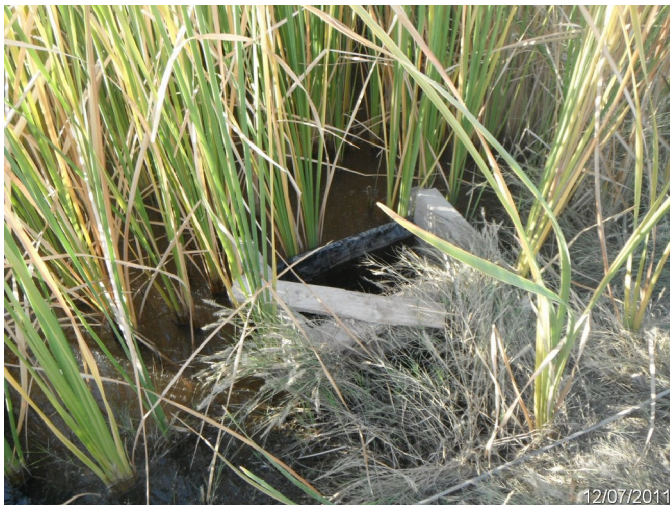
Photo: SASE\_C4\_0068 Route: 402-002-1.72  
Plastic WCS Flashboard Riser 40ft long 18in dia. 1ft deep  
Asset# 10000660

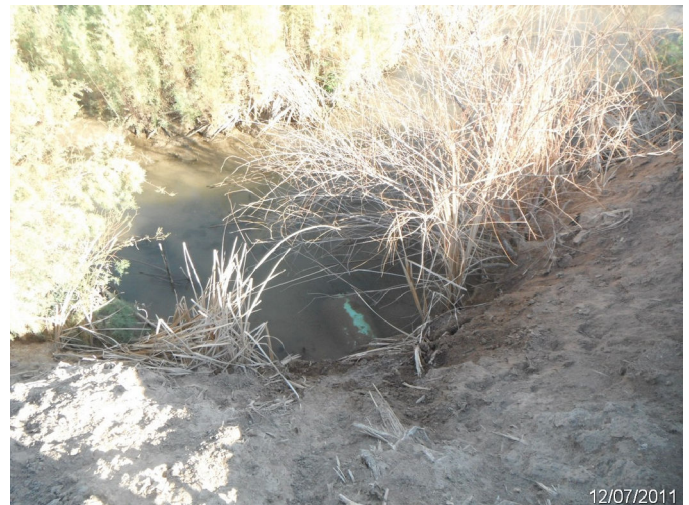
Photo: SASE\_C4\_0069 Route: 402-002-1.72  
Plastic WCS Flashboard Riser 40ft long 18in dia. 1ft deep  
Asset# 10000660  
8-008

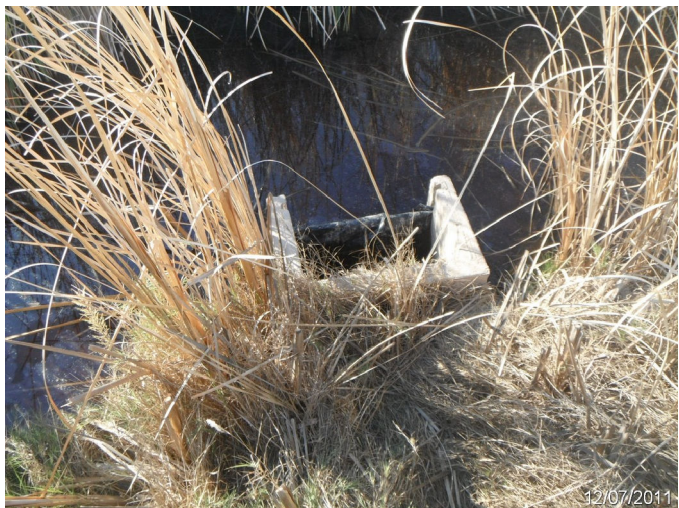
Photo: SASE\_C4\_0070 Route: 402-002-1.83  
Plastic WCS Flashboard Riser 40ft long 18in dia. 1ft deep  
Asset# 10000660

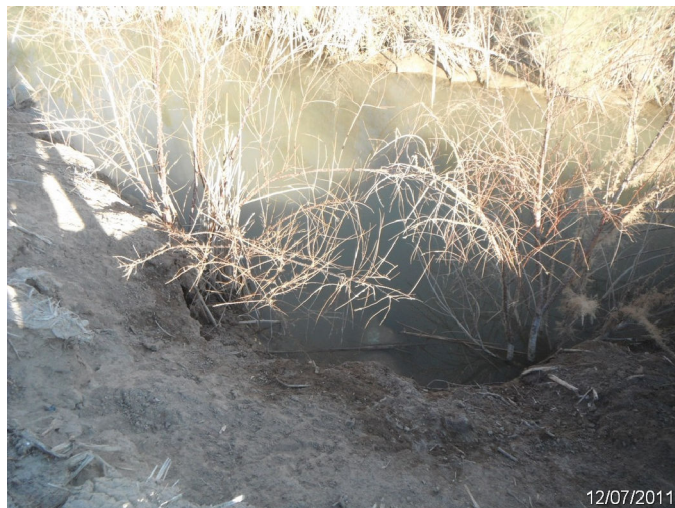
Photo: SASE\_C4\_0071 Route: 402-002-1.83  
Plastic WCS Flashboard Riser 40ft long 18in dia. 1ft deep  
Asset# 10000660

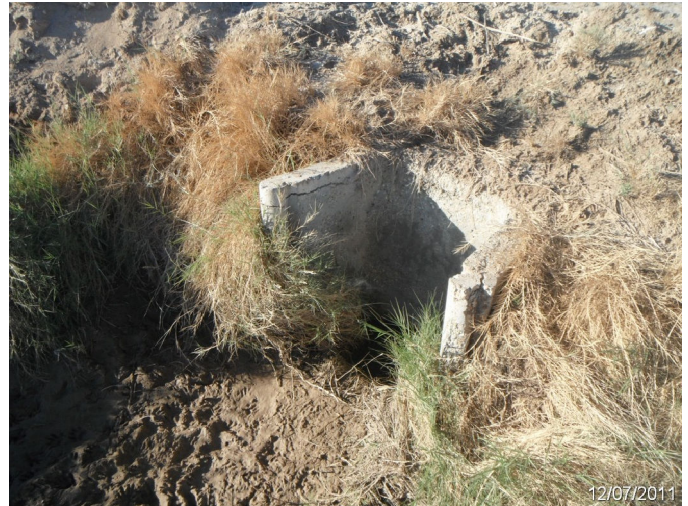
Photo: SASE\_C4\_0073 Route: 403-001-0.0  
Plastic WCS Flashboard Riser 40ft long 12in dia. 2ft deep  
Asset# 10000672

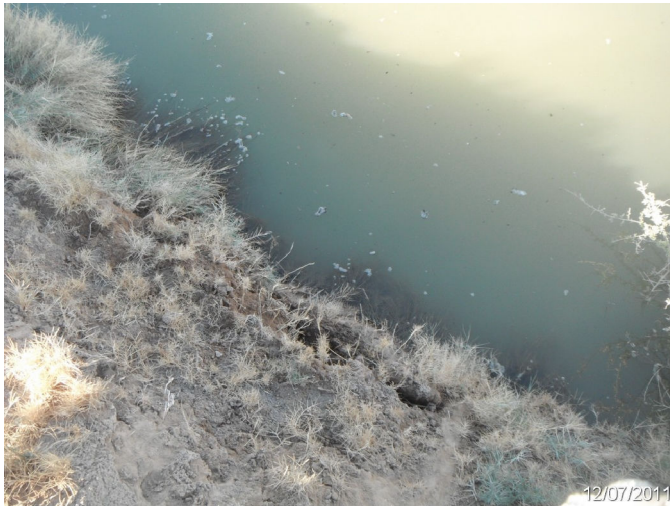
Photo: SASE\_C4\_0074 Route: 403-001-0.0  
Plastic WCS Flashboard Riser 40ft long 12in dia. 2ft deep  
Asset# 10000672

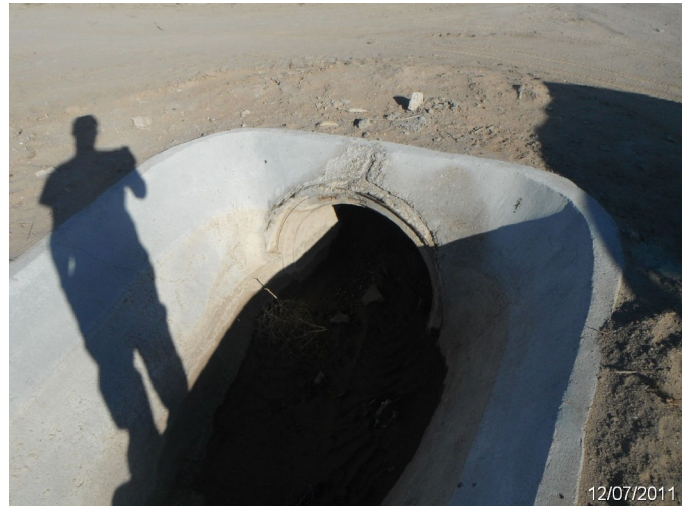
Photo: SASE\_C4\_0076 Route: 403-001-0.99  
Metal Culvert 50ft long 48in dia. 1ft deep  
Asset# 10000672

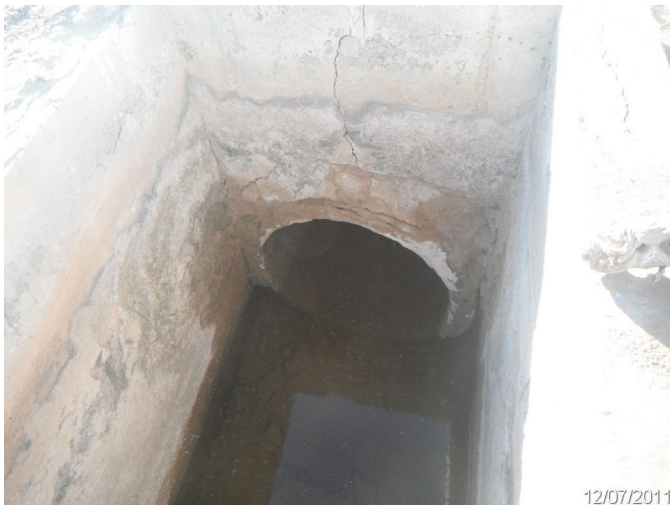
Photo: SASE\_C4\_0077 Route: 403-001-0.99  
Metal Culvert 50ft long 48in dia. 1ft deep  
Asset# 10000672

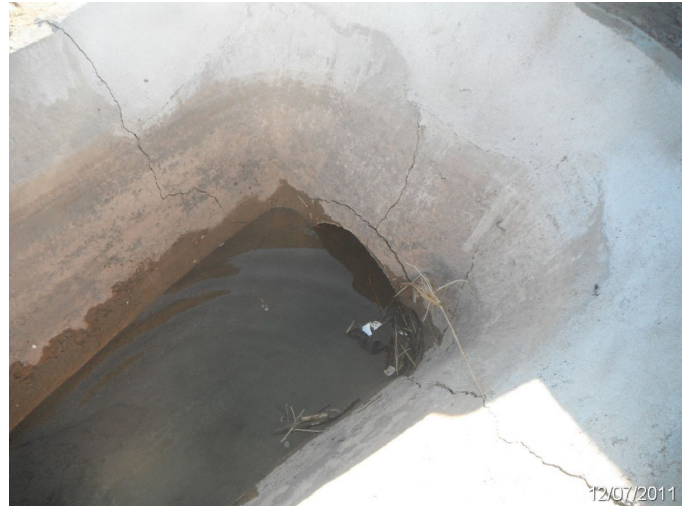
Photo: SASE\_C4\_0080 Route: 404-001-0.37  
Concrete Culvert 20ft long 36in dia. 1ft deep  
Asset# 10000644

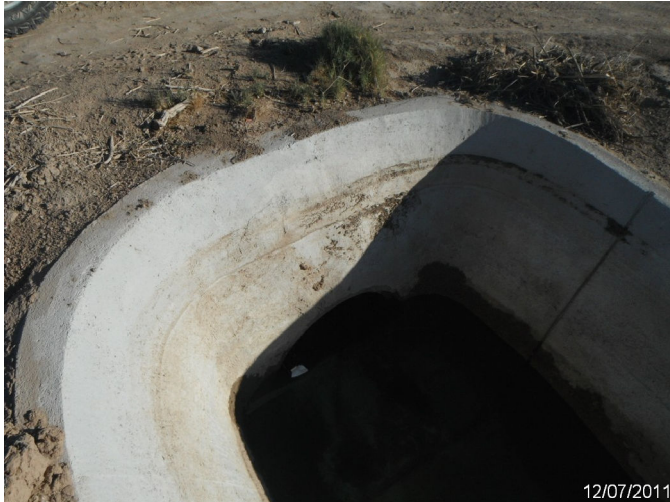
Photo: SASE\_C4\_0081 Route: 404-001-0.37  
Concrete Culvert 20ft long 36in dia. 1ft deep  
Asset# 10000644

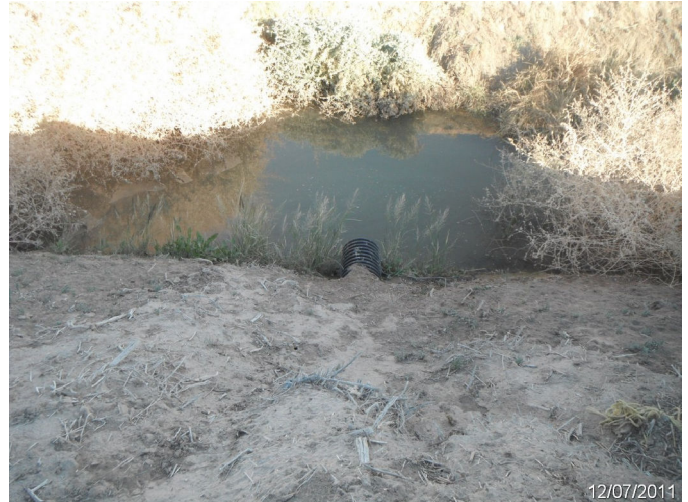
Photo: SASE\_C4\_0082 Route: 404-001-0.4  
Plastic WCS Flashboard Riser 60ft long 12in dia. 20ft deep  
Unable to locate inlet Asset# 10000644

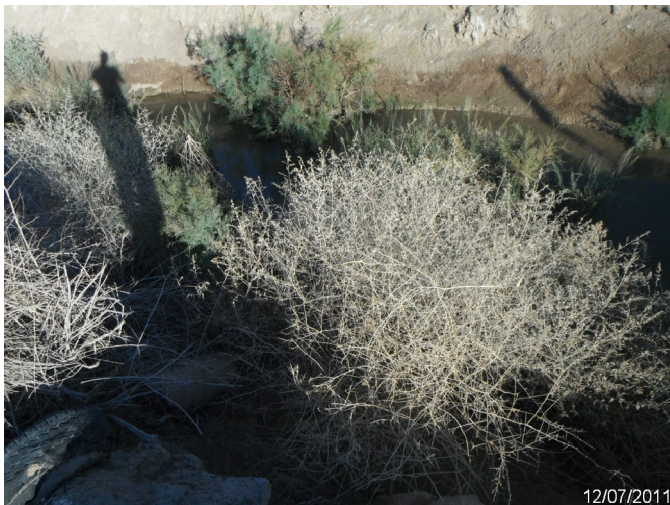
Photo: SASE\_C4\_0084 Route: 404-001-0.4  
Plastic WCS Flashboard Riser 60ft long 12in dia. 20ft deep  
Unable to locate inlet  
Asset# 10000644

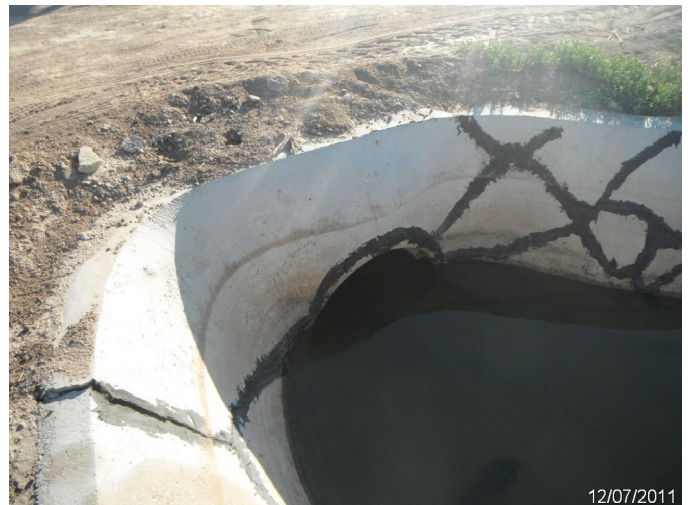
Photo: SASE\_C4\_0085 Route: 404-001-0.59  
Concrete Culvert 25ft long 36in dia. 1ft deep  
Asset# 10000644

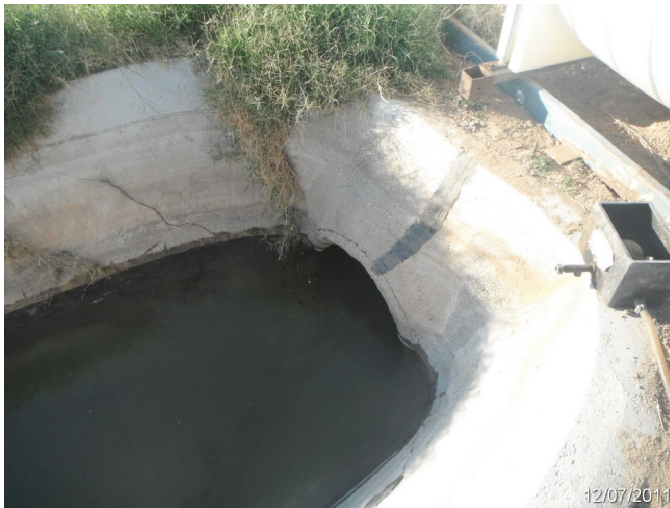
Photo: SASE\_C4\_0086 Route: 404-001-0.59  
Concrete Culvert 25ft long 36in dia. 1ft deep  
Asset# 10000644

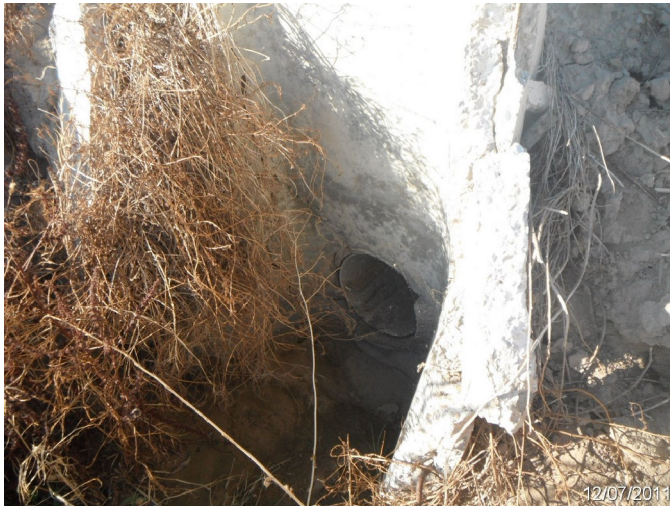
Photo: SASE\_C4\_0087 Route: 404-002-0.87  
Plastic Culvert 30ft long 12in dia. 2ft deep  
Asset# 10000644

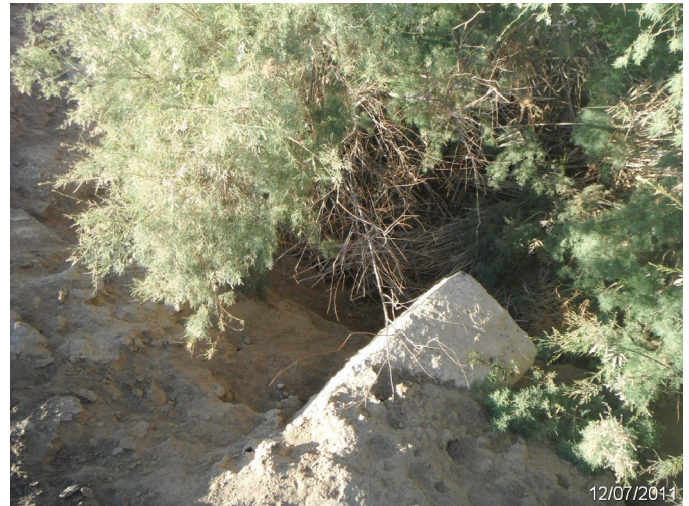
Photo: SASE\_C4\_0088 Route: 404-002-0.87  
Plastic Culvert 30ft long 12in dia. 2ft deep  
Asset# 10000644

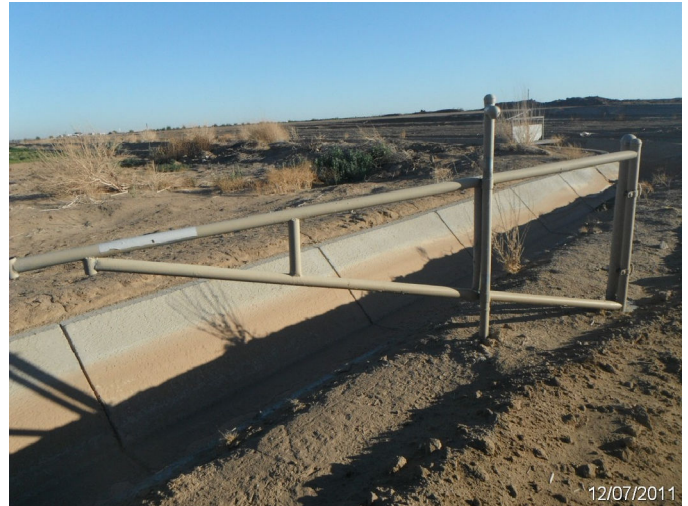
Photo: SASE\_C4\_0091 Route: 405-001-0.5  
Metal Open Rail Gate  
Asset# 10000665

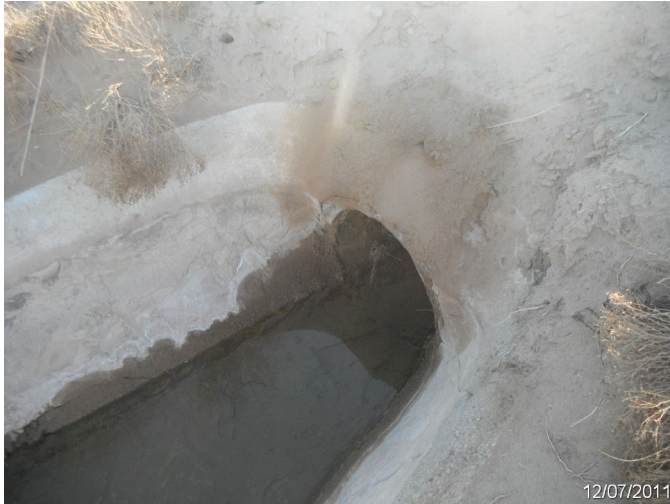
Photo: SASE\_C4\_0092 Route: 405-001-0.64  
Concrete WCS Flap Gate/Full-Round Riser  
30ft long 36in dia. 2ft deep Asset# 10000665

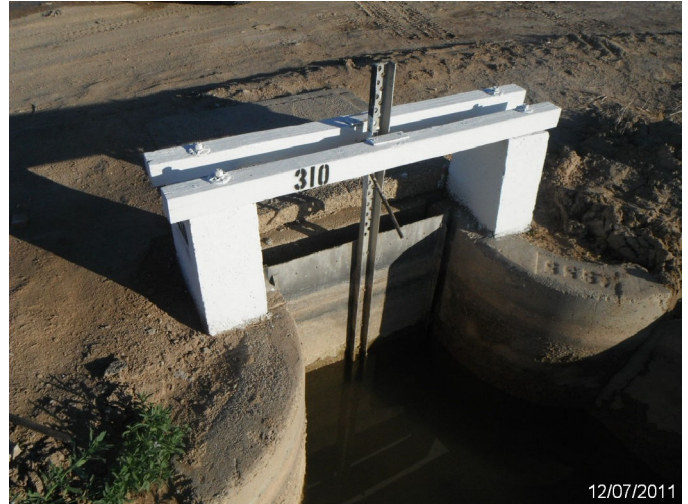
Photo: SASE\_C4\_0093 Route: 405-001-0.64  
Concrete WCS Flap Gate/Full-Round Riser  
30ft long 36in dia. 2ft deep Asset# 10000665

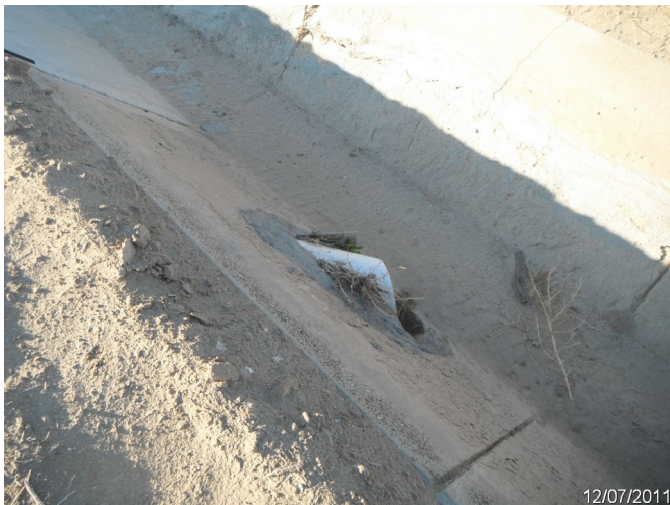
Photo: SASE\_C4\_0094 Route: 405-001-0.78  
Plastic WCS Flashboard Riser 60ft long 12in dia. 2ft deep  
Asset# 10000665

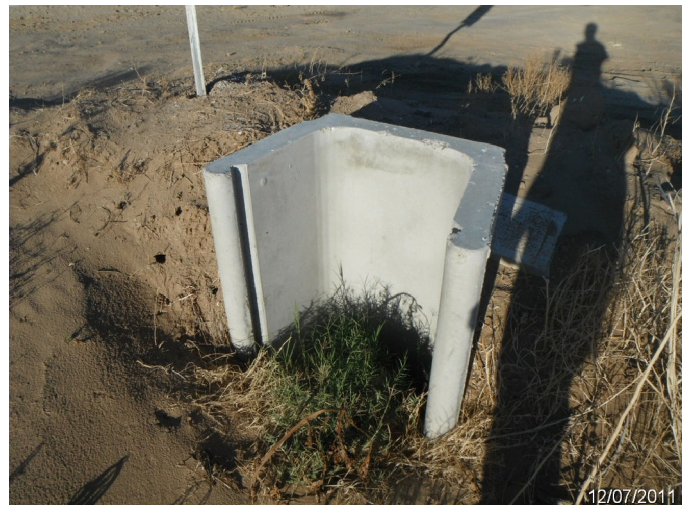
Photo: SASE\_C4\_0095 Route: 405-001-0.78  
Plastic WCS Flashboard Riser 60ft long 12in dia. 2ft deep  
Asset# 10000665 8-013

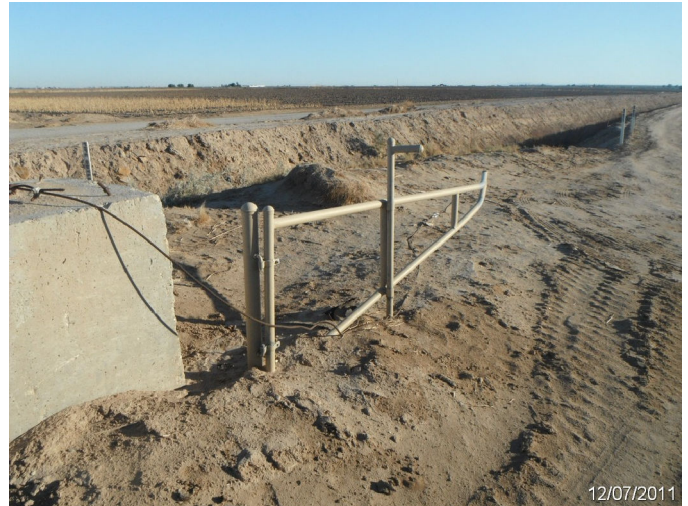
Photo: SASE\_C4\_0096 Route: 405-002-1.03  
Metal Open Rail Gate  
Asset# 10000665

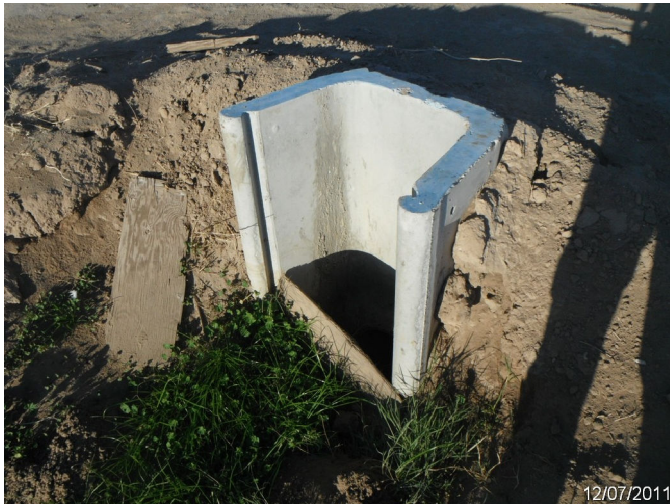
Photo: SASE\_C4\_0098 Route: 405-002-1.32  
Plastic WCS Flashboard Riser 25ft long 12in dia. 2ft deep  
Asset# 10000665

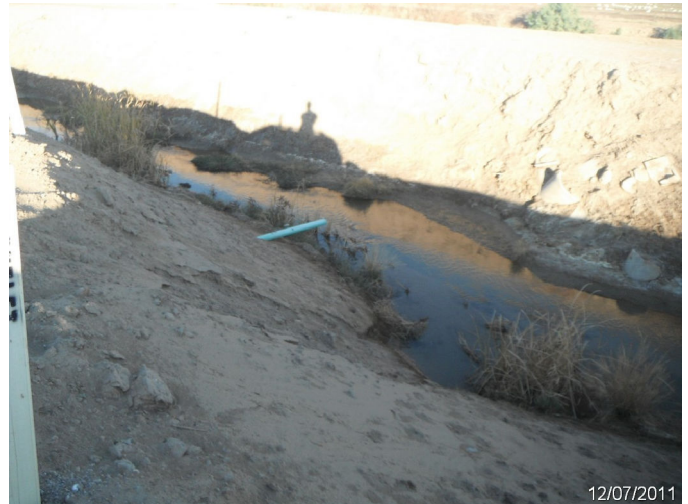
Photo: SASE\_C4\_0099 Route: 405-002-1.32  
Plastic WCS Flashboard Riser 25ft long 12in dia. 2ft deep  
Asset# 10000665

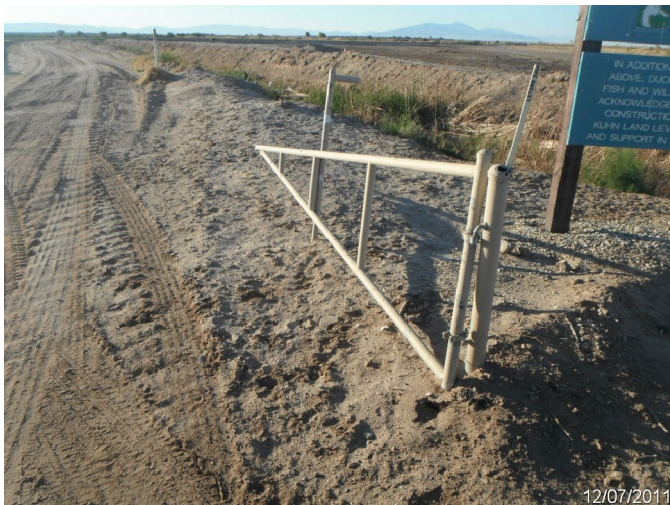
Photo: SASE\_C4\_0100 Route: 405-002-1.52  
Metal Open Rail Gate  
Asset# 10000665

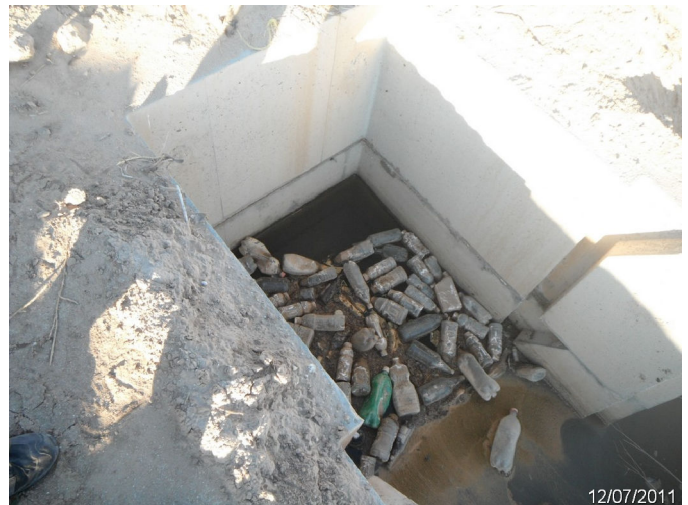
Photo: SASE\_C4\_0101 Route: 405-002-1.52  
Plastic WCS Flashboard Riser 30ft long 12in dia. 3ft deep  
Asset# 10000665  
8-014

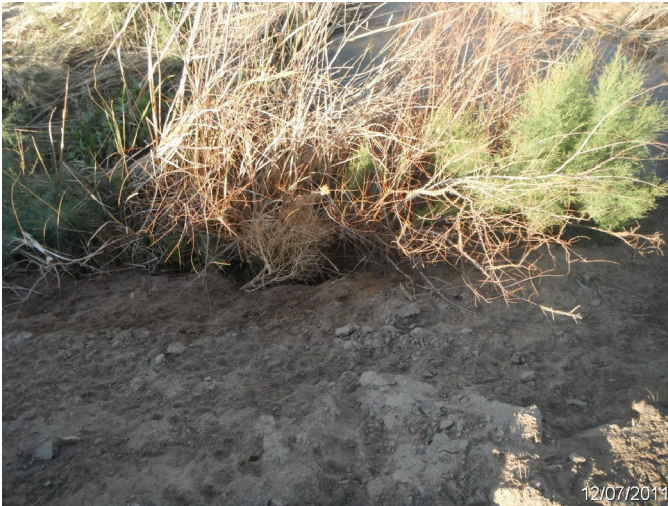
Photo: SASE\_C4\_0102 Route: 405-002-1.52  
Plastic WCS Flashboard Riser 30ft long 12in dia. 3ft deep  
Asset# 10000665

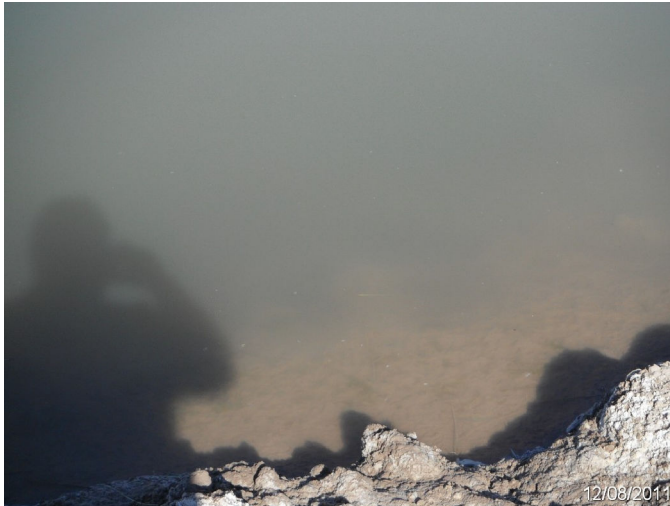
Photo: SASE\_C4\_0280 Route: 411-003-0.84  
Plastic WCS Flashboard Riser 30ft long 18in dia. 3ft deep  
Asset# 10000655

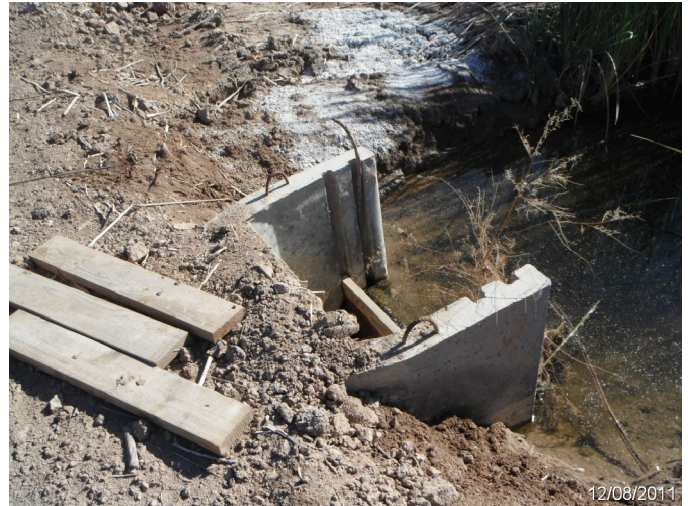
Photo: SASE\_C4\_0282 Route: 411-003-0.84  
Plastic WCS Flashboard Riser 30ft long 18in dia. 3ft deep  
Asset# 10000655

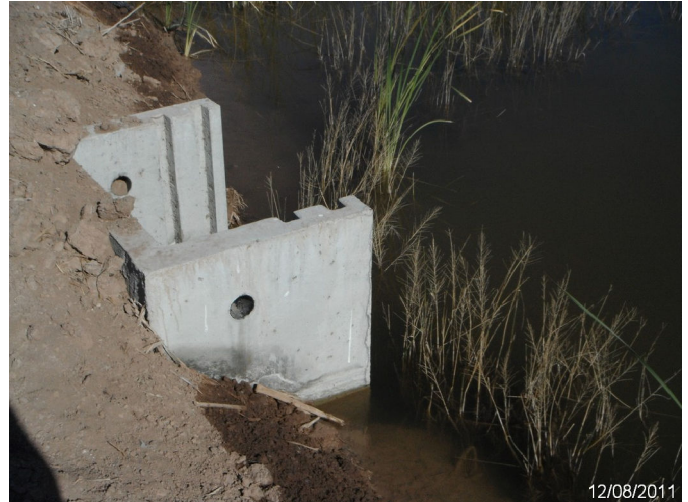
Photo: SASE\_C4\_0296 Route: 411-004-0.68  
Plastic WCS Flashboard Riser 25ft long 18in dia. 5ft deep  
Asset# 10000655
