# The Road Inventory of Sonny Bono Salton Sea National Wildlife Refuge Calipatria, CA

Prepared By:  
Federal Highway Administration  
Central Federal Lands Highway Division  
April 2012

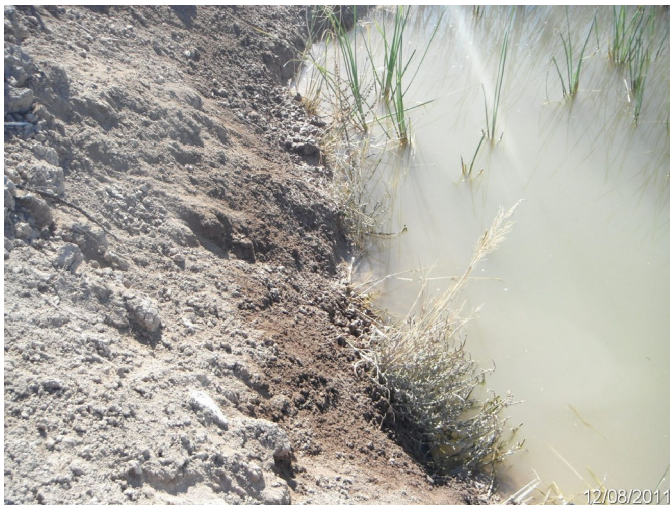
Photo: SASE\_C4\_0297 Route: 411-004-0.68  
Plastic WCS Flashboard Riser 25ft long 18in dia. 5ft deep  
Asset# 10000655

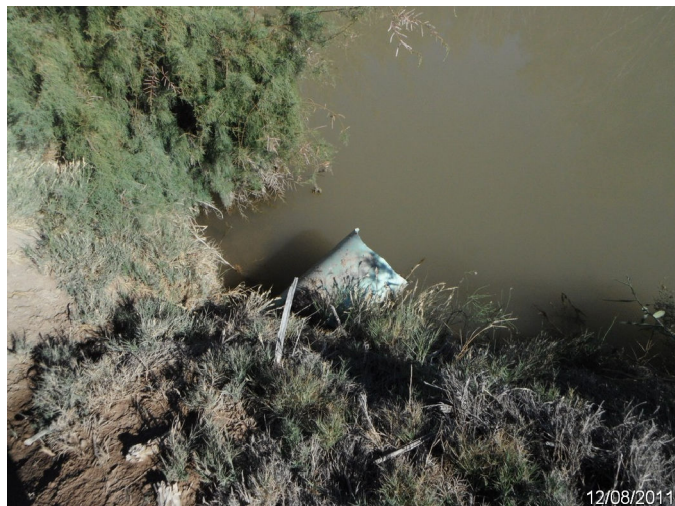
Photo: SASE\_C4\_0300 Route: 411-007-0.56  
Plastic Culvert 30ft long 18in dia. 4ft deep  
Asset# 10000655

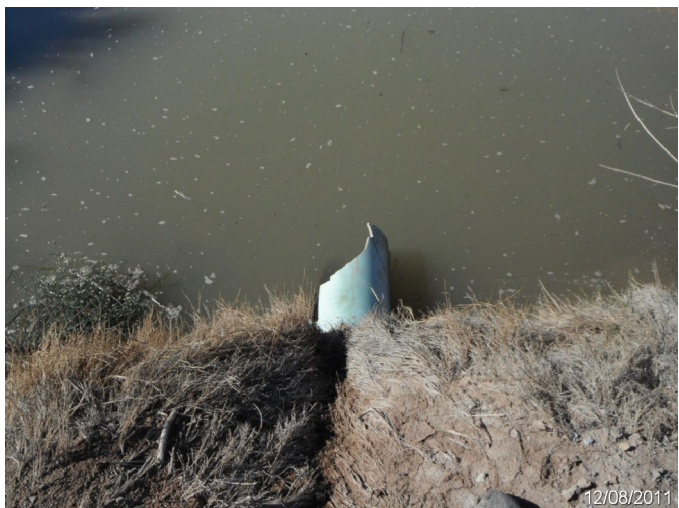
Photo: SASE\_C4\_0301 Route: 411-007-0.56  
Plastic Culvert 30ft long 18in dia. 4ft deep  
Asset# 10000655

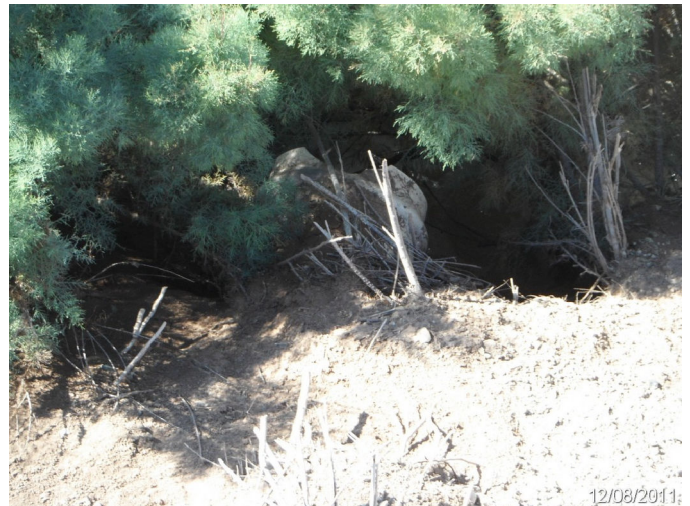
Photo: SASE\_C4\_0314 Route: 412-001-0.48  
Plastic WCS Flashboard Riser 25ft long 18in dia. 5ft deep  
Asset# 10000694

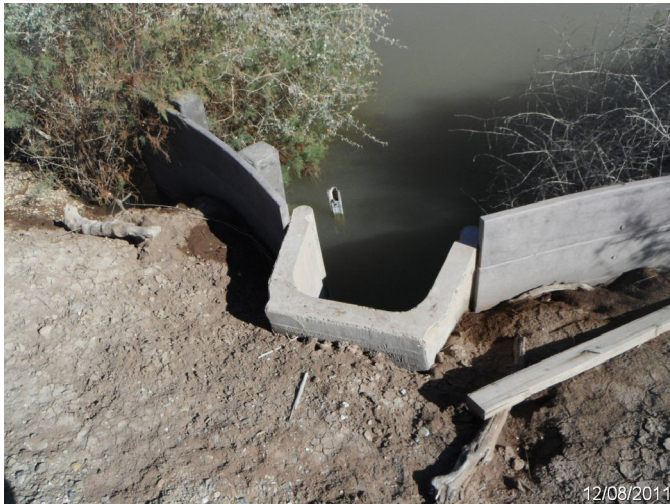
Photo: SASE\_C4\_0315 Route: 412-001-0.48  
Plastic WCS Flashboard Riser 25ft long 18in dia. 5ft deep  
Asset# 10000694

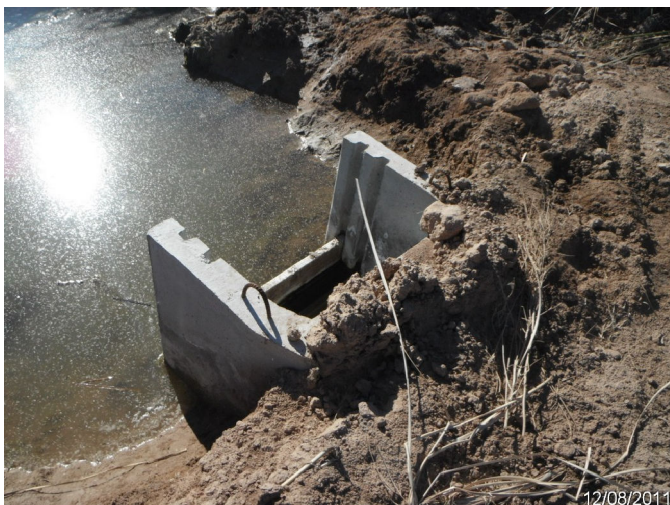
Photo: SASE\_C4\_0317 Route: 412-002-1.15  
Plastic WCS Flashboard Riser 50ft long 18in dia. 3ft deep  
Asset# 10000694

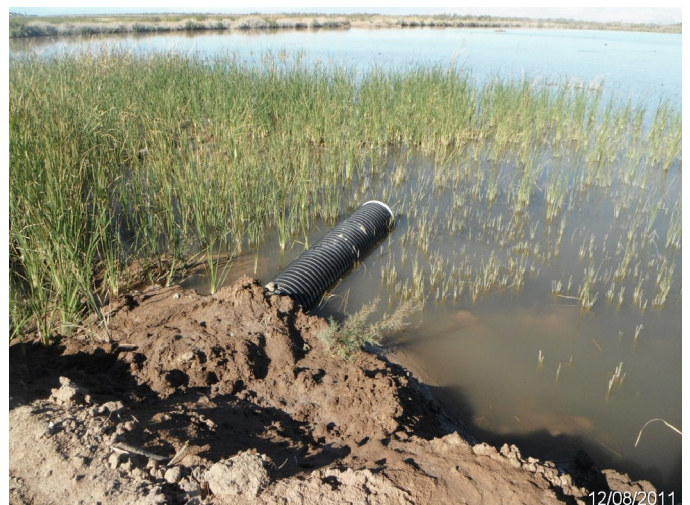
Photo: SASE\_C4\_0318 Route: 412-002-1.15  
Plastic WCS Flashboard Riser 50ft long 18in dia. 3ft deep  
Asset# 10000694 8-033

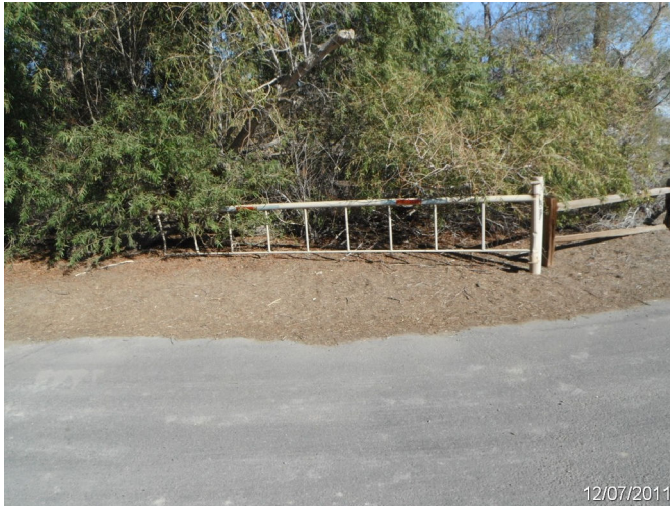
Photo: SASE\_C4\_0189 Route: 800  
Metal Open Rail Gate  
Asset# 10000666
